Earthworks risk assessment on a heritage railway

Crapper, Fell and Gammoh

http://dx.doi.org/10.1680/geng.12.00099
Paper 1200099
Received 10/09/2012 Accepted 19/03/2013
Keywords: embankments/railway systems/risk & probability analysis

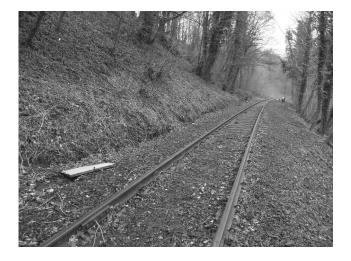
Figure 2. The Bo'ness and Kinneil Railway, showing typical cutting and embankment structure

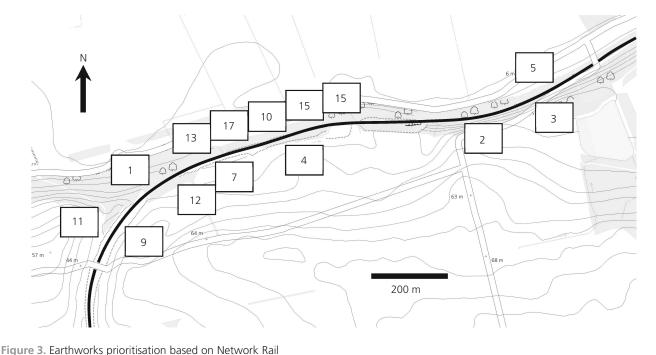
In order to prioritise possible interventions on the B&KR earthworks, the prioritisation toolkit was applied using all the original NR scheme unaltered. The main results of this analysis are shown in Figure 3, in which the prioritisation of earthworks is indicated by the large boxed numbers, with 1 indicating the earthwork section with the highest priority for monitoring and possible intervention. Some areas have equal priority, and thus the same number appears twice; the priorities shown are not all consecutively numbered, as some of the priorities between 1 and 17 were on sections of the railway not covered by the figure.

In this result, the top priority is at a location where there has been previous disturbance due to excavation for an oil pipeline crossing in the 1980s, and the consequence includes possible impact on the pipeline. This therefore appears to make sense. However, many of the next priorities are cutting sides on the south side of the railway. Applying engineering judgement, the prioritisation of these areas makes much less sense, since examination on site, together with the experience of some small past failures, suggested that the cutting sides could collapse with no significant consequence to third parties, there being only woodland or agricultural land on the top side of the cutting.

Figure 3. Earthworks prioritisation based on Network Rail weightings. Base map © Crown Copyright/database right 2013. An Ordnance Survey/EDINA supplied service

On the other hand, the embankment slopes given the 10th, 13th, 15th and 17th priorities had poor SSHIs, and engineering judgement suggested that any failure here could have a major impact on the railway. This would include undermining the track formation, severing the line and causing all income-generating operations to cease, as well as presenting a safety risk to trains and in some cases to owners of domestic property positioned below the railway.

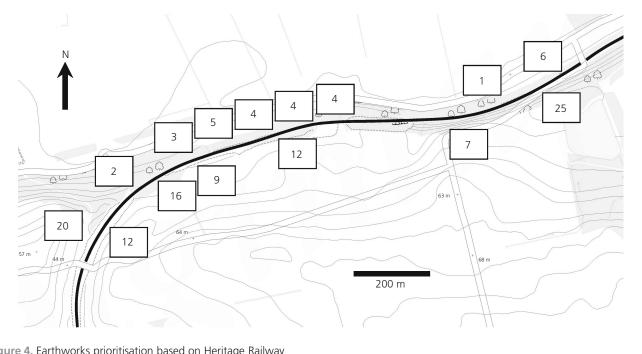
Figure 4. Earthworks prioritisation based on Heritage Railway weightings. Base map © Crown Copyright/database right 2013. An Ordnance Survey/EDINA supplied service

The revised priorities are indicated in Figure 4. They now tie in much more effectively with engineering judgement, the high, steep and sometimes wet embankment slopes north of the railway being given the highest priorities. If damaged, these embankments would potentially undermine the line, perhaps in a way not immediately noticeable from the driving cab of an approaching train, and they might result in collapse onto line-side property. The resulting disruption would entirely remove the railway's access to an income stream either from sale of passenger tickets or from revenue associated with rail tour movements, for which mainline access from Bo'ness station is required.

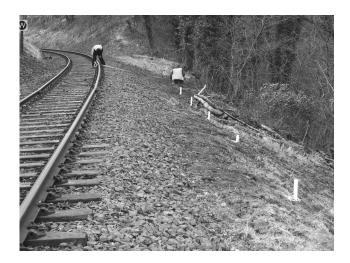
Figure 5. Setting out telltales in a priority area

Further, it is commonly noted that earthwork failure is rarely sudden or without warning (e.g. Bonnett, 2005, section 6.5, p. 85), and simple monitoring techniques are available to give early warning, the most obvious one being 'telltales', which consist of a number of pegs set out in a straight line. Any significant movement of the earthwork would result in pegs moving out of line, which would be readily observable even by an unqualified staff member. The matter could then be further investigated, and potential consequences reduced. Four sets of telltales have therefore been placed in priority areas 1 to 4, as shown in Figure 4, and will be inspected regularly, with the distance from the running edge of the rail and track cant being monitored at each peg (Figure 5).
