Full-scale fire test on an earthquake-damaged reinforced concrete frame

Kamath, P, Sharma, UK, Kumar, V, Bhargava, P, Usmani, A, Singh, B, Singh, Y, Torero, J, Gillie, M & Pankaj, P 2015, 'Full-scale fire test on an earthquake-damaged reinforced concrete frame', *Fire Safety Journal*, vol. 73, pp. 1-19. <https://doi.org/10.1016/j.firesaf.2015.02.013>

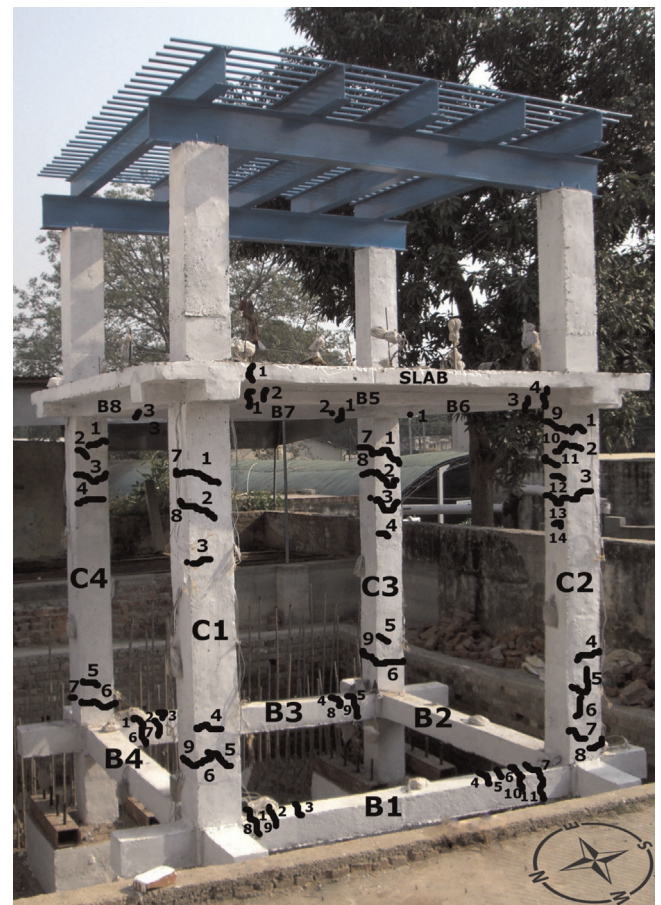
Fig. 8. Nomenclature for the identification of RC test frame members and schematic of cracks due to cyclic loading.

The nomenclature used to identify individual members of the RC test frame is shown in Fig. 8, also showing the north–south orientation of the frame. The test frame was inspected after each cycle of displacement to detect the formation of cracks and monitor their growth. No visually observable cracks were seen up to a lateral displacement of 20 mm corresponding to a roof drift ratio of 0.53%. The first set of cracks developed at the ends of the roof beams oriented along the N–S direction (beam B7) at a lateral displacement of 35 mm (roof drift ratio of 0.92%) corresponding to a base shear of 185 kN. The next set of cracks developed at the ends of the plinth beam B1 also in the N–S direction at the measured lateral displacement of 44 mm corresponding to a base shear of 212 kN. As expected, the flexural cracks occurred earlier and were more pronounced in the beams oriented in the direction parallel to the loading direction. Flexural cracking in the columns was first observed at the junction near the roof beams at a lateral displacement of 31 mm (roof drift ratio of 1.37%). Spalling of concrete was observed at the ends of the roof beams B5 and B7 at a roof drift ratio of about 2%. Widening of cracks was conspicuous in the columns and the plinth beams. It was attempted to maintain the hydraulic pressure in the loading jacks at a constant level when the displacement reached 80 mm (roof drift ratio of 2.11%) corresponding to a base shear of 267 kN (note that the intended displacement was 76 mm). However, due to the limitations of the load-controlled actuators, the actual value of the maximum

displacement reached was 95 mm. Flexural cracking, symptomatic of composite action between the RC slab and the roof beams spanning along the N–S direction was noted. After the final loading cycle, these flexural cracks on the roof slab propagated throughout the span from one end to the other in the direction parallel to the direction of loading. The formation of these flexural cracks indicates that a RC roof slab need not necessarily behave as a rigid diaphragm under in-plane loading [18]. Table 2 outlines the sequence of the occurrence of selected cracks in members of the frame that sustained the greatest damage during cycling loading. This table refers to crack locations shown schematically in Fig. 8. The base shear–roof displacement plot for the test frame depicted in Fig. 9 shows no deterioration in the lateral strength of the frame at life safety level of structural performance. Despite the observed inelastic excursions, the test frame did not suffer any significant

structural damage. Except for noticeable cracking, no major spalling (loss of big chunks) of concrete or loss of cover (exposing reinforcement) was observed at any location in the test frame at the desired level of mechanical pre-damage.

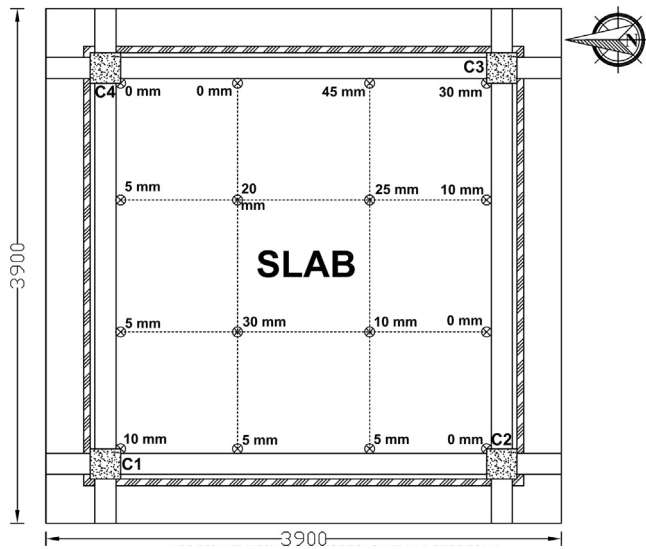
Fig. 13. Vertical residual displacements in roof slab.
