The Condition of the Aberfeldy Footbridge after 20 Years in Service

THE CONDITION OF THE ABERFELDY FOOTBRIDGE AFTER 20 YEARS OF SERVICE

Dr Tim Stratford
School of Engineering, The University of Edinburgh,
The King's Buildings, Edinburgh, EH9 3JL, Scotland
Email: Tim.Stratford@ed.ac.uk

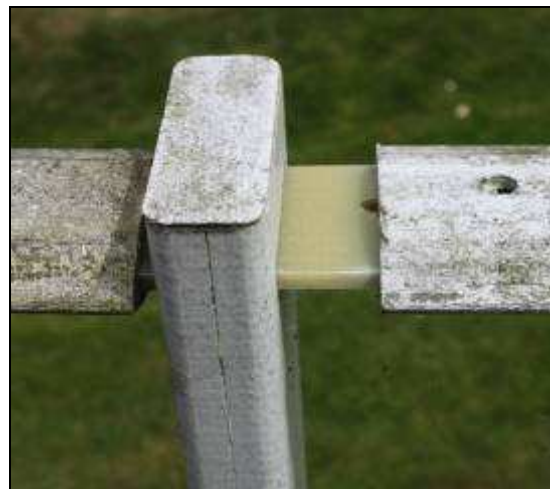
of the parapets as the bridge flexes; the sleeved plate was intended to provide damping through friction and hence improve the dynamic response of the bridge. The post-to-deck and rail-to-post connections have all worked loose, and there is considerable movement of the parapet components as the bridge flexes, but very little friction. Some top rail connections have become completely detached (Figure 12), and rudimentary repairs have been effected using screws and zip ties (Figure 13).

Figure 12. Details of the connection between the top handrail and parapet post (June 2008).
