Repair of a Model Masonry Arch Bridge using FRP

Y. Tao, J.F. Chen and T.J. Stratford

Institute for Infrastructure and Environment
Joint Research Institute for Civil and Environmental Engineering
The University of Edinburgh, Scotland, UK

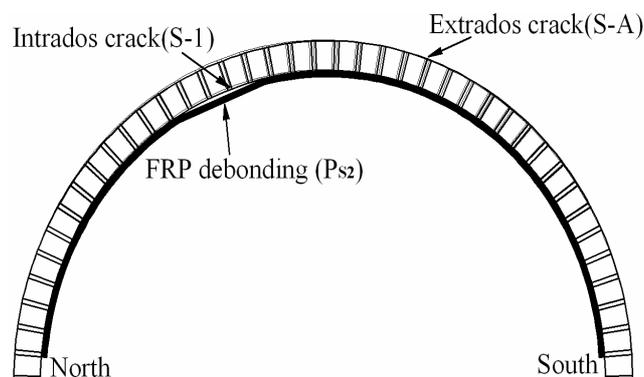
The initial FRP debonding failure occurred at the intrados hinge beneath the loading point at a load 250kN (Figure 4). The opening of the intrados crack (S-1) required high shear stress to be transferred across the adhesive, resulting in debonding of plate Ps₂ from the masonry. At this stage, the bond of the other five CFRP plates remained intact.

Figure 4. Plate P_{S2} on the southern arch after first debonding.

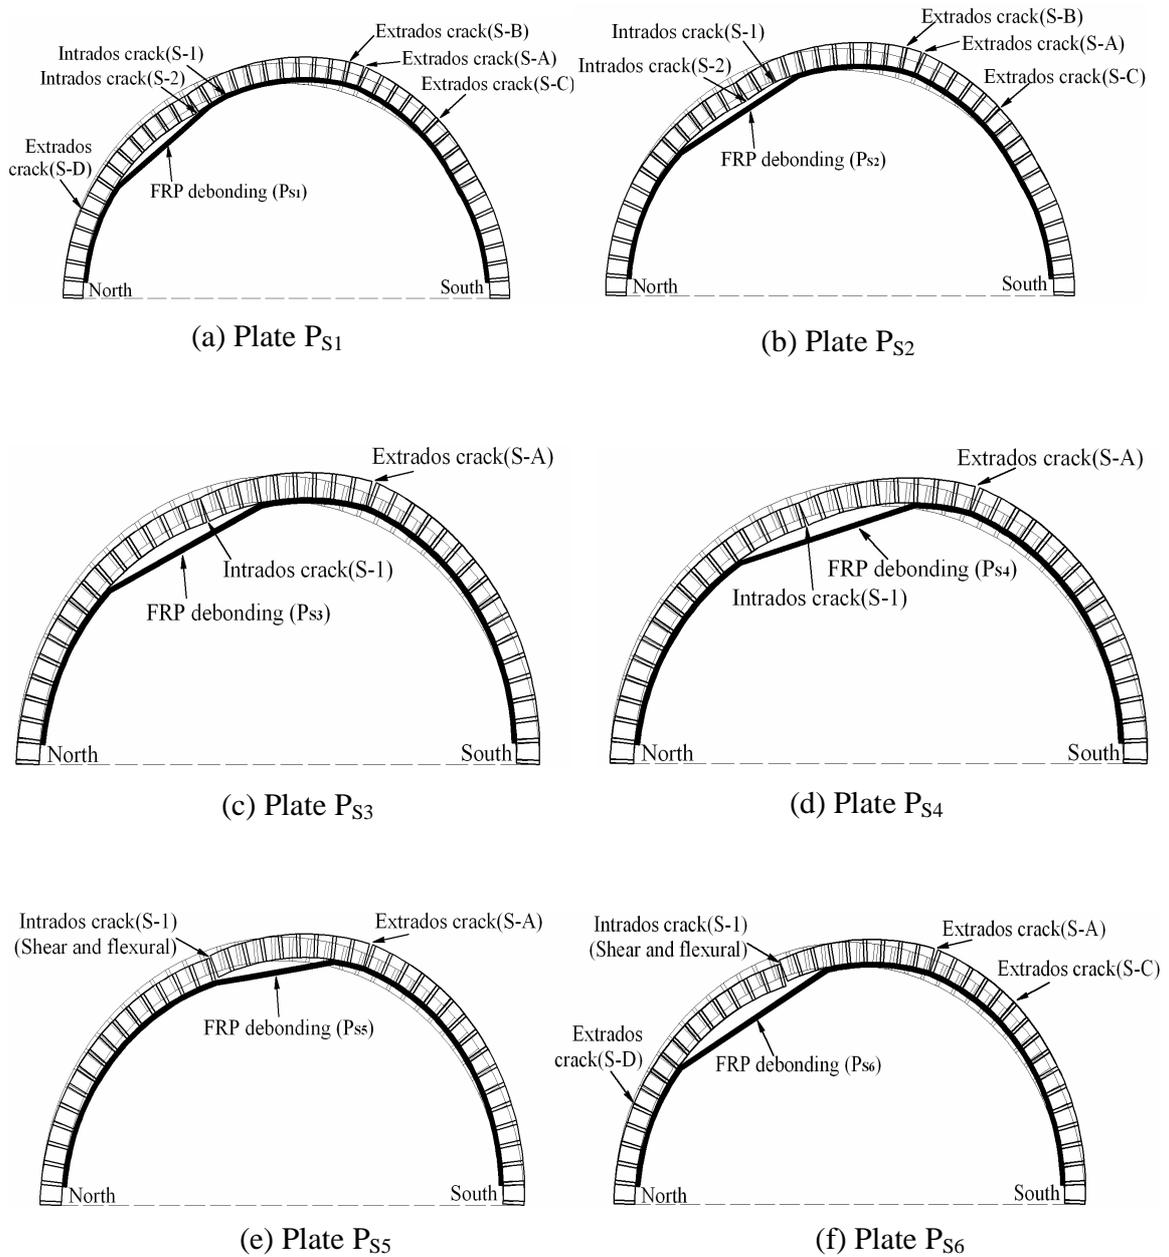
The type of masonry cracking and debonding varied across the width of the bridge as shown in Figure 5 where sections through the arch along each of the CFRP plates are shown. A new intrados crack (S-2) opened two bricks away from the original crack (S-1) at the east side of the bridge as shown in Figure 6. This new crack certainly crossed CFRP plate P_{S1} and P_{S2} , but it was not clear from photographs (direct observation underneath the bridge was not possible due to health and safety concerns) how far it penetrated into the central portion of the arch (P_{S3} and P_{S4}), but it was clear that this new crack did not extend to the west side of the bridge so it did not cross CFRP plate P_{S5} and P_{S6} . At the west side of the bridge, a mixture of rotational opening and shear occurred at intrados crack (S-1) as shown in Figure 7.

Figures 5 and 8 show the extent of debonding of each CFRP plate. Debonding of plates P_{S1} , P_{S2} , P_{S3} and P_{S4} was clearly due to rotational opening of the intrados crack (Figures 5a, b, c and d). The debonding of plate P_{S6} also appears to have been dominated by rotational opening of the intrados crack, as the debonded region bridges the crack (Figure 5f). Plate P_{S5} , however, appears to have been dominated by shearing of the masonry joint, accompanied by peel debonding that started at the intrados crack (Figure 5e).

Figure 5. Deformed shape of the southern arch and position of FRP after final debonding, shown along each CFRP plate section and viewed from the west.

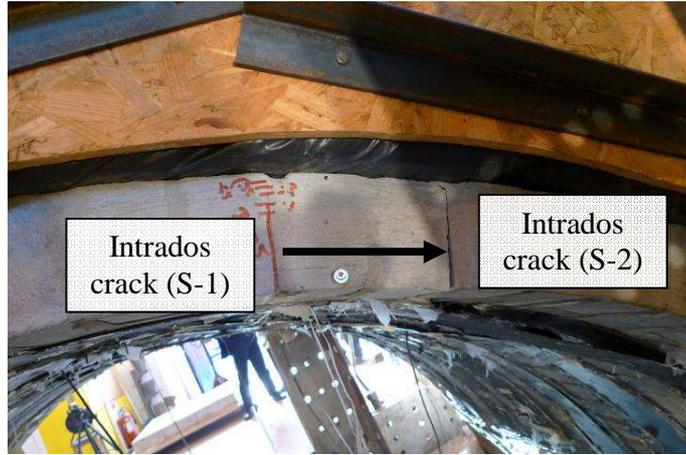
Figure 6. Development of second intrados crack near the loading position - viewed from the west

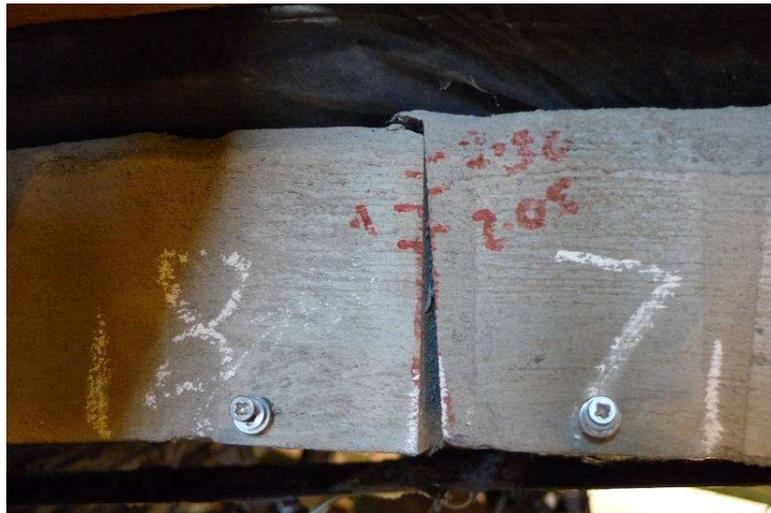
Figure 7. Mixed shear and flexural cracking failure at intrados crack (S-1) - viewed from the east

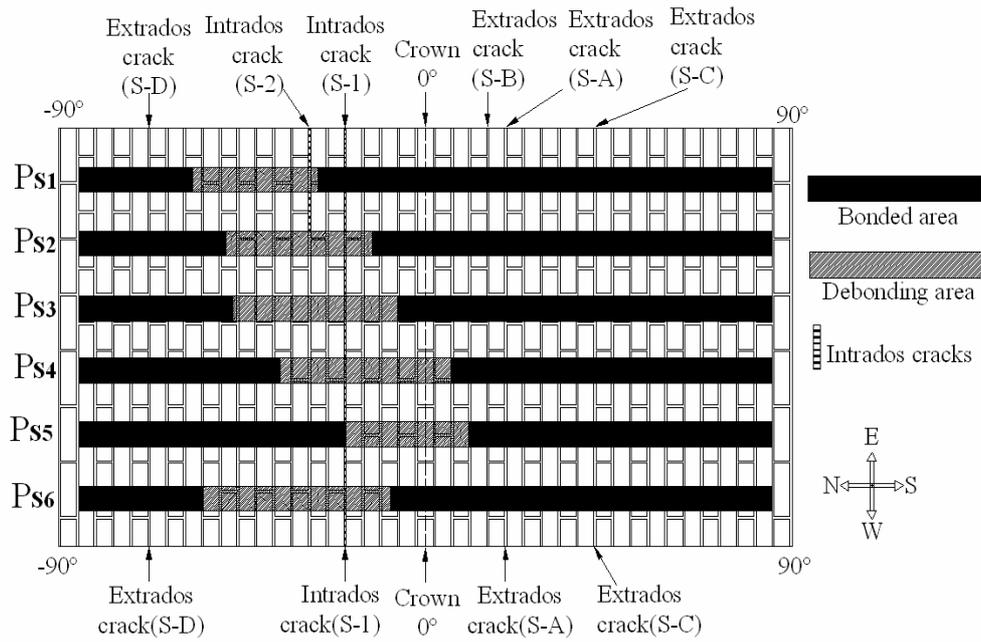
Figure 8. Plan view along the developed length of the southern arch after failure, showing the location of cracks and extent of debonding

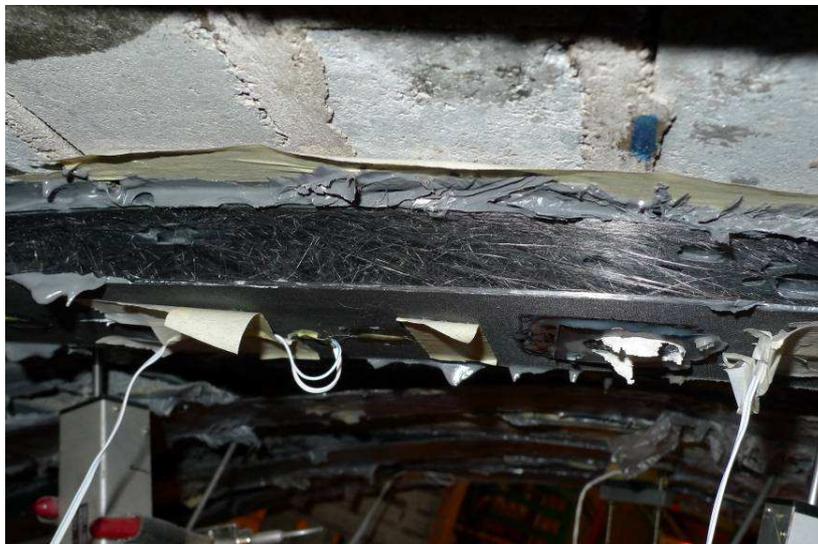
In all cases, separation of the CFRP from the masonry occurred slightly within the masonry, and left a thin layer of brick bonded to the plate to either side of the hinge. Further back from the hinge, however, the separation occurred within the laminate, leaving exposed fibres (Figure 9).

Figure 9. Debonding of the CFRP plate within the laminate, plate Ps₄
