Full-scale fire test on an earthquake-damaged reinforced concrete frame

Keywords: Post earthquake fire Reinforced concrete frame Full-scale testing and structural performance

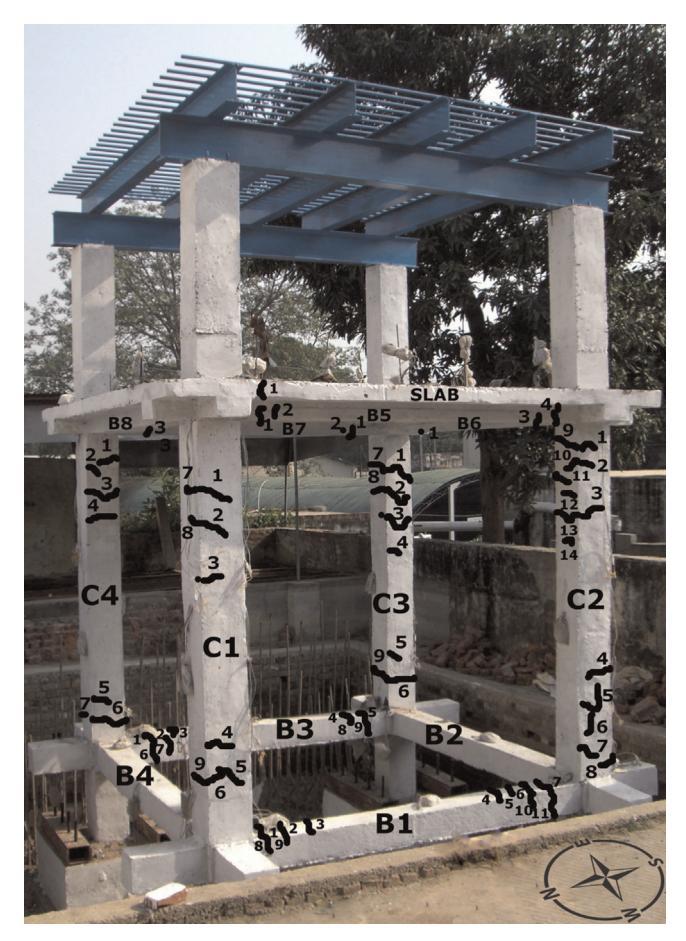
Fig. 8. Nomenclature for the identification of RC test frame members and schematic of cracks due to cyclic loading.

displacement reached was 95 mm. Flexural cracking, symptomatic of composite action between the RC slab and the roof beams spanning along the N–S direction was noted. After the final loading cycle, these flexural cracks on the roof slab propagated throughout the span from one end to the other in the direction parallel to the direction of loading. The formation of these flexural cracks indicates that a RC roof slab need not necessarily behave as a rigid diaphragm under in-plane loading [18]. Table 2 outlines the sequence of the occurrence of selected cracks in members of the frame that sustained the greatest damage during cycling loading. This table refers to crack locations shown schematically in Fig. 8. The base shear–roof displacement plot for the test frame depicted in Fig. 9 shows no deterioration in the lateral strength of the frame at life safety level of structural performance. Despite the observed inelastic excursions, the test frame did not suffer any significant structural damage. Except for noticeable cracking, no major spalling (loss of big chunks) of concrete or loss of cover (exposing reinforcement) was observed at any location in the test frame at the desired level of mechanical pre-damage.

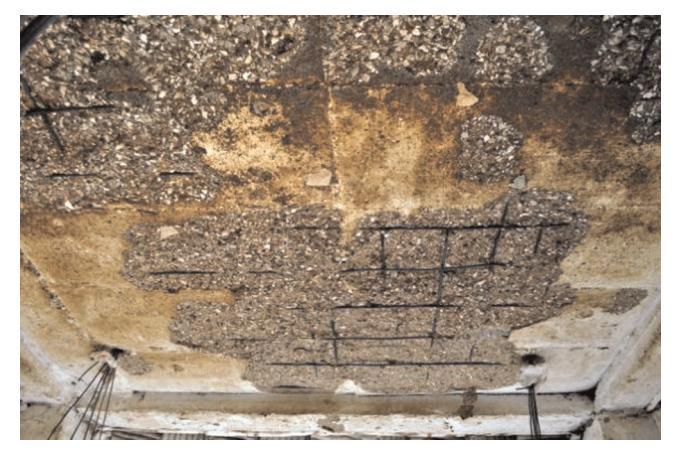
Fig. 12. Spalling in roof slab after fire.

The first major event to be observed, both visually and audibly, was the spalling (loss of cover concrete at the soffit) of concrete at the roof slab initiating 4–5 min after ignition and continuing for almost 15 min and resulting in the exposure of reinforcement. During this period the compartment temperatures near the roof slab were of the order of 300-400 °C in the front and close to 1000 °C at the back of the compartment where the worst of the spalling was observed, suggesting that a high temperature gradient produces more severe spalling (see Fig. 12). Fire induced spalling is often linked to temperature gradients causing rapid development of pore-pressure in concrete exceeding its tensile strength [19–21], especially in regions of higher compressive stresses. Furthermore, the portions of the roof slab already

damaged during the lateral load test were more vulnerable to spalling compared to the undamaged portions. The loud firecracker like sounds which indicated the initiation of spalling suggested that the spalling was of an explosive nature resulting from high pore pressures exacerbated by the fact that the frame had entrapped moisture from the rain earlier in the week before the test. Bazant [22], Ulm [23,24] and Zukov [25] suggest that spalling occurs due to prevented thermal expansion. Careful observation of spalled soffit of the slab suggests high compressive forces were induced in the bottom layers of the roof slab concrete due to the rotational restraint offered by the peripheral beams against thermal bowing (resulting in hogging bending moments across the whole exposed face of the slab). Further high compressive stresses are induced in the layers of concrete near the exposed face which are restrained from expanding thermally by the cooler layers above and ultimately also by the lateral restraint from the peripheral beams. The lack of the spalling around the service holes (made for anchoring thermocouple trees) also indicates that spalling may be influenced by high compressive. Even though compressive stresses exacerbate the severity of spalling, they were also likely to be beneficial to the integrity of the roof slab by aiding compressive membrane resistance (action similar to prestressing). However, spalling remains a very complex phenomenon dependent on parameters such as porosity, permeability, differential thermal expansion between cement paste and aggregate, high moisture content, heating rate and external loads [26] and is not the key focus of the current study. The lack of collapse of the roof slab even after severe spalling means that the effect of thermally assisted compressive membrane action can considerably enhance the load-carrying capacity of the roof slab considerably beyond the calculated flexural resistance. In the later stages of test, i.e., during the growth stage, spalling of concrete and appearance of micro-cracks were observed in beams and columns. In general, the fire induced several surface cracks on all the members which started forming at a temperature of about 600 °C. These cracks further widened at higher temperatures. As observed in the roof slab, the portions of the columns and beams, which suffered greater damage during the simulated earthquake loading, also experienced greater thermal damage.

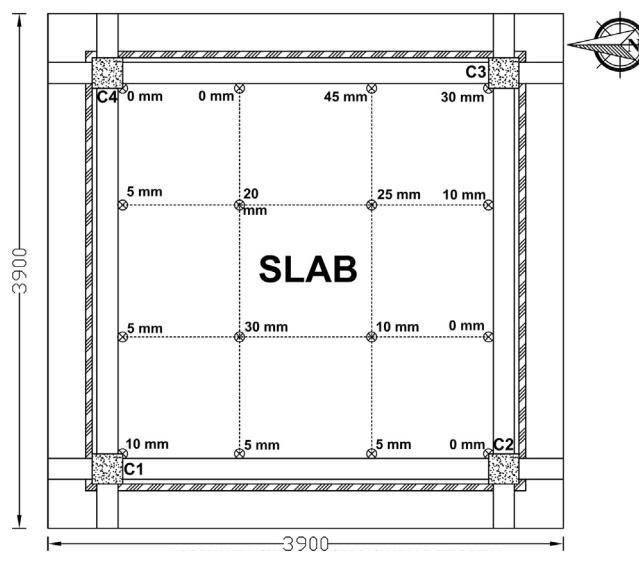
Fig. 13. Vertical residual displacements in roof slab.

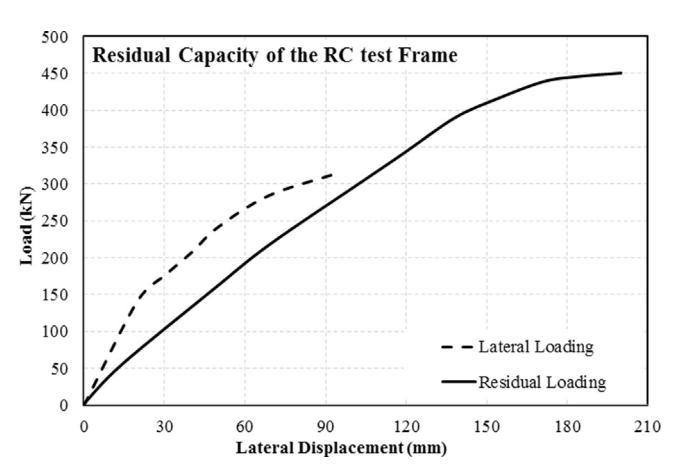
Fig. 20. Comparison of loading envelopes of seismic loading test and residual capacity test.

Uniaxial monotonic lateral loading applied at this stage to the RC test frame was plotted against its corresponding displacement as shown in Fig. 20. The plot is compared with the loading envelope of the cyclic lateral loading in the same direction. The comparison shows a degradation of both strength and stiffness in the test frame after exposure to the simulated seismic and fire loading. An initial loss of 44% in the lateral load resisting capacity was observed at the displacement of 30 mm. At the peak lateral

displacement of 96 mm, applied in the simulated seismic loading stage, 10% degradation in lateral load resisting capacity was observed. It should be noted that the two plots are not strictly comparable as one represents one side of a hysteretic backbone curve and the other represents monotonic pushover. Although numerous cracks and concrete spalling were predominantly observed at displacements beyond 100 mm, the frame showed no sign of collapse. The load was released upon reaching the target displacement of 200 mm. A maximum load of 450 kN was recorded at the target displacement. A residual permanent displacement of 27 mm was observed upon the release of the pushover load.
