## Experimental investigation of reinforced concrete and hybrid fibre reinforced concrete shield tunnel segments subjected to elevated temperature

Yan, ZG, Shen, Y, Zhu, HH, Li, XJ & Lu, Y 2015, 'Experimental investigation of reinforced concrete and hybrid fibre reinforced concrete shield tunnel segments subjected to elevated temperature', *Fire Safety Journal*, vol. 71, pp. 86-99. <https://doi.org/10.1016/j.firesaf.2014.11.009>

## Experimental Investigation of Reinforced Concrete and Hybrid Fibre Reinforced Concrete Shield Tunnel Segments Subjected to Elevated Temperature

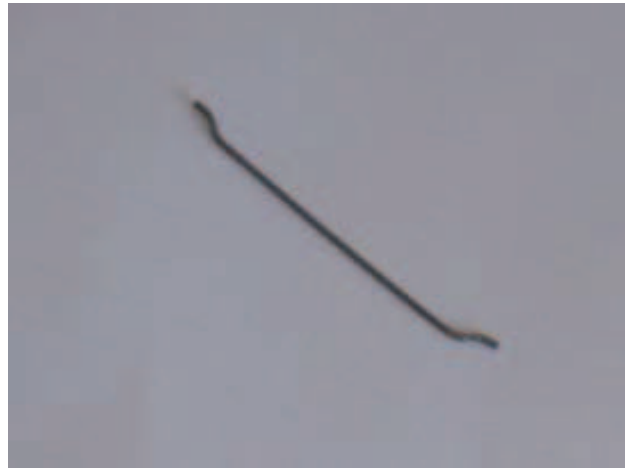
(a) polypropylene fibers

(b) steel fiber

**Fig.2.** Fibers used in this study

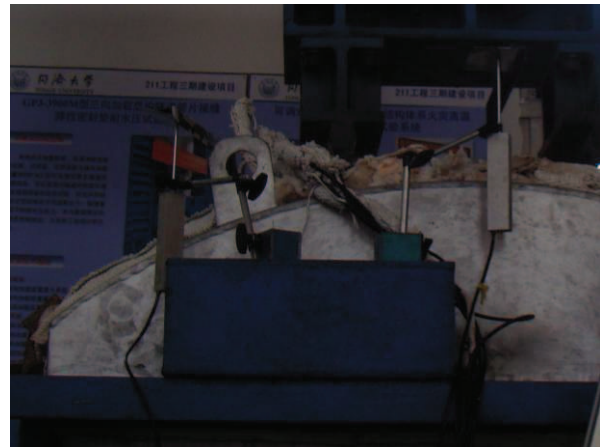
(b) Insulated specimen on top of furnace

Fig.3(b) shows a fully insulated specimen mounted on top of the furnace. A closed heating chamber was formed by two removable cover insulation panels that were situated on the two opposite sides of the segment. Any gaps between the segment and the insulation panels were filled up with ceramic fibres. Hence, the heating condition was considered to represent a uniform, single-face heating of the tunnel linings in fire.

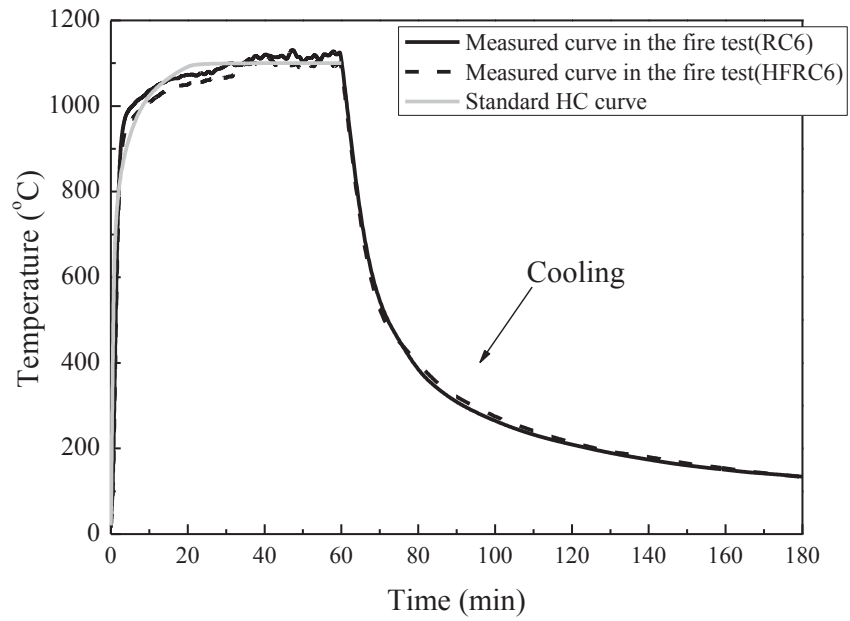
**Fig.4.** Standard HC curve and the measured temperature curves from the fire tests

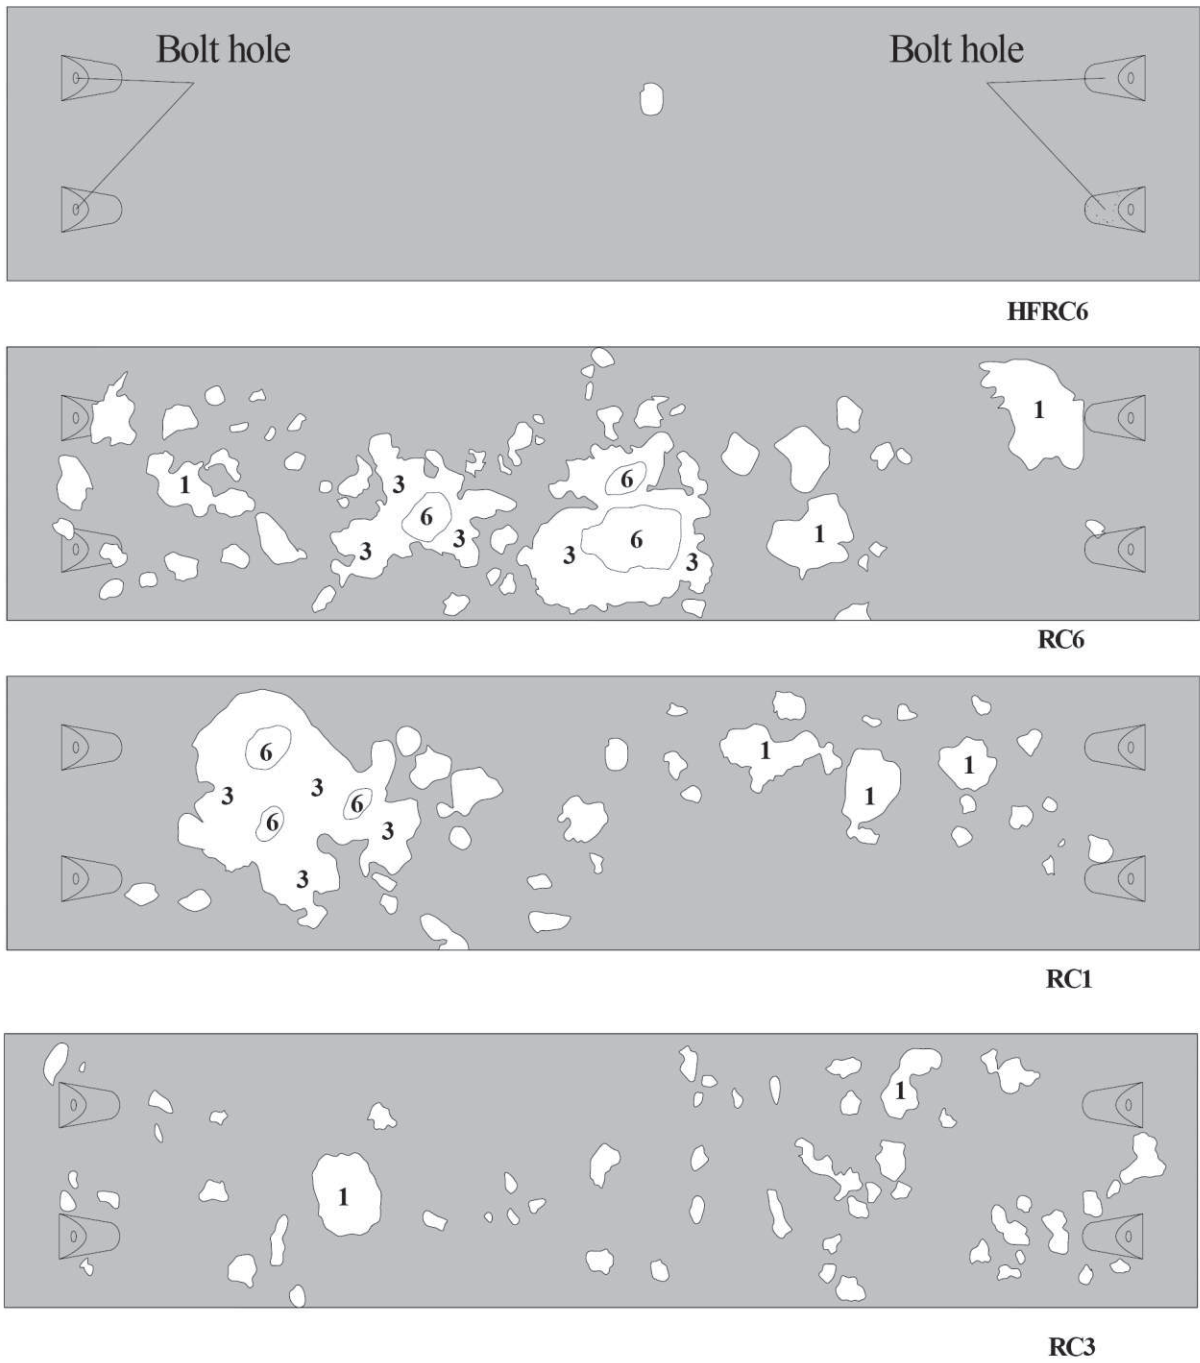
**Fig.6.** Contours of spalling distributions for RC and HFRC segments after fire exposure

The severity of spalling may be measured by both the spalling depth and the spalling spread area, which can be conveniently illustrated by spalling contour plots. Typical spalling contours after the fire exposure for RC and HFRC segments are shown in **Fig.6**. **Fig.7** presents a pair of photographs showing different severity of spalling between RC and HFRC segments. It is worth noting that the spalling occurred from about the 30<sup>th</sup> second to 120<sup>th</sup> second after fire exposure. As almost no spalling occurred in the HFRC, only one HFRC specimen is shown here for a comparison.

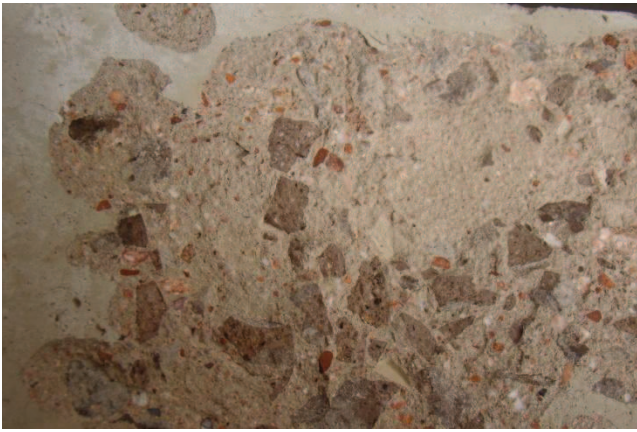
(a) RC segment

(b) HFRC segment

**Fig.7.** Comparison of severity of spalling between RC and HFRC segments after fire exposure

In contrast to HFRC, extensive spalling occurred in the RC segments. Different RC specimens exhibit somewhat different patterns of spalling; however, such variation is deemed to be random and there was no evidence to suggest any close association with the different boundary conditions. As listed in **Table 4**, the maximum spalling area of HFRC segment was less than 0.5% of the inner face whereas the minimum spalling area of RC segment was 8.9%. During the tests, evaporation occurred and the vapour could be visibly observed to escape from the cracks of the lining segments.

In the HFRC specimens, the two types of fibres appeared to have worked effectively in protecting the specimens from explosive spalling and maintaining the surface integrity. Examination after the tests revealed that the steel fibres in the HFRC lining segments remained intact after exposure to high temperature, along with colour changes from a metallic color to a darker color which shows severe oxidation of steel fibres during heating.

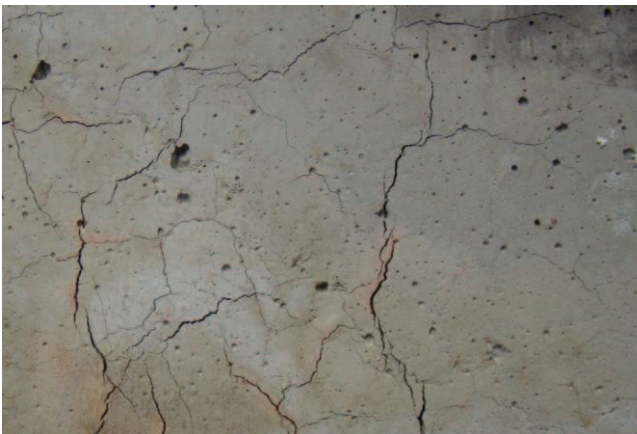
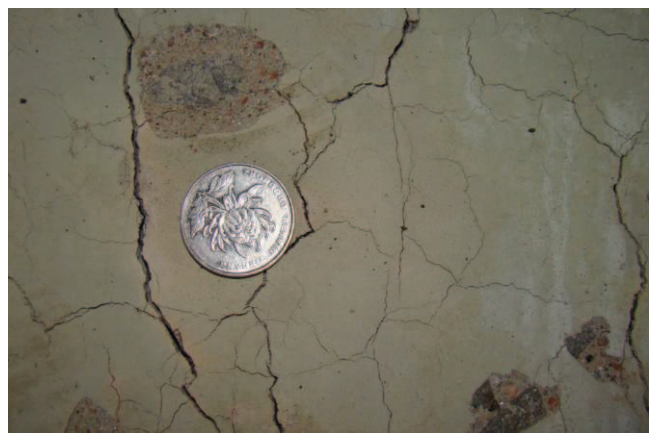
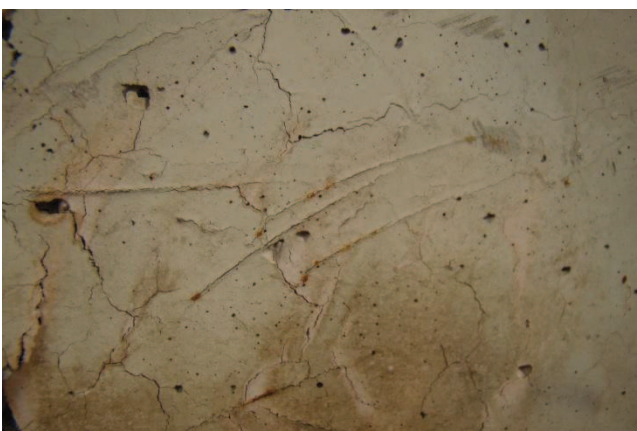
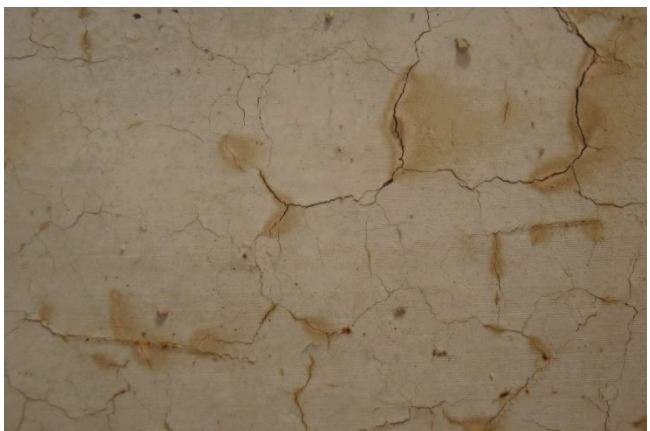
(a) RC segments

(b) HFRC segments

**Fig.8.** Temperature cracks of RC and HFRC segments under LC1 after fire exposure

**Fig.8** shows a comparison of the more detailed crack patterns between typical RC and HFRC specimens under LC1, which represents thermal-induced cracking under a service load condition. The crack widths on the side faces of all specimens were less than 1mm. However, the widths of the main cracks of RC segments on the heated face reached 2~3 mm (as a scale reference the diameter of the coin shown in the photos was 25 mm).

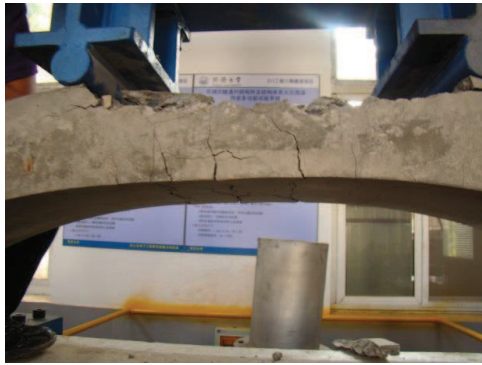
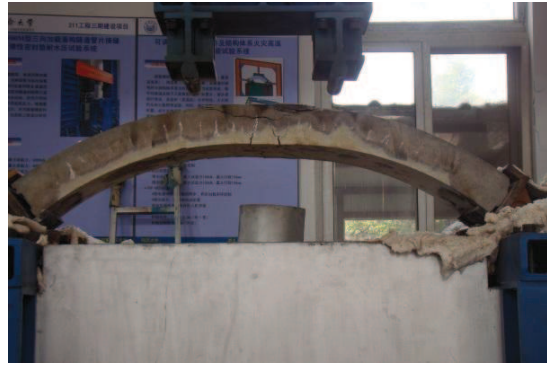
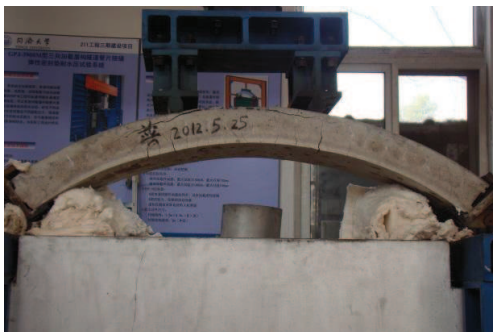
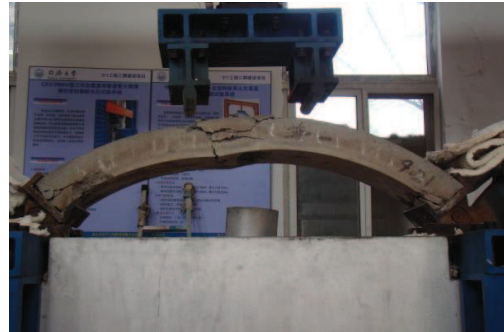
(a1) RC0, Ambient, free slide ( $R_H=0$ )

(a2) RC1, Under fire, free slide ( $R_H=0$ )

(a3) RC5, Post fire, free slide ( $R_H=0$ )

(b) RC4, Post fire, fixed pin ( $d_H=0$ )

**Fig.10.** Failure modes of RC specimens under positive (sagging) moment loading

Inspection of the failure patterns (**Fig.10(a1)-(a3)**) reveals that all the three specimens exhibited a typical compressive bending failure over the mid-span region, with crushing of concrete occurring on the top (compressive) side of the segments, while major flexural cracks also developed. Based on the equilibrium and RC section analysis, it can be found that the tensile steel is slightly over-reinforced, and therefore the observed concrete compressive failure was not surprising. Such a governing mechanism also explains the less significant effect of fire on the overall behaviour and the maximum resistance of these specimens, as the critical compressive concrete on the top side of the specimens was essentially not affected by the fire.

It is worth highlighting that the above specimens were under a sliding support condition. It can be expected that when the horizontal constraint at the two end supports increases, the behaviour of the segment would be inclined further towards a compression-dominated bending mechanism because of the involvement of the axial compression. This was evidenced in specimen RC4, for which the vertical load vs. mid-span deflection curve is shown in **Fig.9(b)** and the failure pattern is given in **Fig.10(b)**. **It can be seen that the specimen failed in a predominantly compressive manner, and as a result the maximum load resistance was about six times larger than the specimens under a sliding support condition, but became even more brittle.** Although there was no direct comparison with an ambient test, based on the observations from the sliding RC specimens it may be reasonable to deduce that fire had an insignificant effect on the resistance of this specimen.

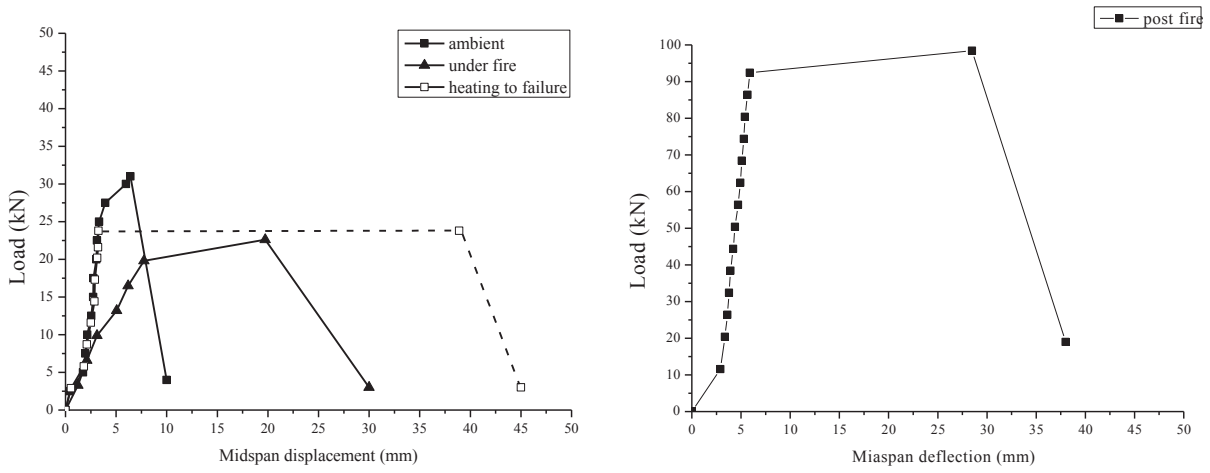
(a) Free sliding BC1 ( $R_H=0$ )

(b) Fixed pins BC2 ( $d_H=0$ )

**Fig.11.** Vertical load vs. mid-span deflection curves for HFRC specimens under positive bending moment loading

For the HFRC specimens under a sliding boundary condition, the vertical load vs. mid-span deflection curves are given in **Fig.11(a)**, and the corresponding failure modes are shown in **Fig.12(a1)-(a3)**. It is noted that the post fire case (HFRC5) failed during the cooling stage and so the curve is not included in **Fig.11(a)**; however the failure pattern was captured

increased axial compression. Therefore, the maximum vertical resistance increased considerably, as illustrated in **Fig. 11(b)** in comparison to **Fig. 11(a)**. The combination of axial force, bending and shear effects led eventually to a clear diagonal shear failure in the high shear region from the support to the first loading point, as shown in **Fig. 12(b)**. Comparing to RC4 which was under a similar boundary and fire condition, the failure mode in HFRC4 appeared to exhibit better deformability at the ultimate load level.

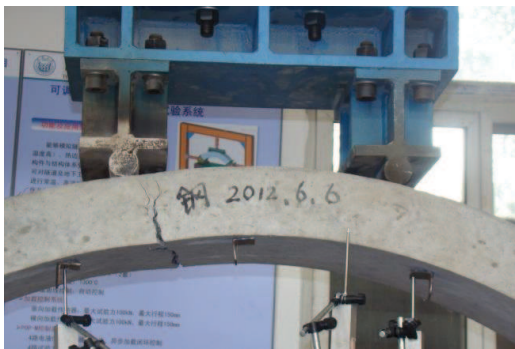
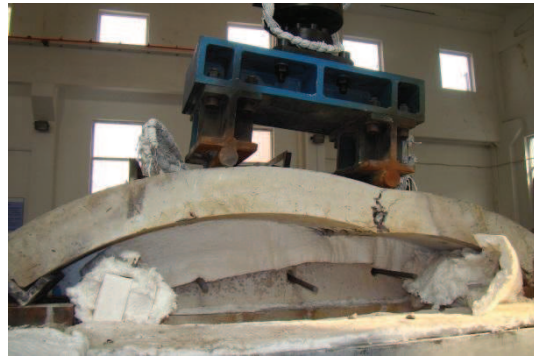
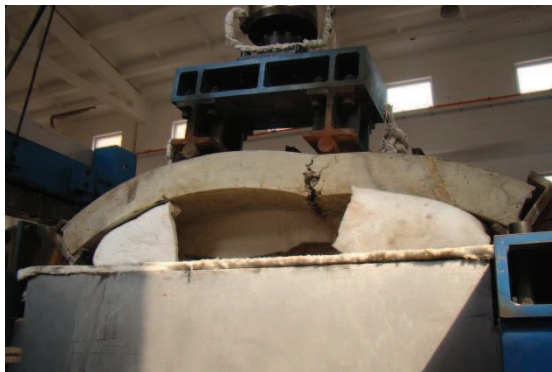
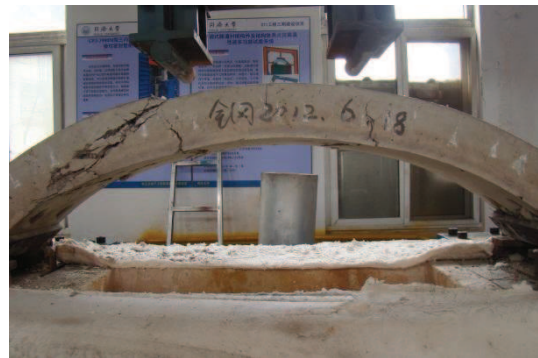
(a1) HFRC0, Ambient, free slide ( $R_H=0$ )

(a2) HFRC1, Under fire, free slide ( $R_H=0$ )

(a3) HFRC5, Post fire, free slide ( $R_H=0$ )

(b) HFRC4, Post fire, fixed pin ( $d_H=0$ )

**Fig.12.** Failure modes of HFRC specimens under positive moment loading

as shown in **Fig.12(a3)**. Generally speaking, these specimens exhibited a less ductile behaviour; but unlike the RC specimens discussed earlier, the failure patterns in these HFRC specimens were apparently due to insufficient tensile capacity, i.e. an under-reinforced bending. Recall that the HFRC specimens had only fibre reinforcement and did not have main reinforcing steel bars. As a result, the specimens quickly reached an ultimate state when bending cracks developed due to the insufficient ability of the fibres in withstanding the tensile force under bending.

The above characteristic of the HFRC specimens under no horizontal constraint renders the segments to be structurally susceptible to the fire effect because the major positive bending cracks exposed the tension fibres near the bottom side to high temperature. This is evidenced by the marked reduction of the maximum vertical load in the under-fire test as compared to the ambient test, as well as the failure of HFRC5 specimen which was subjected to a constant initial load of 15% of the maximum ambient resistance but failed during the cooling phase. The seemingly increased ductility in the “under fire” test might be attributable to the softening of the steel fibres while being exposed to the high temperature.

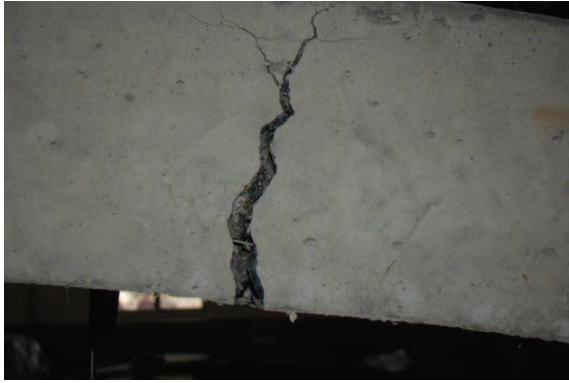
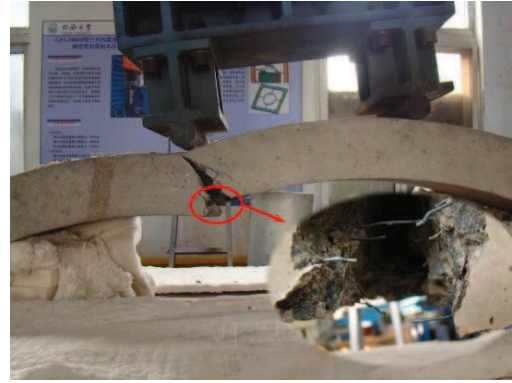
(a) Steel fiber failure under mechanical loading

(b) Steel fiber failure under thermal-mechanical loading

**Fig.13.** Comparison of steel fiber failures between mechanical load test under ambient temperature and fire endurance test

A close-up inspection of the cracks during the ambient test, as shown in **Fig.13(a)**, suggests that the steel fibres were pulled out despite having originally hooked ends. This contributed to the insufficient tensile capacity on the tension side of the section. **Under fire, however, the steel fibres crossing the main crack snapped because of softening under high temperatures; this resulted in an increased deformability but the maximum resistance was reduced considerably.** The snap-rupture and melting of steel fibres was detectable at the main crack shown in **Fig.13(b)**.

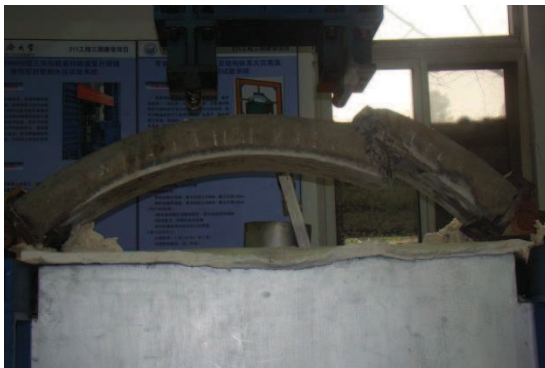
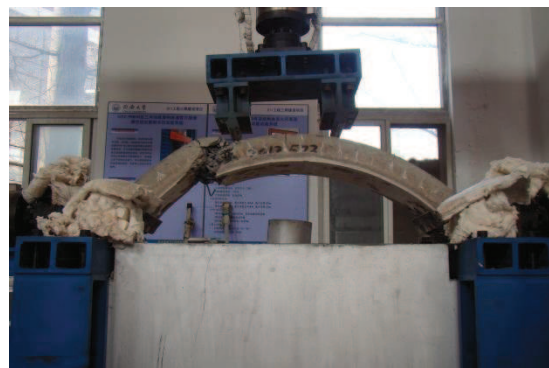
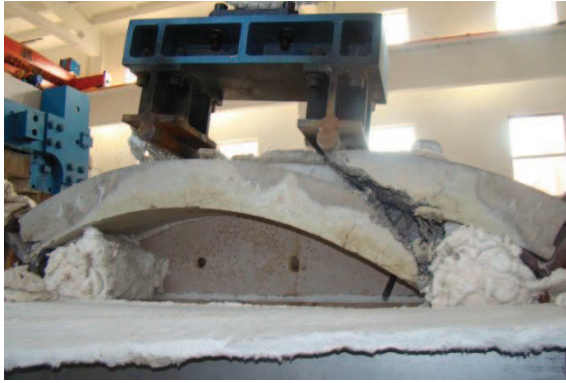
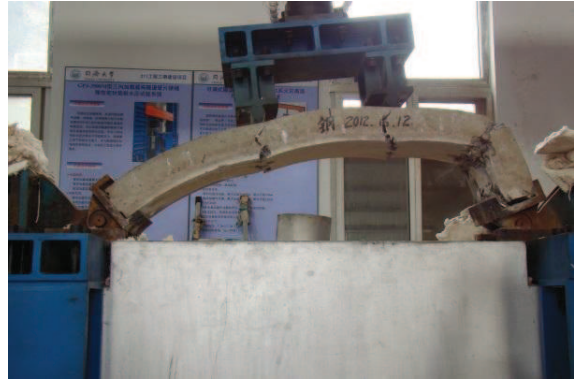
(a) RC2 ( $P_v/R_H=1.2$ , under fire)

(b) RC6 ( $P_v/R_H=1.2$ , post fire)

(c) HFRC2 ( $P_v/R_H=1.2$ , *under fire*)

(d) HFRC6 ( $P_v/R_H=1.2$ , *post fire*)

**Fig.15.** Failure modes for hogging moment loading cases

modes shown in **Fig.15(a) and (b)**, it is clear that the governing mechanism was due to relatively high shear, resulting eventually in shear failure near the loading point (towards the support). As the tension-shear cracks developed from the inner surface, both the reinforcing bars and the upper concrete along the shear crack were exposed to fire, leading to degradation of their strength under high temperature and hence a substantially reduced overall strength in the under-fire test as compared to the post-fire test, in which case the strength of the reinforcing bars recovered after cooling.

The load-deflection curves for the two HFRC segments are given in **Fig.14(b)**, and the failure patterns are shown in **Fig.15(c) and (d)**. Ignoring the initial settlement, the vertical deflection was also small at first (elastic) stage of loading, and tended to sway into the opposite (upward) direction (particularly in the case of post-fire test). The post-fire test specimen (HFRC6) failed in a rather brittle manner when the maximum load was attained, and the failure mode indicates that it was clearly a shear failure. The failure mode of the under-fire specimen (HFRC2) was somewhat peculiar, featuring a mixed bending failure in different regions of the specimen. This may be explained by the fact that, despite a hogging moment at the mid-span section, the controlled horizontal reaction and the vertical load ratio actually rendered the whole specimen to be under high compression (like an arch), while bending and shear failure could sway either way during the ultimate stage depending on the actual damage development under a significant compression state.

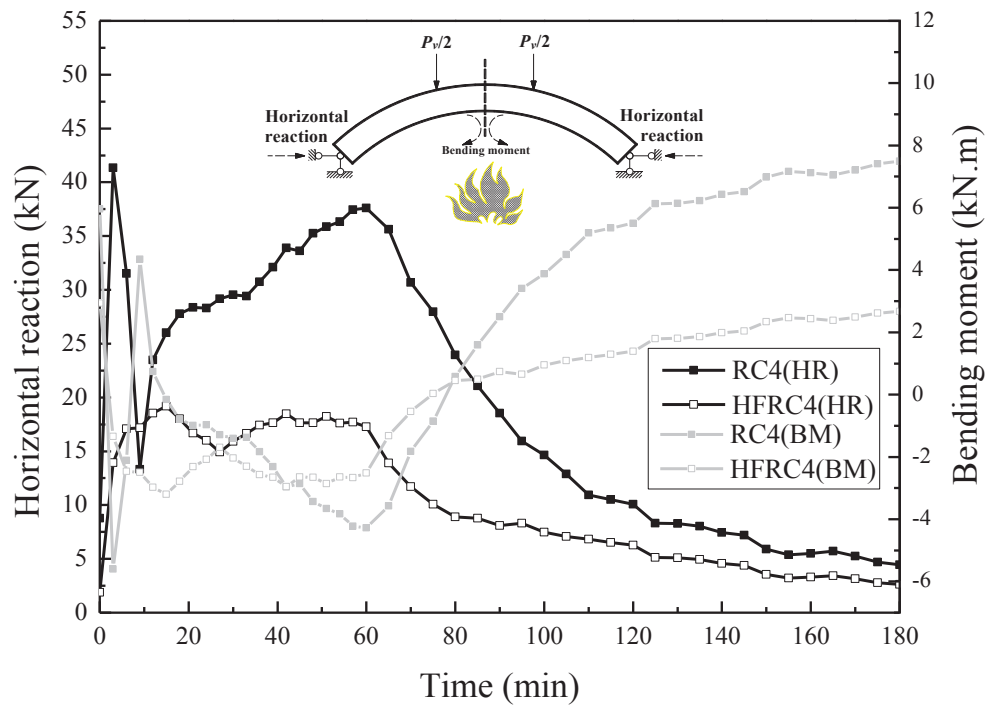
**Fig.17.** Development of horizontal reaction at the supports and bending moment at the central section during heating and cooling phases
