Li, L, Wang, W, Chen, Y & Lu, Y 2015, 'Effect of beam web bolt arrangement on catenary behaviour of moment connections', *Journal of Constructional Steel Research*, vol. 104, pp. 22-36.  
<https://doi.org/10.1016/j.jcsr.2014.09.016>

# Effect of Beam Web Bolt Arrangement on Catenary Behaviour of Moment Connections

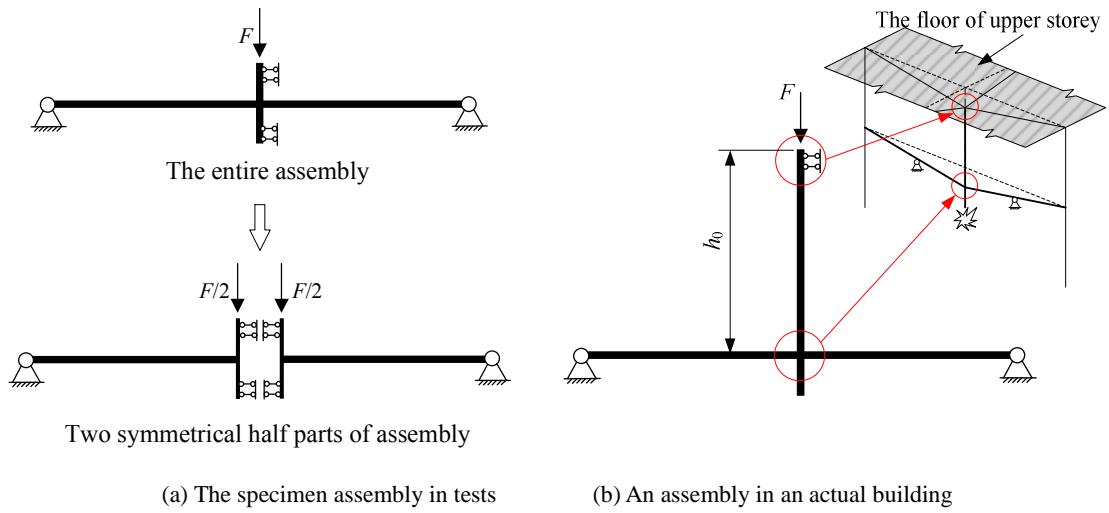
Fig. 4. The boundary conditions of the beam-to-column assembly.

As depicted in Fig. 4 (a), due to the top and bottom constraint of the centre column in the test, a symmetrical assembly is supposed to deform as two independent half parts under the vertical load. It is also acknowledged that, in a column removal scenario for an actual building (refer to Fig. 4 (b)), the constraint at the bottom of the assembly would not be provided. Nevertheless, as observed in relevant test findings [12, 17], the entire assembly still symmetrically carries the upper load prior to the first occurrence of a severe damage (for instance the fracture of beam bottom flange). Thereafter, the column would suffer an unbalanced action as a result of the different resistances of the intact or damaged connections on both sides. Therefore, a certain amount of column slope may be induced and its magnitude is believed to depend upon the flexural stiffness of the column. The influence of such column slope on the response of the assembly during the whole loading process will be assessed in Section 4.5 by the means of the detailed finite element analysis. The analysed assembly consists of a one-storey-height column and two connected beams as shown in Fig. 4 (b), and the connection configuration is identical to that of Specimen SI-WB-2. From the analysis results, the one-storey-height column generally kept vertically moving and the response of the assembly agreed with the simulation results of the Specimen SI-WB-2. In view of this, the response of the assembly in the experimental boundary condition (refer to Fig. 4 (a)) could represent the situation in an actual building (refer to Fig. 4 (b)).

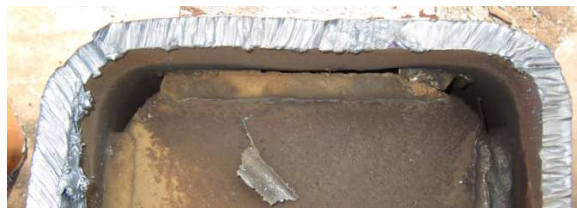
Fig. 9. Separation between the bottom inner-diaphragm and column wall on the west side in Specimen SI-WB-2.

Particularly, in order to capture the local failure of the column wall on the west side in Specimen SI-WB-2, it is necessary to reproduce the separation between the bottom inner-diaphragm and the column wall in the test (refer to Fig. 9). For this purpose, special meshes were set at the western part of the bottom inner-diaphragm, whose material possessed a relatively small fracture strain limit. Thus this part could fracture in advance simulating the separation as stated above, which is a precondition for the subsequent fracture of the adjacent western column wall.

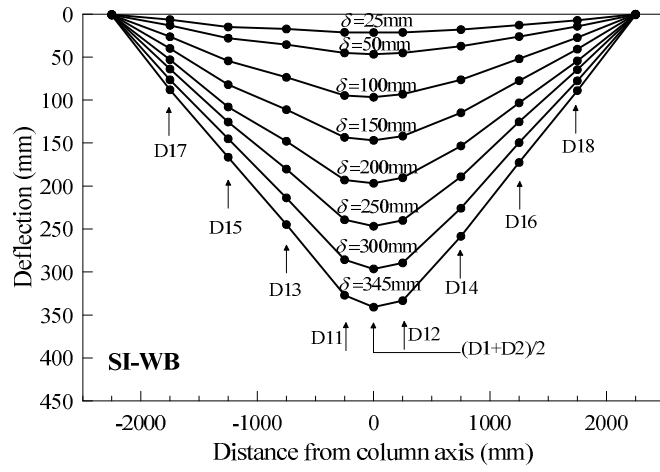
Fig. 10. Deflection profiles of specimen SI-WB.

The shift from a flexural mode of response to a tension-catenary mechanism can be further observed from the change of the deflection shapes in the specimens, as depicted in Fig. 10 for Specimen SI-WB. The deflected profiles exhibited a typical flexural pattern at the early stages of the response. As the deflection increased, the deformation became increasingly concentrated at the connection, and eventually turned into a profile that resembled two straight lines (the beam member) connected to the center column like a hinge. A similar development of the overall deformation was observed in Specimen SI-WB-2, with its permanent deformation pattern shown in Fig. 11.

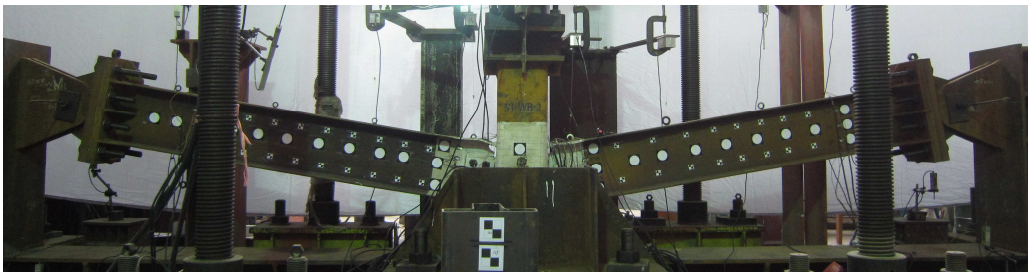
Fig. 11. Photograph of Specimen SI-WB-2 at the end of the test.

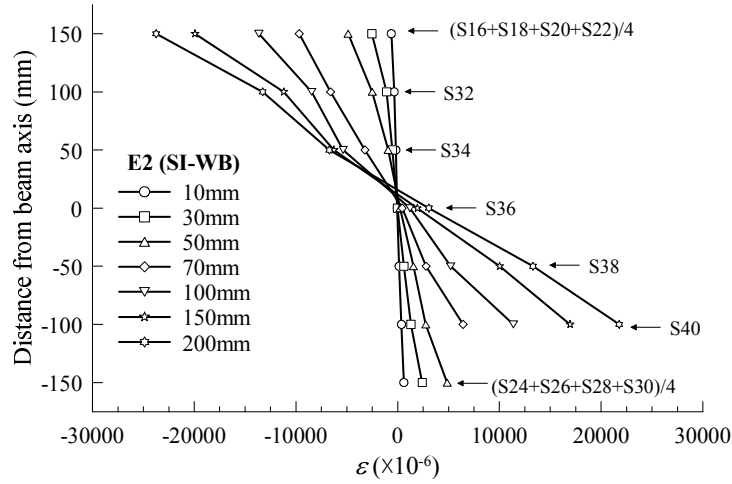
Fig. 13. Strain distributions at Section E2 before bottom flange fracture at Section E3.

Fig. 13 plots the strain distributions of Section E2, which was adjacent to the critical Sections E3, up to the fracture of the bottom flange. Note that some data points are missing because of damage to the corresponding strain gauges. It can be observed that Section E2 also exhibited clear flexural behaviour in the early stage of the response (up to a displacement of about 50mm). With increased loading, the tensile strains at the bottom

flanges and compressive strains at the top flanges grew rapidly because of large plastic deformation. At the later stage the deformation was overwhelmed by the plastic strains, with the maximum strain values exceeding 0.03% before the bottom flanges fractured. This indicates that the critical section was able to achieve almost full plasticity at the verge of the flexural failure.

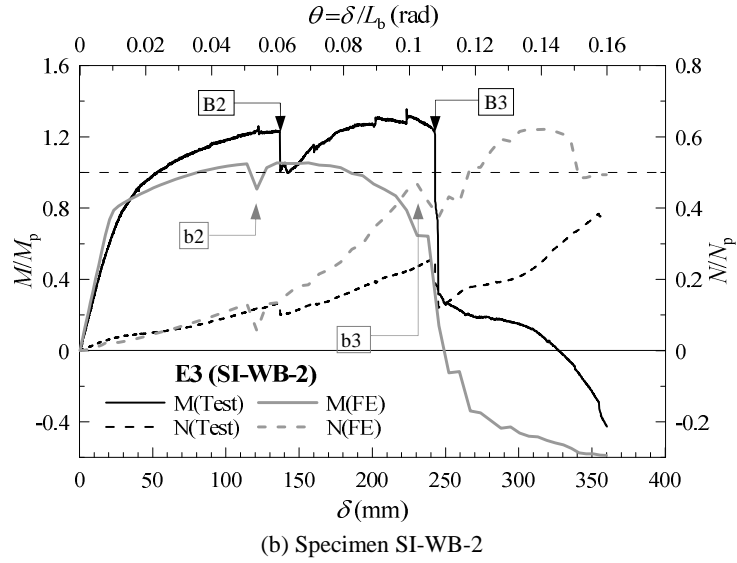
Fig. 17. The development of bending moment and axial force of Section E3.

The bending moment-displacement curves exhibited a usual flexural behaviour during the flexural phase of the response encompassing elastic and nonlinear plastic stages until the bottom flanges fractured. With the fracture of the bottom flange, the bending moments dropped abruptly, and then further decreased to virtually zero and even into the negative region in the final stage. On the other hand, the axial tension generally increased as the plastic bending deformation accumulated, leading to a persistent increase of the vertical resistance (refer to Fig. 16 (a)), despite an almost flat sectional bending moment. The fracture of the bottom flange caused a temporary drop of the axial tension, but it immediately recovered, and thereafter kept increasing to become the primary resistance mechanism in the catenary-dominated phase. In the final stage, the axial tension reached a maximum value of about  $0.6N_p$ .

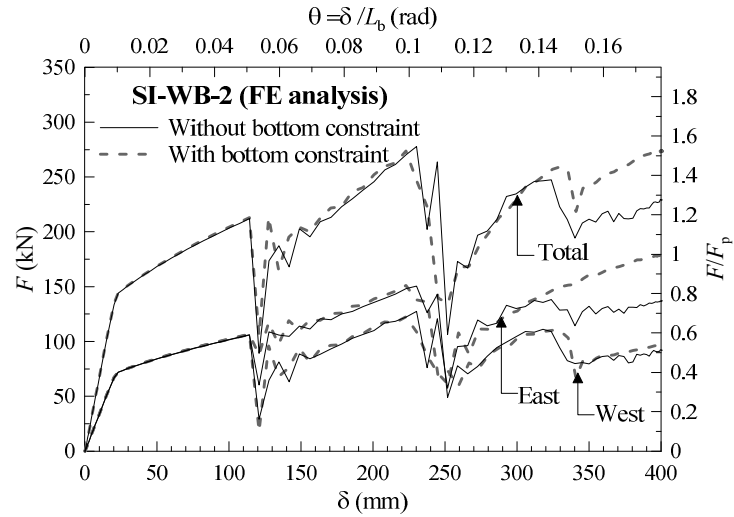
Fig. 18. Vertical resistance comparison between the assembly models with or without the constraints at the column bottom

In this section, an additional analysis was conducted to assess the effect of the constraint at the bottom of the specimen on the response of the beam-to-column assembly. Result comparisons would be made between the finite element models of two similar beam-to-column assemblies with the same connection configuration and material models but with different boundary conditions of the centre column. One was exactly the test specimen assembly (refer to Fig. 4 (a)) as stated in last sections. The other one was modelled on the basis of the former assembly but extending the column up to the upper storey (suppose the storey height  $h_0= 3\text{m}$ ) and making the bottom of the centre column unconstrained (refer to Fig. 4 (b)). The top of the one-storey-height column was rotationally and horizontally constrained to simulate the boundaries provide by the connected beams and the floors of the upper storey. Taking the connection configuration of Specimen SI-WB-2 for example, Fig. 18 compares the vertical resistances of the assembly between two models, which are labeled as ‘with bottom constraint’ and ‘without bottom constraint’, respectively. As can be seen, the two assemblies performed consistently with each other, because the columns could keep vertically moving with increasing displacement in two models. Thus it is implied that, the constraint at the bottom provided by the sliding support in the test is of little influence on the resistance of the connection for preventing progressive collapse. In other words, for an experiment research aiming to study the robustness of the connection, either a sufficient rotational constraint at the top of the column (as employed by Sadek [12]) or a constraint at the column bottom (as employed by Yang [14, 15] and Li [17]) should be set up to keep a smoothly vertical movement of the column in the loading process.

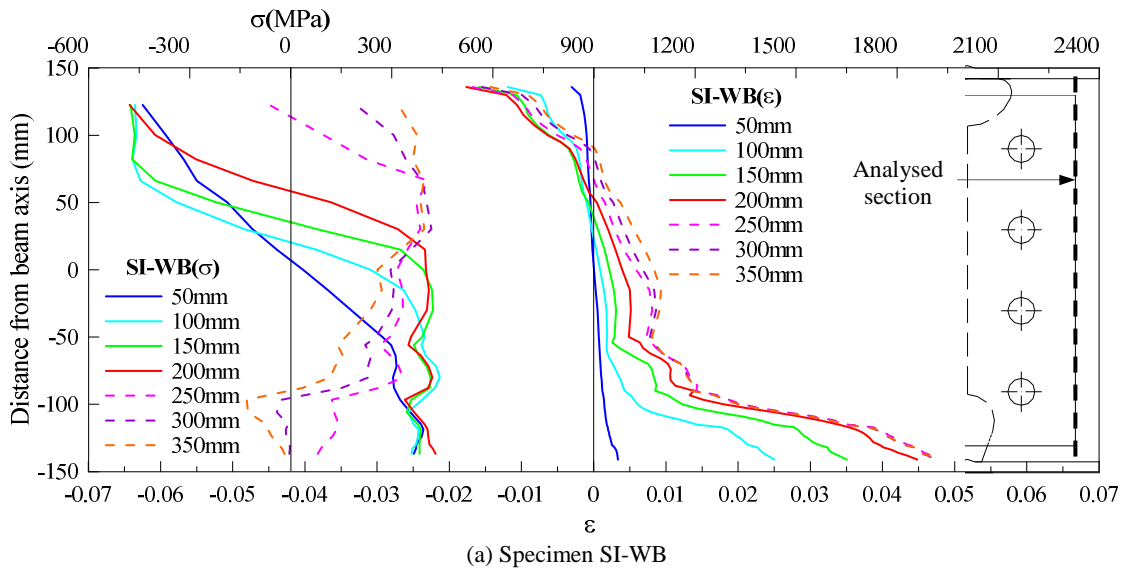
Fig. 19. Stress ( $\sigma$ ) and strain ( $\epsilon$ ) distributions at the bolted web in the vicinity of the connection

With the fracture of the bottom flange, the bolted web becomes the key to the development of the catenary action as well as the residual bending capacity. Fig. 19 shows the stress and strain distributions over a cross-section in the close vicinity of the bolted area from the numerical simulation for the two specimens; the plots of stress and strain in the post-fracture phase are indicated in dashed line. Before the bottom flange fractures (with a central deflection below about 200 mm), the stresses and strains of the web in Specimen SI-WB were greater than those in Specimen SI-WB-2, indicating a larger contribution in the bending resistance from the web when all the four bolts were arranged in a single row. In the post-fracture stage, the stresses and strains of the residual section distributed in a more uniform manner over the entire web depth in Specimen SI-WB than in Specimen SI-WB-2, once again indicating a more efficient participation of the bolted web in the one-row bolt arrangement.

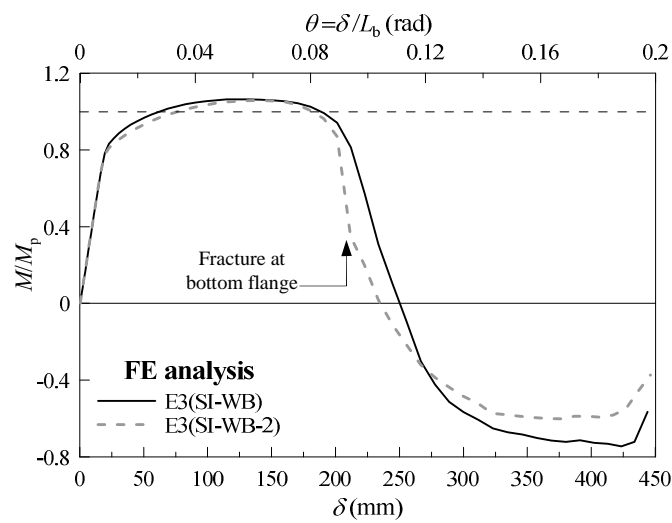
Fig. 21. Development of bending moment and axial tension at critical sections

The development of the bending moment and axial force through the flexural failure at about 200mm and up to an advanced catenary action of around 350mm (end of the experiments) was similar to the comparison shown in Fig. 17. With further increase of the deformation, the axial tension of Specimen SI-WB maintained until a central displacement of approximately 430mm (0.19rad). In comparison, the axial tension in Specimen SI-WB-2 was on a decreasing trend due to the continuous crack at the shear tab when the displacement exceeded 310mm, showing a less ductile behaviour with a smaller tensile capacity.
