Experimental study of tunnel segmental joints subjected to elevated temperature

Experimental Study of Tunnel Segmental joints Subjected to Elevated Temperature

Keywords: Shield TBM tunnel; Lining segmental joints; Fire test; Hybrid fibre reinforced concrete

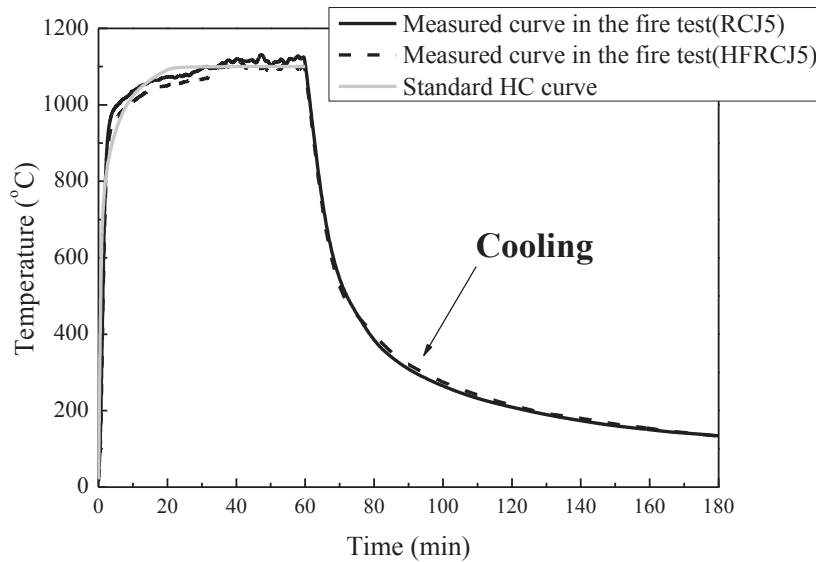
Fig.3. Standard HC curve and the measured curves from the fire tests

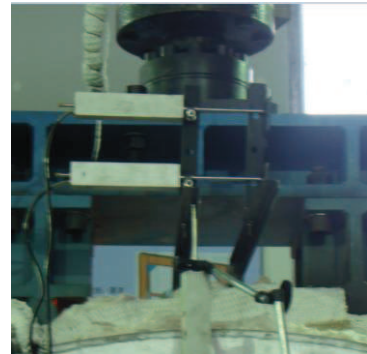
Principle

Test set-up

Fig.4. Measurement of opening angle of the lining joints

unexposed surface (in mm); ΔL_1 and ΔL_2 are the displacement increments of the first and the second LVDT, respectively (in mm); H is the thickness of the tunnel linings (in mm). It should be noted that the joint rotation and gap openings inferred from Eq. 2 included also the differential strain deformation between the inner and outer sides of the specimens over the measuring length. But relatively speaking these strain deformations were generally small as compared to the deformations at the joint gap and therefore they are neglected.

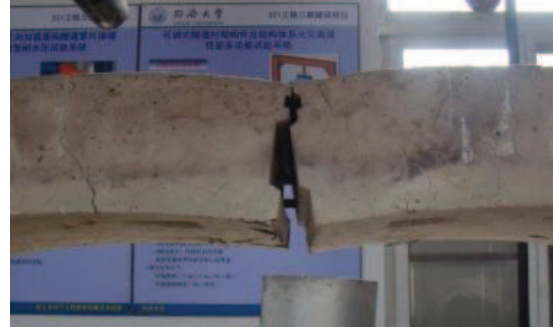
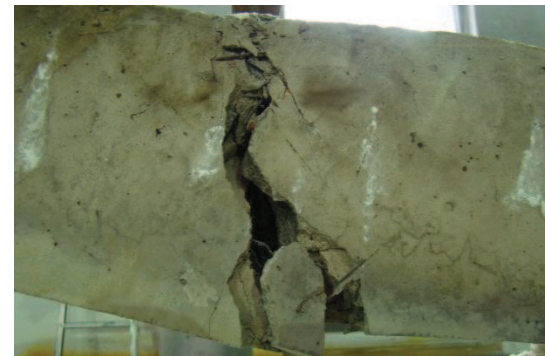
Fig.9. Failure modes of specimens tested at ambient temperature and under fire

Fig.9 (a) and (b) show the failure modes of the two specimens. The relationships of vertical load vs. vertical displacement at the joint, and bending moment vs. gap opening are

illustrated in **Fig.10 (a)** and **(b)**. Specimens RCJ1 exhibited a behaviour which was clearly dominated by the bending-rotation at the segment joint, and failed at the joint due to yielding of the curved bolts. As stretching and yielding of the bolts continued, the compression zone reduced, leading to crushing of the top edge concrete at the final stage (**Fig. 9 (a)**).

Specimen RCJ3 is directly comparable to the reference specimen RCJ1 as the mechanical loading conditions were the same except the fire effect. Similarly HFRCJ3 can be compared with HFRCJ1 directly. **Fig.14** shows the relationships of vertical load vs. vertical displacement and joint bending moment vs. joint opening gap for the two specimens. The final failure patterns are shown in **Fig.9 (a), (b), (e) and (f)**.

Specimen HFRCJ3 performed poorly under fire, and the maximum load capacity in terms of the bending moment developed at the joint location was only 3.45 kN.m as compared to 8.68 kN.m in specimen HFRCJ1 under ambient temperature. The failure mode was controlled by the rupture failure of the HFRC section, which was similar to the failure mode of HFRCJ1. However, the HFRC section had no main steel rebar, so when the section cracked and the thin steel fibres were exposed to high temperature, the bending capacity quickly diminished resulting in an accelerated failure of the specimen.

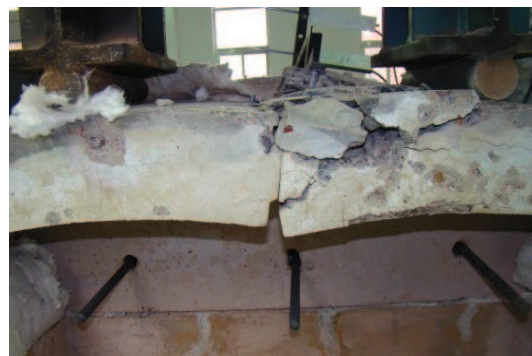
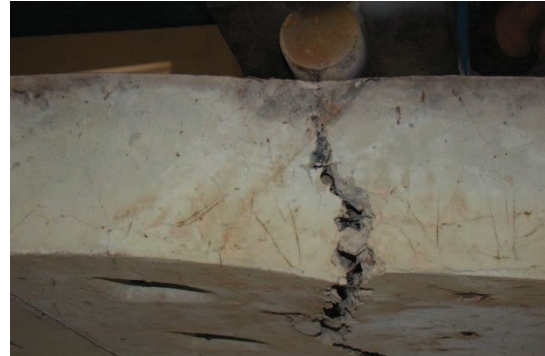
(g) Joint concrete failure (RCJ4)

(h) Concrete fracture (HFRCJ4)

For another two pairs of specimens which were also tested under elevated temperature but with different levels of axial forces, namely RCJ2 & HFRCJ2 and RCJ4 & HFRCJ4, Fig.15 shows the vertical load vs. vertical displacement and joint bending moment vs. joint rotation relations. The corresponding final failure patterns are shown in Fig.9 (c), (d), (g) and (h). The results are summarized and discussed in what follows.

Specimen RCJ4 under an increased axial force of 60 kN exhibited a markedly increased resistance capacity as compared to RCJ2 of 40 kN under the same fire condition, with a maximum vertical load of 140 kN comparing to 90 kN, or maximum joint bending moment of 15.26 kN.m comparing to 9.04 kN.m. Whereas this was clearly attributable to the general effect of increased axial force resulting in a reduced tension demand on the bolts, it is interesting to note that the bending capacity exceeded even the predicted joint bending strength under ambient temperature by a significant margin, and the final failure mode shifted to a compression failure at the joint. One possible explanation is thought to be related to the load induced thermal strain (LITS) effect, such that the higher level of compressive stress caused an extra compressive strain due to LITS. The increased compressive strain would have delayed the development of tensile stress in the bolts during the mechanical load phase under fire, while the compressive stress on the compression zone intensified. This resulted in an overall increase of the bending capacity, but at the same time led to accumulation of higher compressive strain on the top side of the joint section, leading eventually to a compressive bending failure of the joint. **This phenomenon is worth further investigation in subsequent studies.**

Similar situation is believed to have occurred at the joint region of HFRCJ4. The increase of the axial force also enhanced the bending capacity of the HFRC sections. **However, the increased bending moment capacity at the HFRC sections tended to be less than the increased bending capacity at the joint; as a result rupture of the HFRC section at the vertical loading point (where maximum bending moment took place) occurred prior to a joint compressive bending failure as in RCJ4.**

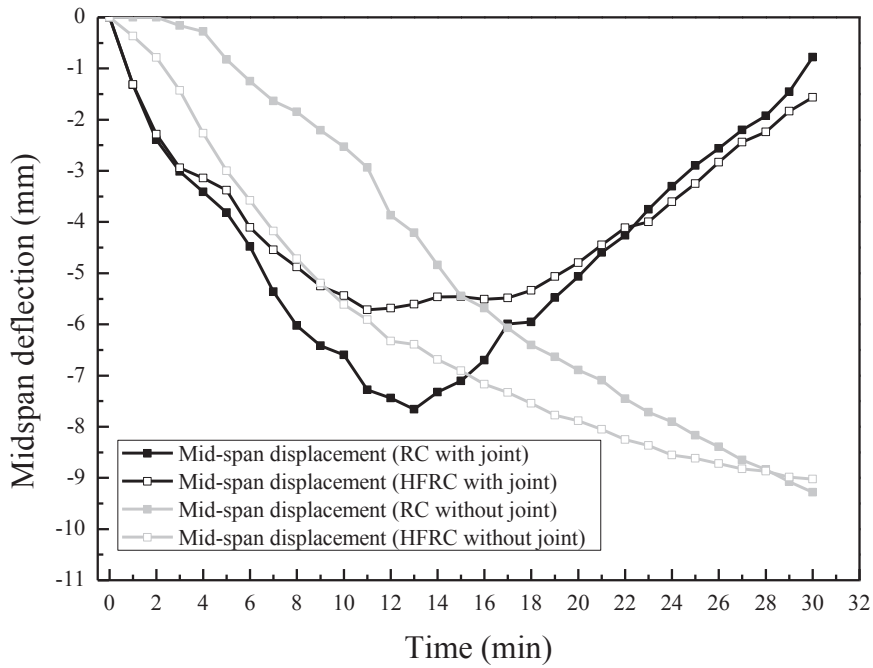
Fig.11. Mid-span deflection histories during heating: comparison between jointed segments and stand-alone segments

The variation of the vertical deflections measured at the joint location for the RC specimens (RCJ2, RCJ3, RCJ4) and HFRC specimens (HFRCJ2, HFRCJ3, HFRCJ4) with the free heating time are depicted in **Fig.11**. For a comparison, the vertical deflections measured from single segment specimens (i.e., without the joint; details of those tests are omitted here) under a similar fire condition are also included.

As can be observed, for the segments without involving a joint, the mid-span deflection kept increasing downwards (i.e. towards the heating side). This is expected from the differential thermal elongation of specimen intrados and extrados induced by the temperature distribution. For the jointed segments, the vertical deflection at the mid-span (joint location) also increased gradually downwards with increase in temperature for about 13 minutes after ignition; however, this trend was reversed afterwards; the incremental vertical deflections moved upward, resulting in a decrease of the total deflection. The total deflection was almost recovered after about 30 minutes of heating. After that time, the vertical deflections continued to move upward slightly.

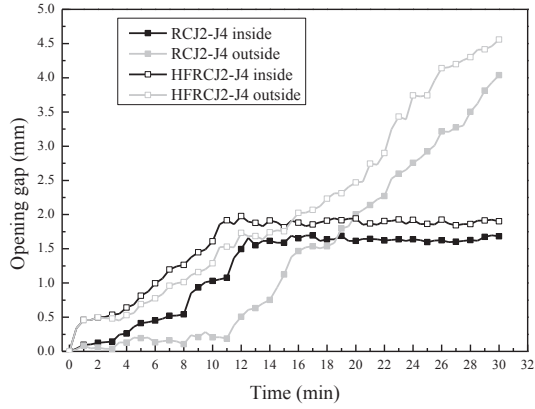
(a) Opening gap

(b) Rotation

Fig.12. Rotation and gap opening histories of the under-fire cases

The above observed reversal of deflection trend during heating was attributable to the local deformation and gap development at the joint. **Fig.12** shows the rotation and opening gap histories for these specimens tested under elevated temperature. As shown in **Fig.12 (a)**, in the beginning the opening gap increased faster on the inner side than on the outer side. After a period of about 12-13 minutes, the opening gap on the inner side almost maintained at a constant value while the opening gap on the outer side continued increasing. From the

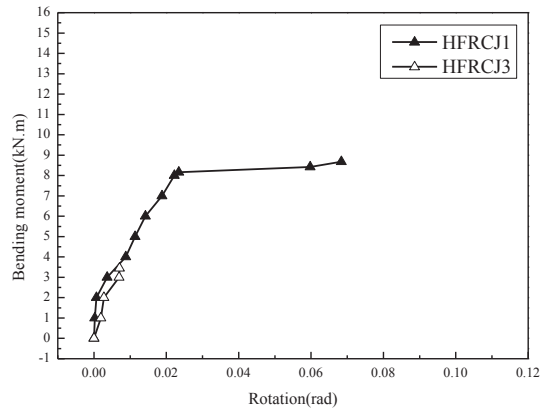
(a) Vertical load vs. vertical displacement

(b) Joint bending moment vs. rotation

Fig.14. Load vs. deformation curves for RCJ1 & RCJ3 and HFRCJ1 & HFRCJ3 ($P_H=40$ kN)

Under the elevated temperature, specimen RCJ3 exhibited generally similar load-deformation behaviour as RCJ1 and the failure mode was also dominated by yielding of the bolts at the joint until the concrete on the compression edge at the joint region crushed. The loading capacity was governed by the maximum bending moment at the joint, which was 9.04 kN.m as compared to 11.38 kN.m in RCJ1, showing a decrease of about 20%. This decrease of the bending moment capacity may be explained by the reduction of the yield strength of the bolts under the fire effect. According to the temperature measurements discussed in Section 3, the temperature at the location of the bolts during the

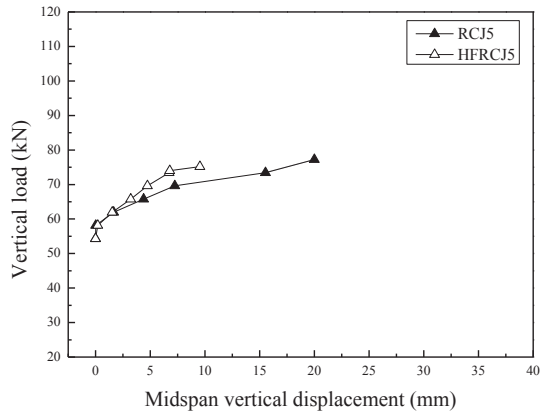
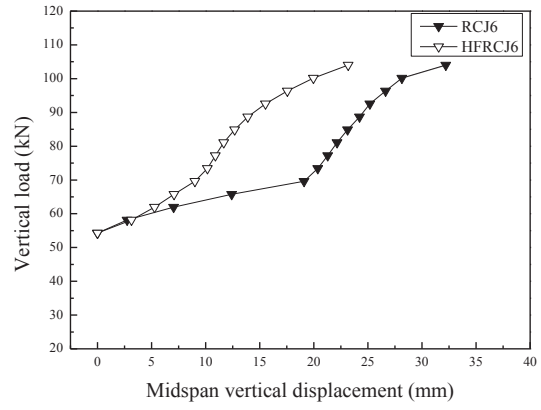
Fig.17. Load vs. deformation curves for the post-fire loading tests

condition during the heating phases had significant effects on the moment-curvature curves in the post-fire loading tests. For specimens RCJ5 & HFRCJ5 which were subjected to sagging initial moment, the moment-curvature curves in the post-fire loading phase were almost linear until the specimens failed abruptly. On the other hand, for specimens RCJ6 and HFRCJ6 which were initially subjected to a hogging moment during heating, the moment-curvature curves exhibited a bi-linear character, and the stiffness in the first stage appears to be smaller than that in the second stage.

loading, the critical joint region was subjected to reversed sagging moment. The degradation of the concrete at the bottom side resulted in a “softer” behaviour in terms of the bending deformation under the reversed sagging moment, but as the top side concrete was generally intact during the heating phase, the specimens were able to retain their load resistance capacities, as clearly shown in the comparative curves in **Fig. 17**.
