Maluk, C, Terrasi, GP, Bisby, L, Stutz, A & Hugi, E 2015, 'Fire Resistance Tests on Thin CFRP Prestressed Concrete Slabs', *Construction and Building Materials*, vol. 101, no. Part 1, pp. 558–571.
<https://doi.org/10.1016/j.conbuildmat.2015.10.031>

1 **Fire Resistance Tests on Thin CFRP Prestressed Concrete Slabs**

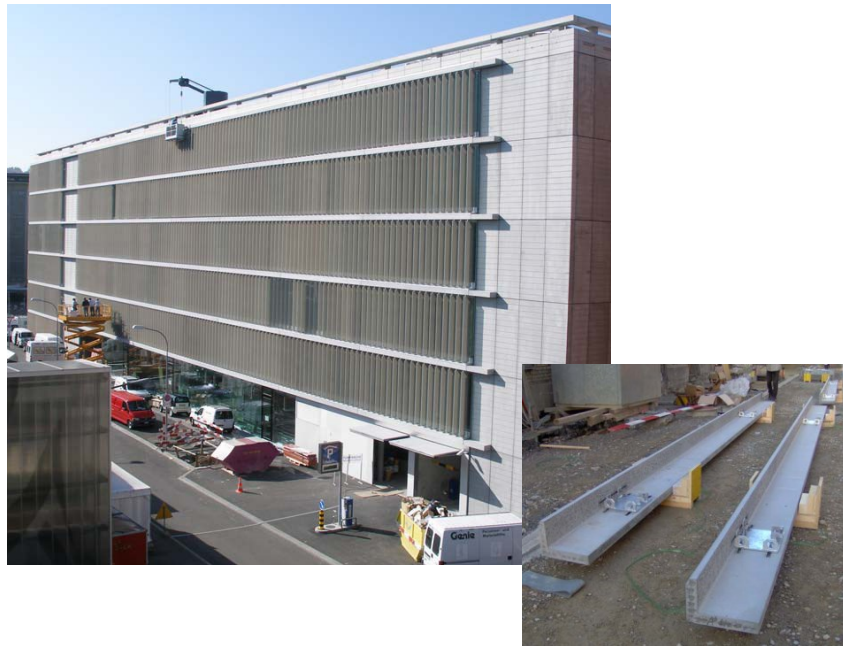
28 **Figure 1 – Application of CFRP prestressed concrete L-shaped beams for structural façade elements in**
29 **Zurich, Switzerland [1].**

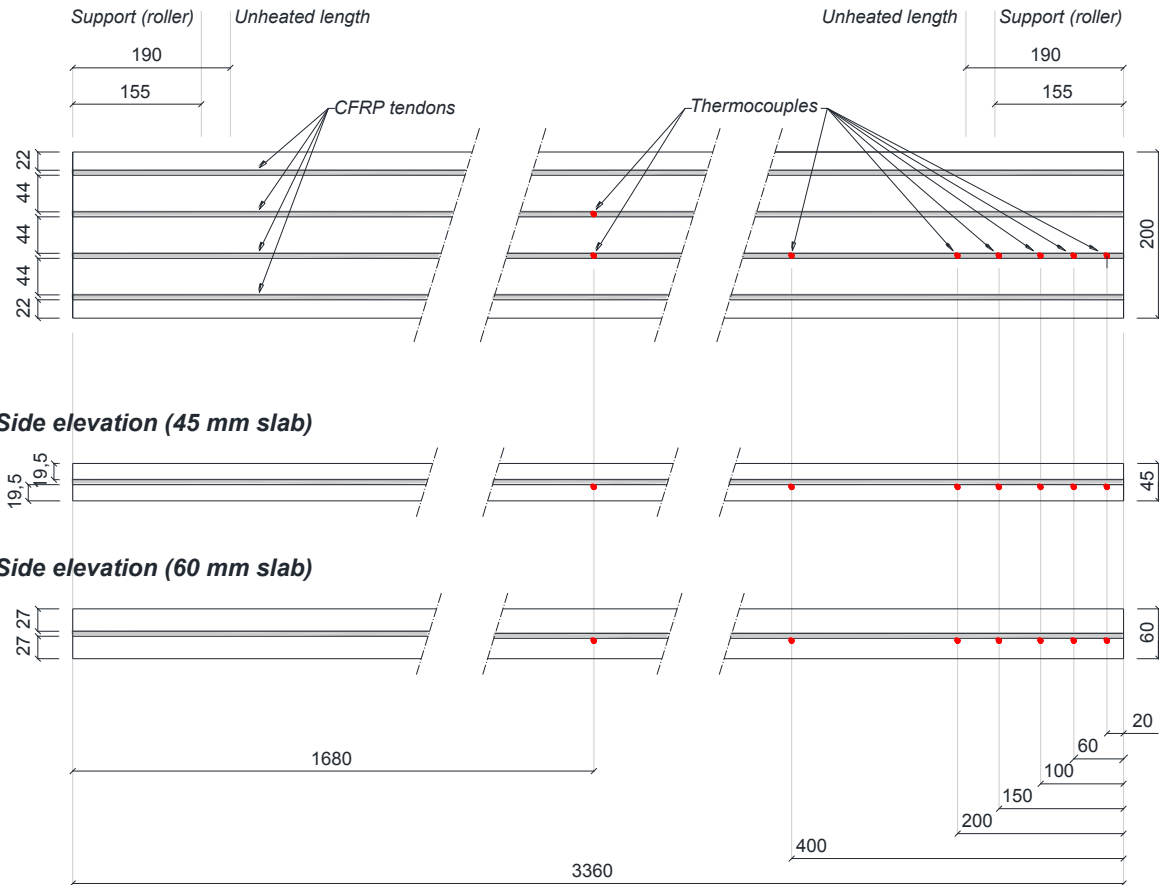
Figure 2 –Plan view and side elevations for slabs 45 and 60 mm thick, also showing thermocouples position (CFRP grids in the anchorage zones are not shown).

355 Figure 15 shows a comparison of the temperature of the CFRP tendon at midspan and at 400
 356 mm from the end of the slab (still within the heat exposed zone of the slab, see Figure 2) for
 357 slabs #1, #4, and #5 (all of which failed due to loss of anchorage). Figure 15 suggests that the
 358 temperature of the CFRP tendons was essentially constant over the exposed length of the
 359 slabs. It is noteworthy that thermocouples were placed along the lower edge of an interior
 360 CFRP tendon, and therefore recorded the temperature at the interface between the tendon and
 361 the concrete, rather than the temperature of the CFRP itself. Due to the low thermal inertia of

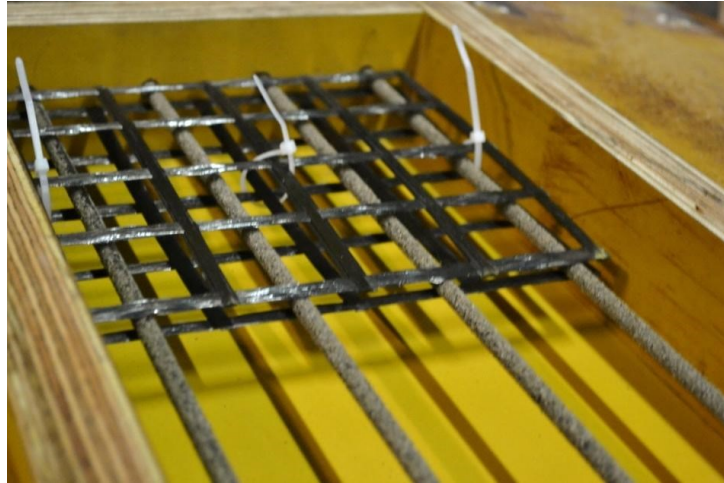
192
193 **Figure 5 – Placement of CFRP grids within the anchorage zones (above and below the CFRP tendons).**

184 In an attempt to limit splitting cracking and improve the bond strength in the prestress
185 anchorage zones at elevated temperatures, commercially available CFRP grids (C-GRID®)
186 were placed locally within the anchorage zones of four of the five slabs (refer to Table 1).
187 Prior to casting, these CFRP grids were placed above and below the CFRP tendons (see
188 Figure 5). The aim was to minimize heat-induced longitudinal splitting cracks, and hence loss
189 of confining action provided by concrete in the anchorage zones. The CFRP grids had

190 transverse and longitudinal spacings of 46 mm and 41 mm, respectively, with a design tensile
191 elastic modulus of approximately 120 GPa in both directions.

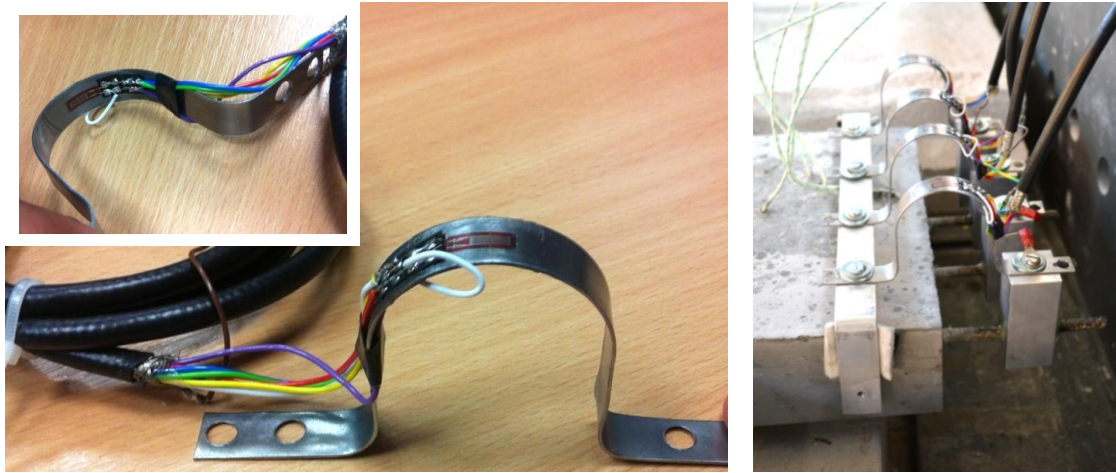
307
308 **Figure 10 – Custom-fabricated ‘pi-gauges’ (left) and gauges installed for measuring tendon draw-in for**
309 **all four tendons at one end of Slab #1 (right).**

- 295 • *Draw-in gauges* – Aiming to measure possible draw-in of the CFRP tendons during
296 testing due to loss of anchorage from heating or splitting cracking of the anchorage zones
297 high accuracy yet economical, semi-disposable custom-built “pi” displacement gauges
298 (pi-gauges) were designed and fabricated for the project described herein (one of these
299 gauges is shown in Figure 10). These were placed at either end of the slabs (active and
300 passive ends). These ‘pi-gauges’ consisted of foil strain gauges applied to a piece of
301 curved spring steel, which when flexed due to deformation could be correlated to
302 displacement. To obtain the required accuracy of the instruments, the gauges were
303 designed with a half-bridge connection with strain gauges placed on the top and bottom

304 of each pi-gauge (see Figure 10). The pi-gauges were calibrated over a displacement
305 range of ± 4 mm. Draw-in measurements were performed for all four CFRP tendons, at
306 both ends of slabs #1, #2, and #3 (refer to Table 1).

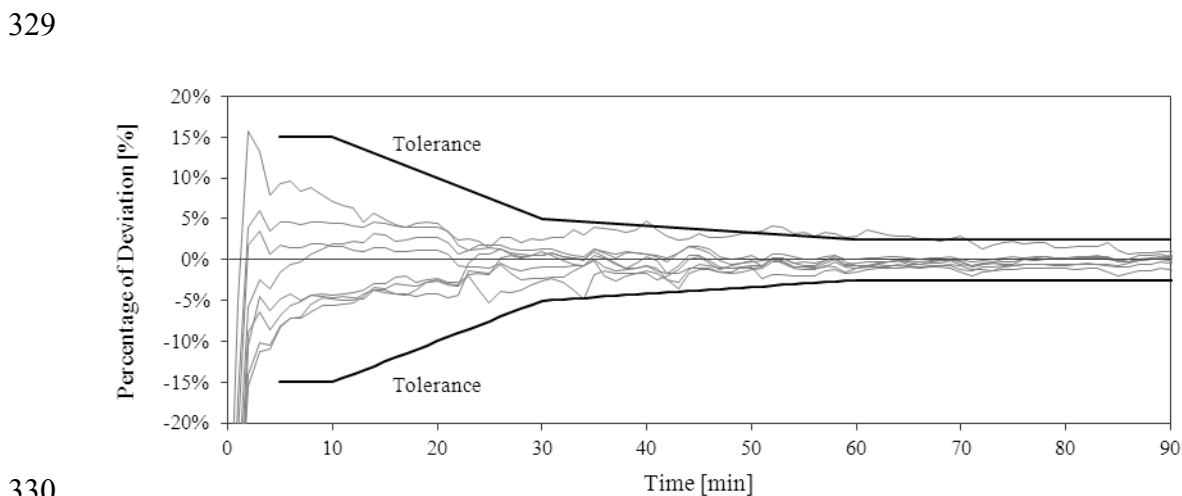
330
331 **Figure 12 – Percentage of deviation of the temperature measured by plate thermometers from that of the**
332 **objective temperature, and the maximum allowable deviation (tolerance) [32].**

320 testing standard [32], the temperature measurements show substantial deviation in the
321 temperature measured inside the furnace, especially during the first 20 minutes (see Figure
322 12). Due to the obvious technical challenge of precisely controlling the furnace to follow the
323 rapidly growing prescribed time-temperature curve [32] during early stages of the test, most
324 testing standards do not prescribe an allowable deviation during the first 5 minutes (see
325 Figure 12).

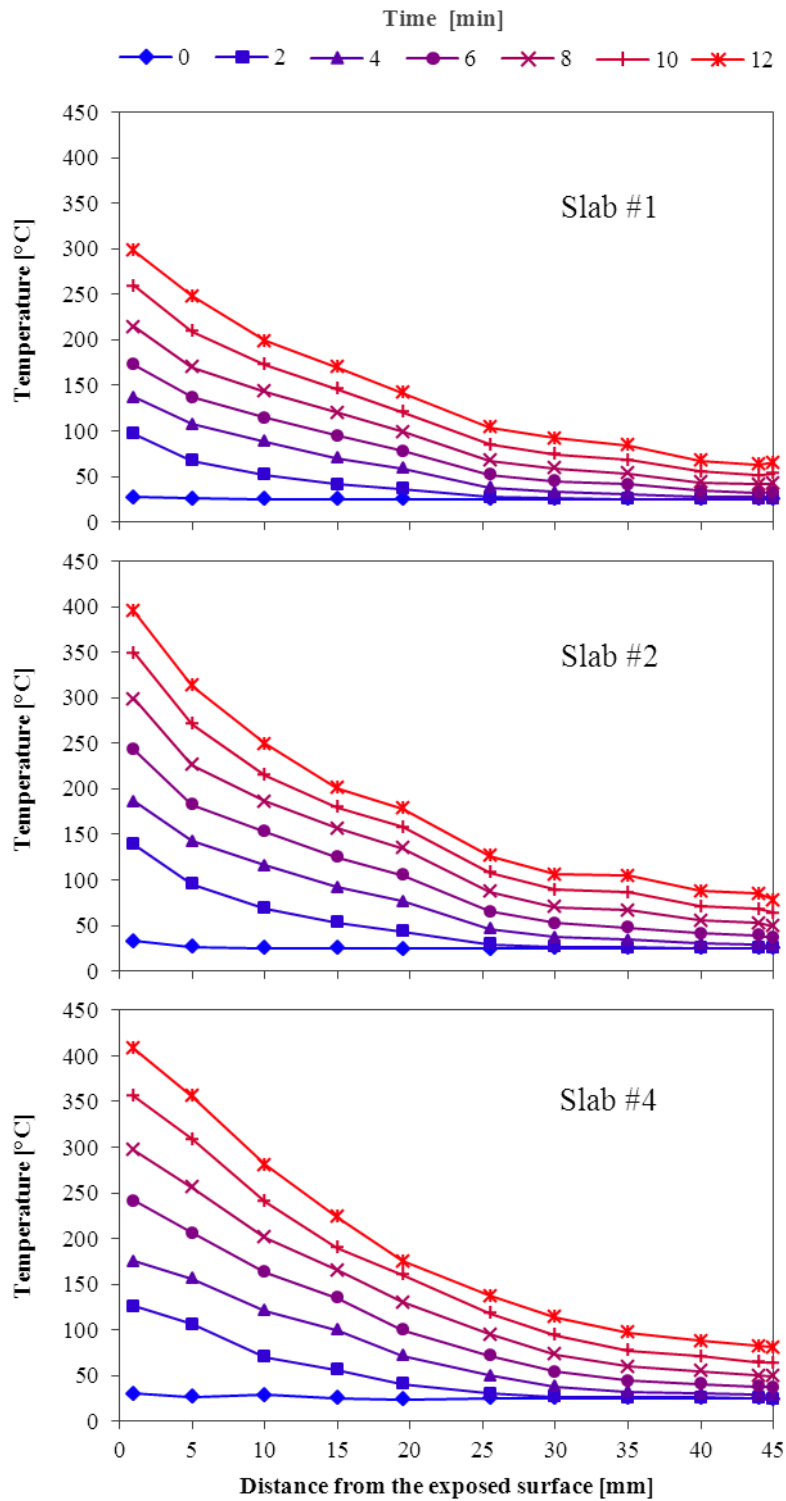
334 A comparison of through-thickness temperature distributions measured at midspan is shown
335 in figures 13 and 14 for slabs 45 and 60 mm thick, respectively. Temperature for the first 12
336 minutes of the test are shown; the time at which the first of the slabs failed due to explosive
337 spalling (refer to Table 1).

338 Considerable variation of through-thickness temperature distributions was observed for slabs
339 with equivalent thickness, possibly demonstrating poor homogeneity of the thermal
340 exposures for slabs tested simultaneously during a single furnace test; this is despite the
341 temperatures measured by the plate thermometers complying with the test standard. Figure 13
342 suggests a more rapid through-thickness temperature increase for 45 mm thick slabs
343 positioned near the centre of the furnace, slabs #2 and #4, relative to Slab #1 positioned near
344 the edge of the furnace (see Figure 7). A similar, however less severe, comparison is shown
345 in Figure 14 for Slab #3, positioned at the centre of the furnace, and Slab #5, positioned near
346 the edge of the furnace.

412 Slab #2 failed after 12 minutes, whereas the virtually identical Slab #1 failed due to loss of
 413 anchorage after 42 minutes of fire exposure (refer to Table 1); Figure 13 shows that Slab #2
 414 experienced more rapid heating during the early stages of the test. This suggests a possible
 415 important influence of the time-history of through-thickness temperatures on the occurrence
 416 of heat-induced concrete spalling [11]. For instance, Slab #2 spalled when the measured
 417 temperature 1 mm from its exposed surface was 400°C, while for Slab #1 the temperature at
 418 the same location was only 300°C. The possibility that this was due to misplacement of

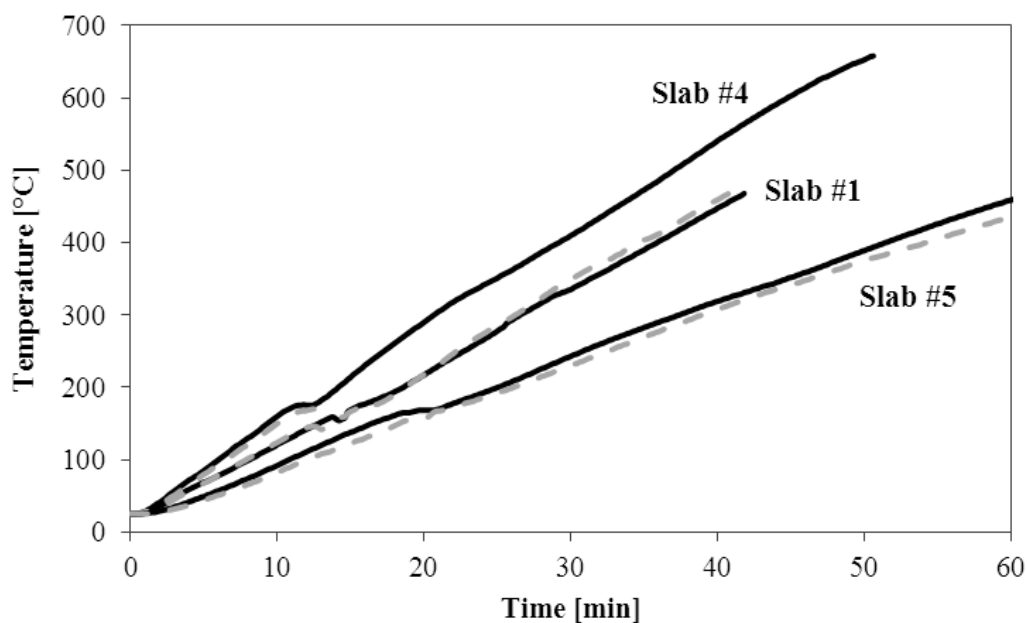
374 **Figure 15 – Comparison between temperatures of the CFRP tendons measured at midspan (continuous**
375 **line) and at 400 mm from the end of the slab (segmented line) for slabs #1, #4, and #5.**

- 450 • *The first longitudinal cracks were observed at the unexposed surface* – This occurs when
451 temperature of the CFRP tendons at midspan was between 320 and 390°C (refer to
452 Figure 15), regardless of the temperature in the unheated overhangs (e.g. 200 mm from
453 the end of the slab, refer to Figure 16). Longitudinal splitting cracks were first observed
454 at the unexposed surface (i.e. top surface), near the midspan region (see Figure 20).

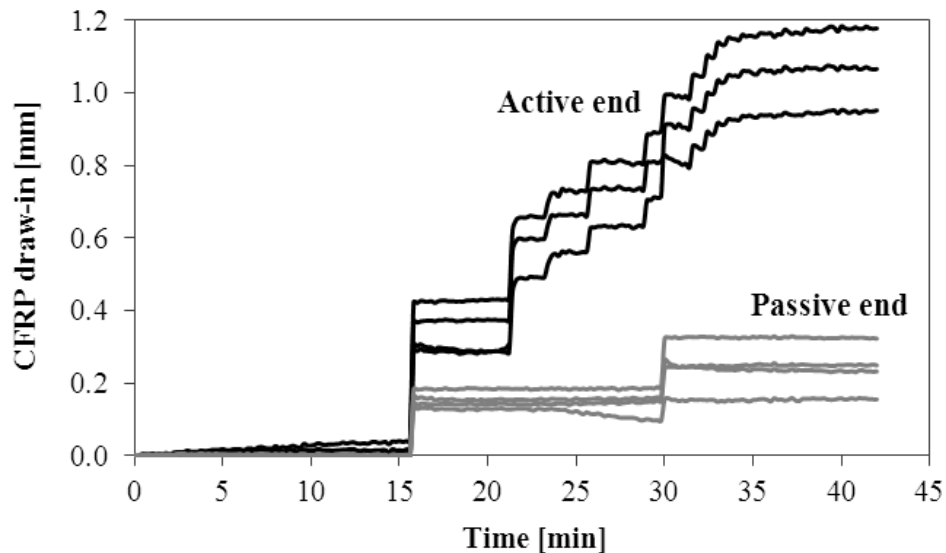
404 **Figure 18 – Draw-in measurements for tendons at the active and passive ends of Slab #1 during testing.**

395 Draw-in measurements were taken for all four CFRP tendons at both ends of slabs #1, #2,
 396 and #3. Unfortunately, because slabs #2 and #3 failed catastrophically at an early stage of the
 397 test due to explosive concrete spalling, no useful draw-in measurements were recorded for
 398 these slabs. For Slab #1 however, tendon draw-in measurements were taken until failure, at
 399 42 minutes from the start of the test as shown in Figure 18. While no attempt was made to
 400 quantify the relationship between draw-in measurements and the failure mechanism of Slab
 401 #1, a qualitative analysis considering draw-in measurements, loss of anchorage, and failure is
 402 presented later.

472 Figure 18 shows draw-in measurements for CFRP tendons in Slab #1, evidencing that draw-
473 in initiated 16 minutes from the start of the test; at both the active and passive end of the slab.
474 Thereafter, draw-in progressively increased only at the active end up to 30 minutes from the
475 start of the start when a sudden increase in draw-in was measured at the passive end; around
476 the time at which an increase in the rate of midspan vertical displacement was observed for
477 Slab #1 (refer to Figure 17).

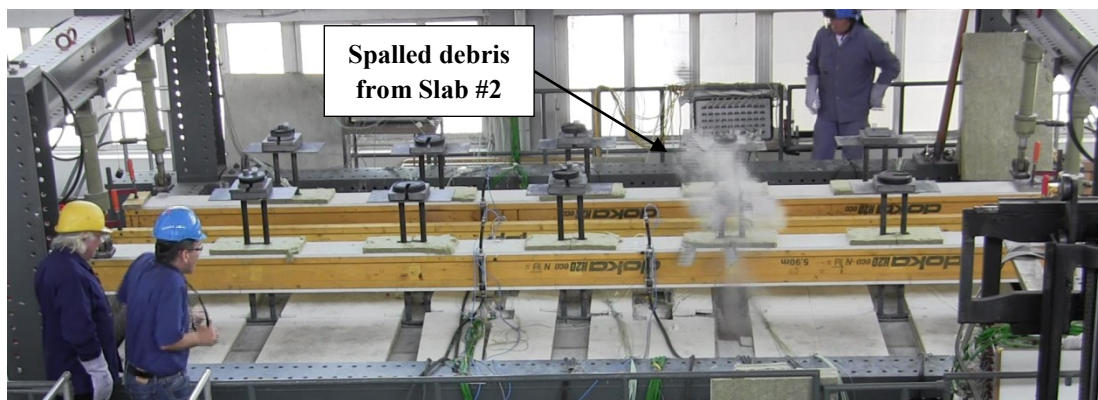
Figure 19 – Explosive spalling and immediate collapse of Slab #2 at 12' 37".

407 Failure of slabs #2 and #3 was driven by the occurrence of single explosive concrete spalling
 408 events, 12 and 22 minutes from the start of the test, respectively (refer to Table 1).
 409 Immediately after spalling, each of these slabs suffered catastrophic failure and collapsed into
 410 the furnace. Video stills recorded during testing showed the moment at which spalling
 411 occurred (shown for Slab #2 in Figure 19).

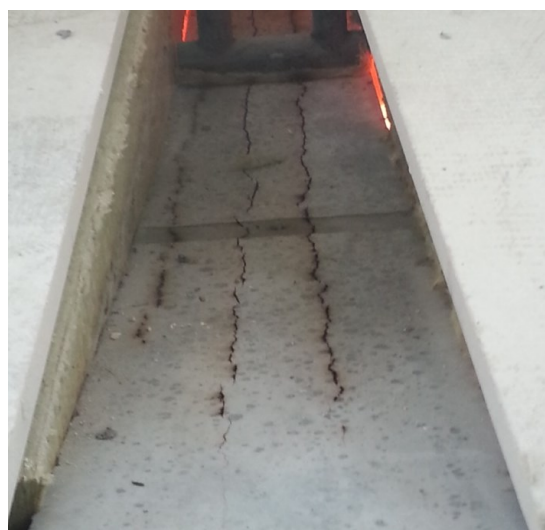
470
 471 **Figure 20 – Longitudinal splitting cracks at the unexposed surface of Slab #4 shortly before failure.**

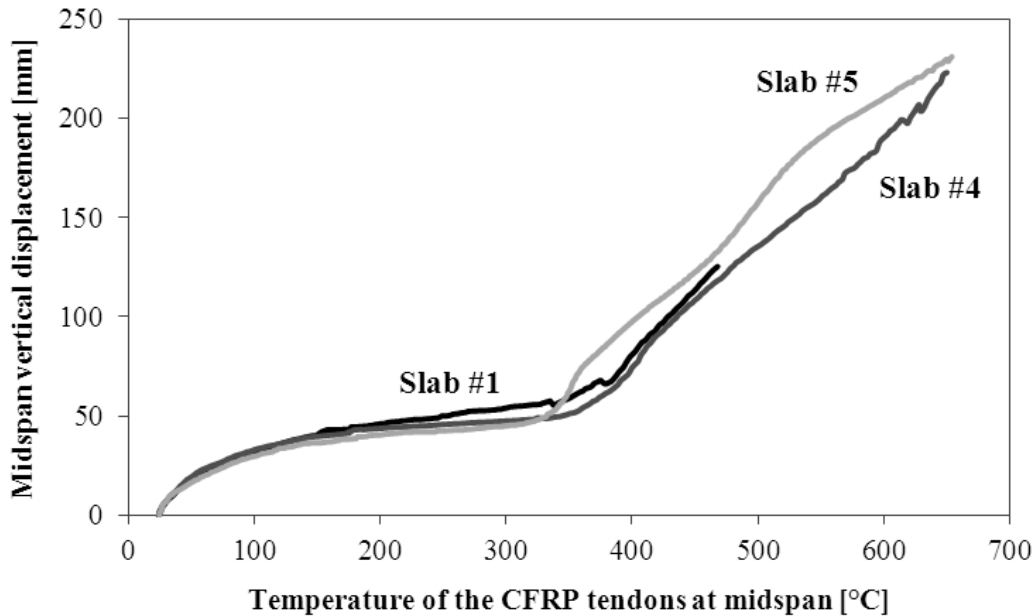
478 Interestingly, the time-history of midspan vertical displacement directly correlates with the
479 temperature of the CFRP tendons at midspan (see Figure 21), rather than temperature in the
480 unheated overhangs. This physical mechanism is thought to be associated with heat-induced
481 reduction for strength and stiffness of the epoxy resin within CFRP tendons; since the epoxy
482 resin is essential for anchorage to be maintained [4], and moreover for preserving interaction
483 and stress transfer between individual carbon fibres. Thermogravimetric analysis performed
484 by the authors on these particular CFRP tendons showed that decomposition of the epoxy
485 resin rapidly initiates at around 290°C [4]; in accordance with the temperature of the CFRP
486 tendons at midspan for which an increase in midspan vertical displacement was observed
487 (refer to Figure 21).
