Monitoring Corrosion Process of Reinforced Concrete Structure using FBG Strain Sensor

Almubaied, O, Chai, HK, Rajibul Islam, M, Sing Lim, K & Ghuan Tan, C 2017, 'Monitoring Corrosion Process of Reinforced Concrete Structure using FBG Strain Sensor', *IEEE Transactions on Instrumentation and Measurement*. <https://doi.org/10.1109/TIM.2017.2676218>

Monitoring Corrosion Process of Reinforced Concrete Structure using FBG Strain Sensor.

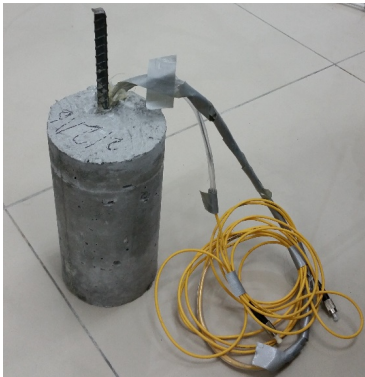
Fig. 5. Specimen after curing.

Two 200 x 100 mm concrete cylindrical specimens were prepared for the study, as shown in Fig. 5. Ordinary Portland cement was used as the binder. The concrete mix was designed by referring to a previous work [22] with binder to water ratio of 0.55. The proportional ratio for binder, coarse aggregate and fine aggregate was 1:1.65:3, with maximum coarse aggregate size of 10 mm. A structural grade deformed steel bar of 10 mm in diameter was placed at the center of specimen. After casting, the specimens were demolded after 24 hours and cured inside a water tank for 16 days. Among the two specimens, one was used to assess capability of the FBG strain sensor in detection and evaluation of steel corrosion, while the other one was intended for investigating the feasibility of FBG strain sensor in assessing concrete cracking. The top and bottom faces of the second specimen were coated with epoxy resin to prevent concrete from directly in contact with NaCl solution during accelerated corrosion process, considered as an attempt to mimic the actual exposure condition of a typical RC element to corrosion, in which moisture and chloride ions are penetrating from concrete cover and in a direction perpendicular to steel reinforcement.

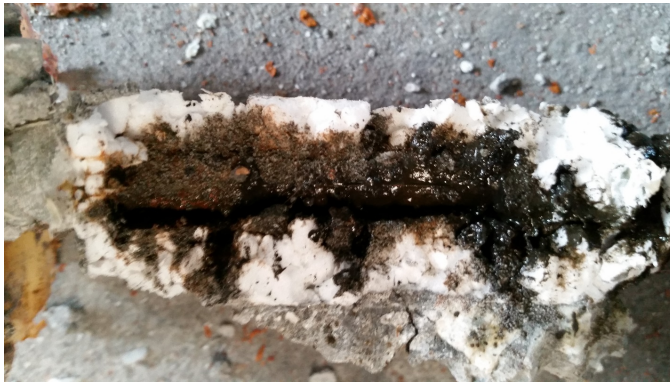
Fig. 12. Condition of FBG strain sensors in specimen 1 and 2 after corrosion test. (a) specimen 1. (b) specimen 2.

Following the end of accelerated corrosion process for the first specimen, FBG measurement was stopped and the specimen was break opened to examine the conditions of steel bar and the FBG strain sensor. Fig. 12 shows the condition of steel bar found in the first and second specimen at the end of accelerated corrosion process. As given by the time history plot in Fig. 7 suggested the occurrence of accumulated corrosion activities that have introduced stresses cause gradual change in the FBG wavelength over time. Also Fig. 7 relates the change of FBG wavelength with the level of corrosion, expressed in terms of mass loss of steel by percentage, in other words it is the weight loss of steel bar (Faraday's law) by the original weight of the bar before start of corrosion process. Fig. 8 shows the development of FBG wavelength measurement for the second specimen against time and steel corrosion percentage.

Fig. 12a shows that the responses attained from the sensors are due to the volume of the corrosion products layer. However, the FBG wavelength reading was found to be almost constant for Specimen 2 during a period of 97 hours to 103 hours after corrosion has started. constant values This inferred that in this period, the continuing corrosion activity did not induce significant stress to the FBG strain sensor. In other words, the corrosion products at this stage act as fluid which passes around the fiber without changing the wavelength shift. After that stage, which is at the beginning of the fifth day, cracks were observed to have propagated from the bottom of the specimen at 7.54 % of corrosion. Nevertheless, the first specimen has reached over 12% of corrosion level without any indication of crack, and the reason behind that is the non-uniformity of the reinforcement corrosion. Table I shows the current's Ampere and voltage, where the ampere has changed for the second specimen to keep the voltage constant for safety reasons. Due to the low Ampere at the beginning of the second specimen the reinforcement corrosion was more uniform. However, the first specimen started with high ampere value which lead to less corrosion uniformity. Fig. 12 shows the actual corrosion at the location of the sensors. In other words, the reinforcement part that had most corroded was not on the sensor area. After 103 hours into the corrosion process for specimen 2, there was a decline in the wavelength shift which signified the change in corrosion products arrangement. As the polystyrene foam was in contact with concrete, cracks that formed in concrete have created a release stress on the polystyrene foam. Therefore, the polystyrene foam inner volume was increased to allow for the corrosion products to fill the side boundaries of the polystyrene foam. A marked jump in the wavelength shift as noted between 96 hours to 97 hours after the corrosion process initiated. The jump was corresponded to the increase in electric current, where the increment occurs to allow the current voltage to be constant throughout the experiment, the fifth column in Table II shows the corrosion increment which is the corrosion percent of the current hour minus the corrosion percent of the previous hour ($6.291 - 6.223 = 0.068 \%$).

At the end of experiment, both specimens were crack opened to examine the conditions of FBG strain sensors. Fig. 12 shows the conditions of FBG sensors in specimen 1 and 2 after corrosion process. It is obvious that specimen 2 has developed a more severe corrosion than Specimen 1, which is confirmed by our theoretical calculations. Fig. 12a shows the corrosion layer formed on the steel bar that induced stress on the FBG sensor, this layer was formed from two types of corrosion products namely, adherent and non-adherent products in which the adherent layer is deposited over the bar surface. On the other hand, the non-adherent layer was loosely bounded to the metal surface and it may dissolve into the solution during the corrosion process [26]. Therefore, at high corrosion level the non-adherent corrosion products with the presence of solution may act as fluid as shown in Fig. 12b. Upon detailed examination, the FBG sensors in both specimens were found intact and their bonds with steel reinforcement remained sound. In other words, the sensors were found to be in good working condition and could be recycled for other use by detaching them through from the steel bars through heating of the bonding epoxy resin. This finding is important in validating the feasibility of the mounting procedure for FBG strain sensor developed for monitoring and evaluating steel reinforcement corrosion in concrete.
