Bonded Fibre Reinforced Polymer Strengthening in a Real Fire

BONDED FIBRE REINFORCED POLYMER STRENGTHENING IN A REAL FIRE

T.J. Stratford*, M. Gillie and J.F. Chen

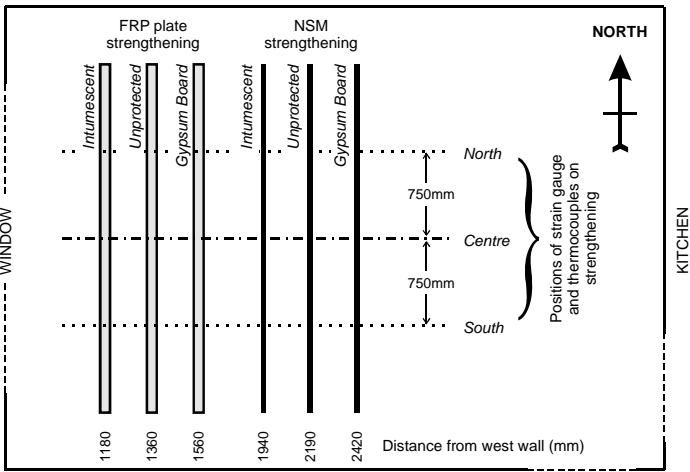
Figure 1. Schematic view of the strengthening.

Six strips of bonded FRP strengthening were installed in the compartment used in Test 1: three FRP plates and three near-surface-mounted (NSM) bars (Figures 1 and 2). The strengthening was installed by a contractor skilled in the application of bonded FRP and was completed 20 days before the fire test. The fire protection systems were installed by the University of Edinburgh. One of each type of strengthening was left unprotected, one painted with an intumescent coating, and one was protected within a gypsum board box. The gypsum board protection comprised two layers of 12mm board, spaced away from the bottom of the slab by a further two layers of board, placed to either side of the strengthening. The joints were staggered and the layers were sealed with an intumescent sealant. A single unprotected plate and unprotected NSM bar were installed in Test 2.

The fire tests took place in the living rooms of two flats, part of a 23-storey residential building that was built in 1964. The layout of the compartment is shown in Figures 1 and 2a. The fire load consisted of office furnishings, and was dominated by a sofa placed towards the east of the compartment. In the uncontrolled test, the compartment was ventilated by an open door to the rest of the flat and the openings left by breaking windows during the later stages of the fire. During the controlled test the ventilation parameters were changed by remote control of the windows and door (Abecassis Empis *et al.*, 2007).

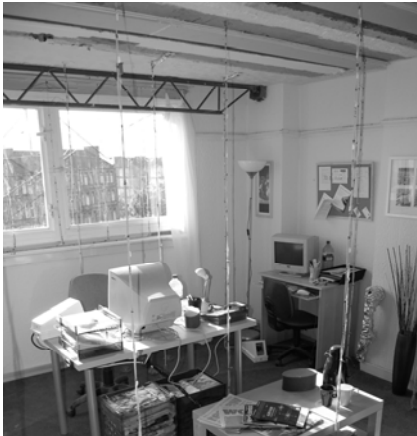
Figure 2. The installed FRP strengthening and protection.

(a) Fire compartment, with FRP at top

(b) The six strips of strengthening

Before installation, the FRP components in Test 1 were instrumented with strain gauges (attached to the upper surface of the FRP at the North, Centre and South positions shown in Figure 2), and thermocouples (placed within the adhesive layer at the same positions). The wires were led up through the concrete slab, with any holes filled using intumescent foam. A large quantity of additional instrumentation was used to record the progress of the fire and to monitor the structural response of the slab (Abecassis Empis et al., 2007).

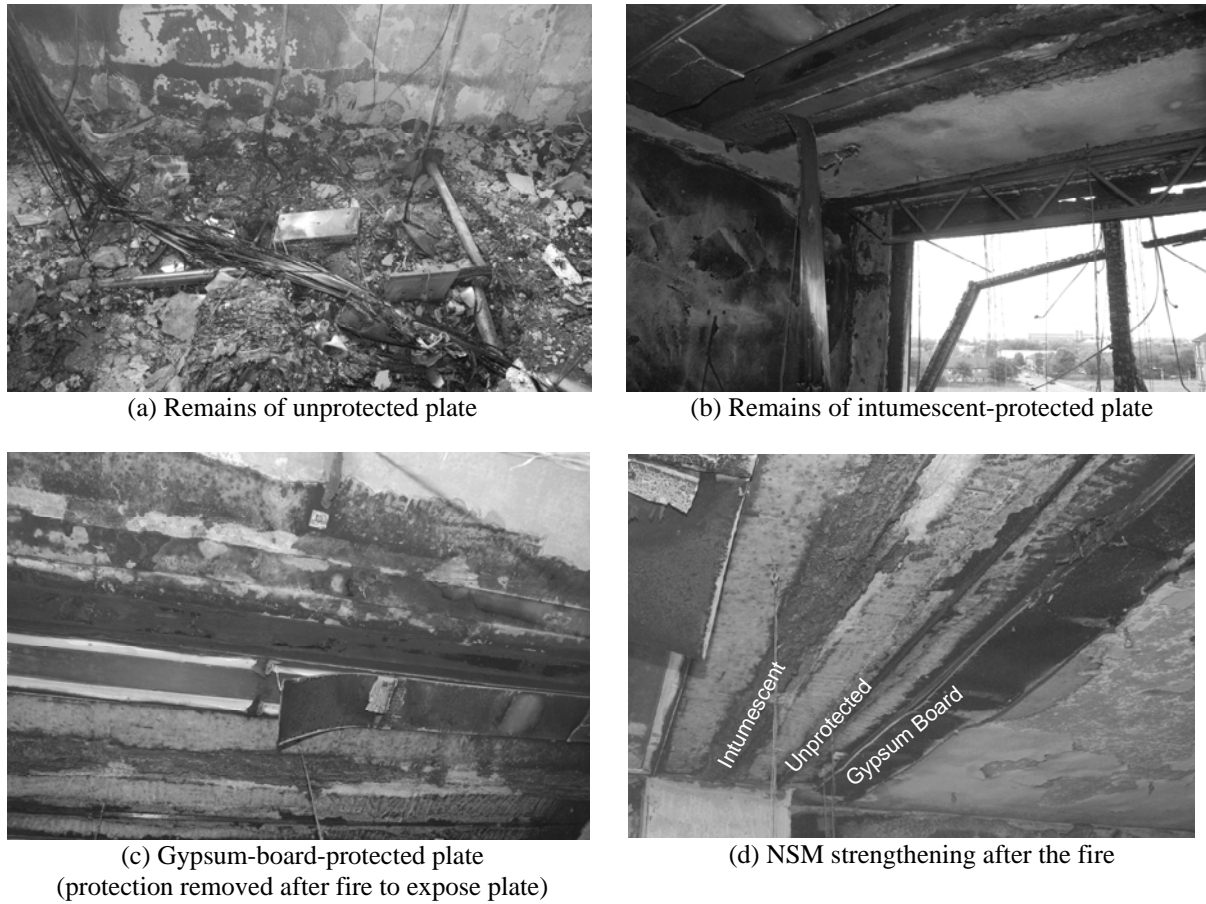
Figure 3. The condition of the bonded strengthening after the fire.

The condition of the bonded strengthening after the uncontrolled fire (Test 1) is shown in Figure 3:

- The unprotected plate (Figure 3a) had completely separated from the concrete. Both the bonding adhesive and the matrix polymer had burnt away, leaving exposed concrete on the ceiling and the bare fibres exposed on the floor.

- The intumescent protected plate (Figure 3b) separated from the concrete, except for a short length at its southern end, where it remained bonded to the concrete. Away from this end, the matrix polymer had burnt away to expose the fibres. The bonding adhesive was charred, but remained on the ceiling.

- The gypsum-board protection was inspected after the tests, and was fully intact. When the board was removed (Figure 3c), the plate was fully bonded to the concrete, and there was no *visual* damage to either the plate or adhesive. (Unfortunately it was not possible to carry out mechanical tests to quantify the post-fire properties).

- The adhesive around the unprotected NSM bar (Figure 3d) had burnt away, leaving the FRP partially exposed.
- The intumescent coating over the NSM strengthening (Figure 3d) had activated. The strengthening beneath the intumescent was in place, although the adhesive was glazed and contained transverse cracks.

- The gypsum-board protected NSM (Figure 3d) remained intact, and the strengthening beneath was visually unaltered.

Nevertheless, the uncorrected strain evolutions in Figure 5 are useful. Separation of the intumescent plate from the concrete, for example, occurred about 10 minutes from the start of the test, but the plate remained in contact at the southern end (confirmed by Figure 3b). The gypsum board protected strengthening have complete strain traces. The negative strains for the north gypsum-protected NSM gauge suggest the FRP has slipped relative to the concrete slab due to adhesive viscosity at high temperatures, but solidified during cooling. Further work, however, is required to analyse these results.
