Fire behaviour of reinforced concrete slabs under combined biaxial in-plane and out-of-plane loads

Wang, Y, Bisby, LA, Wang, T, Yuan, G & Baharudin, E 2018, 'Fire behaviour of reinforced concrete slabs under combined biaxial in-plane and out-of-plane loads', *Fire Safety Journal*, vol. 96, pp. 27-45.
<https://doi.org/10.1016/j.firesaf.2017.12.004>

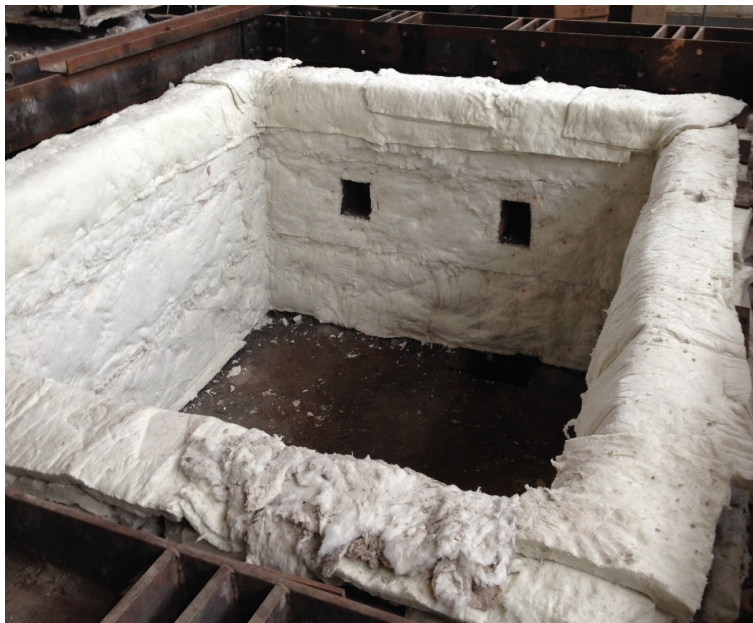
Fig. 1. Self-design furnace (all dimensions in mm).

(a) Plan view of the furnace

(b) External view of the self-designed furnace

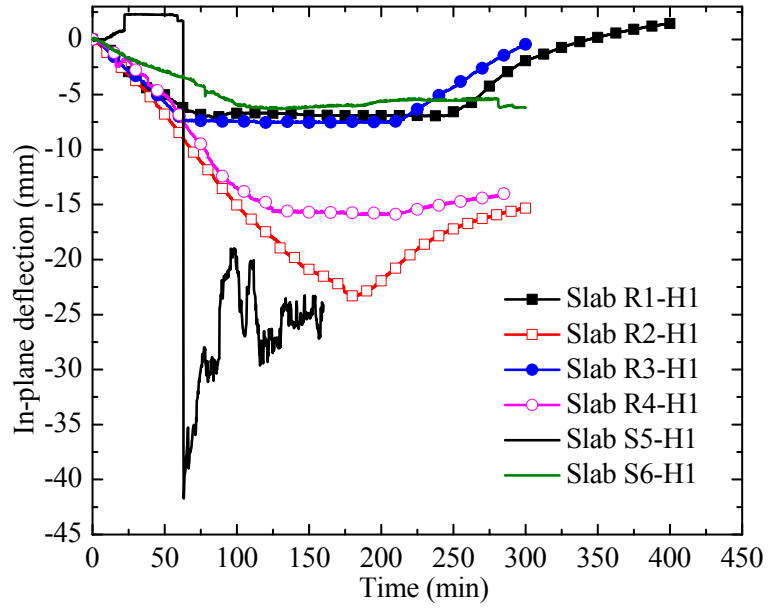
Fig. 10. Horizontal deflections of six concrete slabs

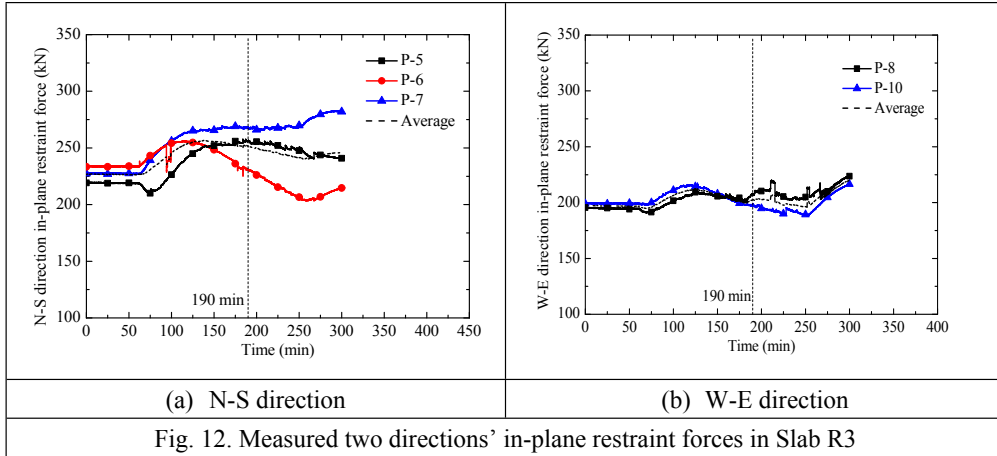
Fig. 12. Measured two directions' in-plane restraint forces in Slab R3

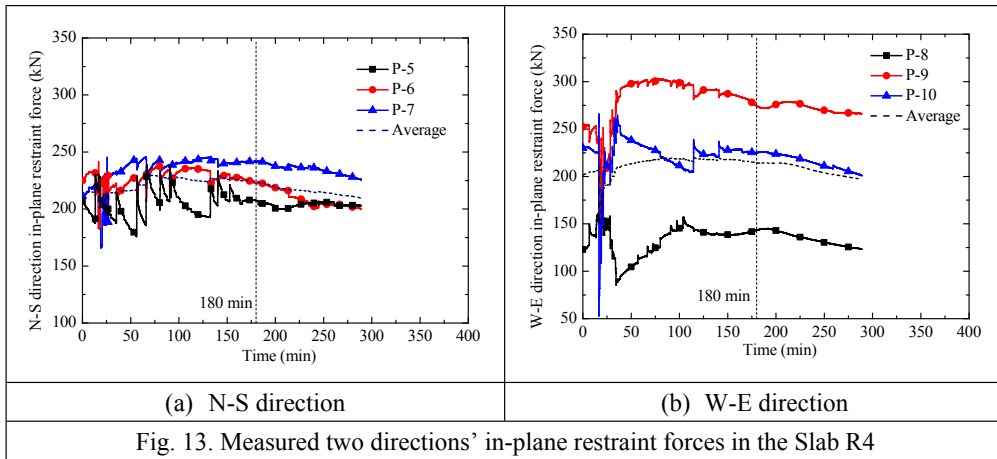
Fig. 13. Measured two directions' in-plane restraint forces in the Slab R4

380 Fig.13 (b) shows the in-plane forces at Points P-8 to P-10 in the test. Clearly, the in-plane forces at three points
381 rapidly increased during the early stage, and then considerably fluctuated in W-E direction. In other words, the
382 big “jump” behaviour was observed between 5min and 40min due to the drastic internal force redistribution, and
383 then followed by different development trends. For instance, the forces at Point P-8 (9, 10) ranged from 86kN
384 (133kN, 57kN) to 232kN (292kN, 264kN). After that, the in-plane forces at three points gradually kept constant
385 until the end of the fire test. In addition, it is noted that the average value of restraint forces basically remained
386 constant during the whole fire test, with the stress of 1.6MPa.
