Experimental study on progressive collapse resistance of steel frames under a sudden column removal scenario

Li, G, Li, L, Jiang, B & Lu, Y 2018, 'Experimental study on progressive collapse resistance of steel frames under a sudden column removal scenario', *Journal of Constructional Steel Research*, vol. 147, pp. 1-15.
<https://doi.org/10.1016/j.jcsr.2018.03.023>

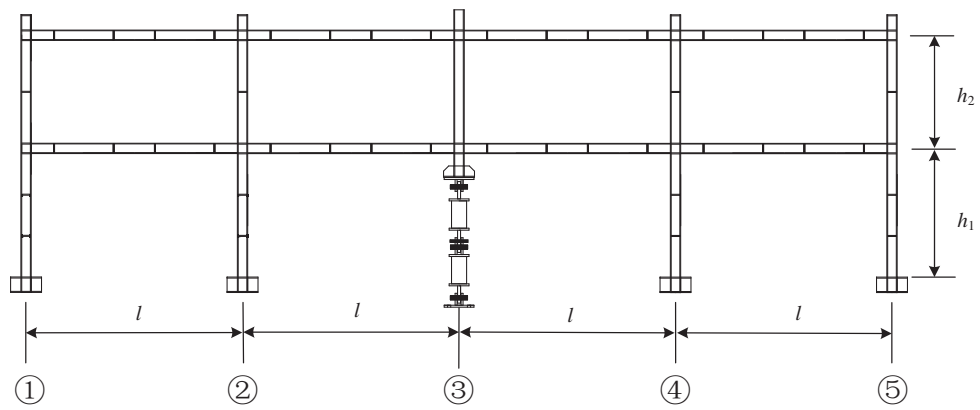
Fig.1 Layout of the steel frame specimen

Three two-storey, four-bay planar steel frames were designed and fabricated to evaluate their resistance against progressive collapse under a typical scenario with a sudden removal of a middle column at the first storey, as schematically illustrated in Fig. 1. The temporary replacement support for the middle column will be explained later.

After the instantaneous removal of the first storey middle column, all three steel frame specimens resisted progressive collapse and no severe material failure such as fracture of the beam-to-column connections took place. However, significant local buckling occurred at the bottom flange of beams near the beam-column connections in the adjacent spans to the removed column, as shown in Fig. 15. Note that in the figure “I” “II” stands for the first and second storey of the steel frames, respectively, and ② stands for the column number illustrated in Fig. 1.

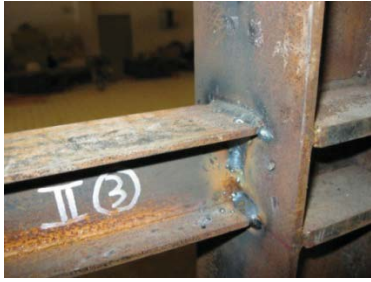
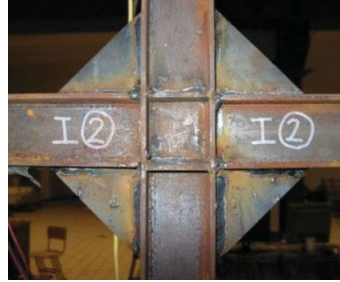
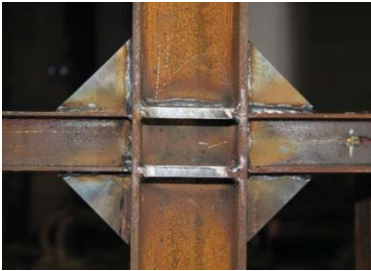
Fig. 2 Beam-column connections in different frames and column base fixture

The first test frame, FRAME1, was focused on the behaviour of the beam-column critical regions in a middle column removal scenario, with enhanced fully welded connections (Fig. 2a). FRAME2 and FRAME3 were focused on the influence of the column performance on the resistance of the frames against progressive collapse, and to avoid connection failure the beam-to-column connections were further strengthened by stiffeners (Fig. 2b and Fig. 2c). In all the specimens, the beams and columns were strengthened by distributed stiffeners to limit the influence of the local buckling on the global behaviour of the steel frames.

a. FRAME1

b. FRAME2

c. FRAME3

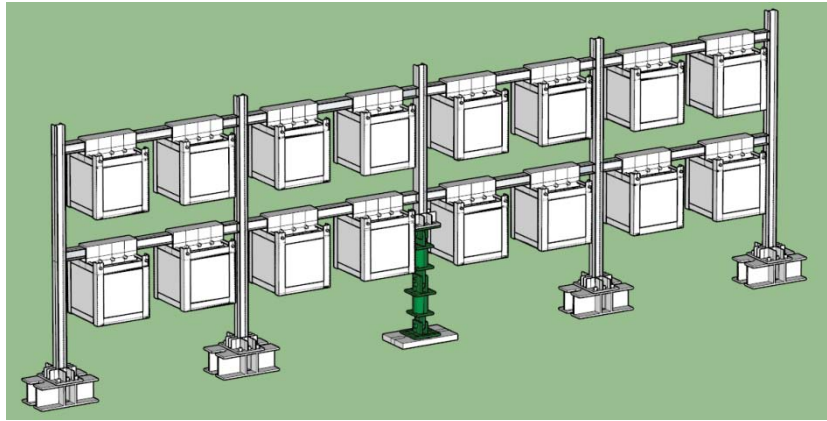
Fig. 3 Schematic diagram of test steel frame

To simulate a fixed support at each column base, the column foot was strengthened by steel plates and rigidly fastened to the steel base using high-strength bolts. The steel base was fixed on the strong floor using anchor bolts (Fig. 2d). A schematic diagram of a test frame is presented in Fig. 3.

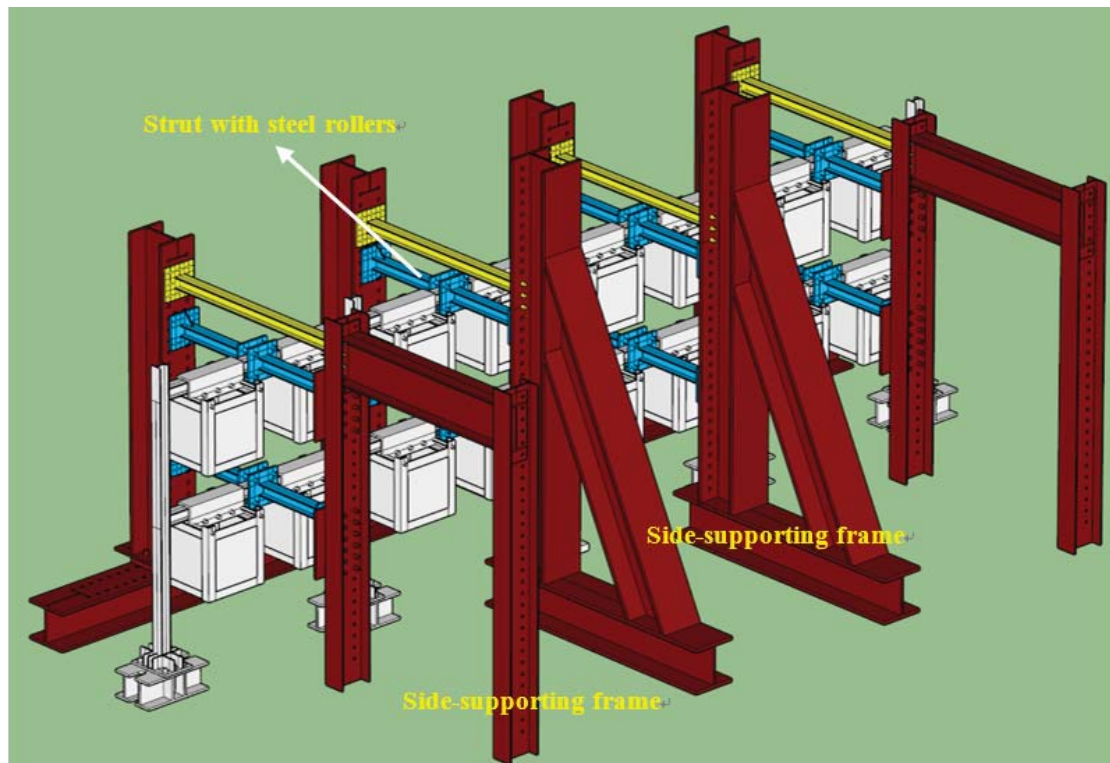
Fig.4 Schematic of out-of-plane supporting setup

In order to avoid the out of plane instability of the planar steel frame specimens, an out-of-plane supporting system was designed and installed. Fig. 4 shows an overall view of the out-of-plane supporting setup. The main supporting rigs were fixed on the ground using anchor bolts.

The struts that restrained the out-of-plane movements were fixed at one end onto the midspan of each beam of the test steel frame, and attached at the other end to the flanges of the side-supporting frames through a set of rollers. In this way, the test frame was allowed to move freely within its plane while any out-of-plane movement was prevented.

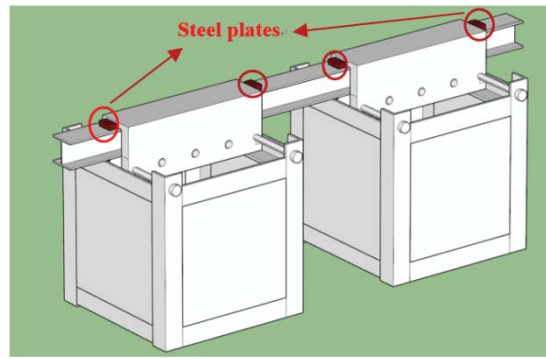
Fig.5 Schematic diagram of attachment of weight-holding baskets

The attachment of added loads to the test steel frame was an important aspect of the test setup. The design of the holding basket (box), illustrated in Figure 5, was made to

ensure the following: a) avoid out-of-plane movement, b) the whole set of the basket including the weights rigidly connects to the steel beam and moves in a synchronous manner, and c) avoid slipping – this is achieved by welding steel plate stoppers, as also shown in Figure 5.

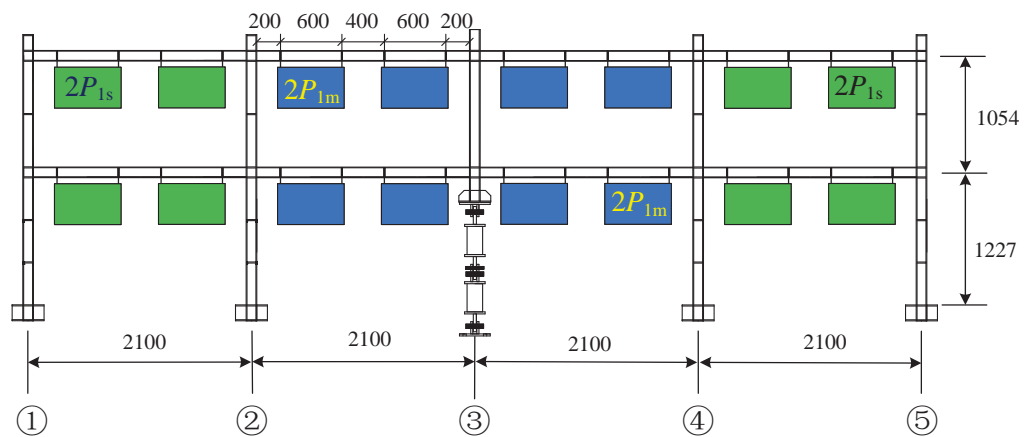
Fig.6 Illustration of distribution of loads (unit: mm).

As a main objective of this study is to develop a better understanding of the load transfer mechanisms and the progressive collapse failure modes of the steel frames, the applied loads of the beams were larger than the design loads specified in codes in order to yield large deformations following the column removal and expose the catenary action in the steel beams. Based on the finite-element analysis, the amount of applied weights on each beam was determined considering the possible progressive collapse modes, namely a connection fracture mode, a loss of stability mode, and a catenary action mode associated with large deflections of beams. Fig. 6 and Table 3 show the loads applied on each beam of the test frames. The weight in each suspended basket is $2P_{1m}$ for middle spans and $2P_{1s}$ for side spans.

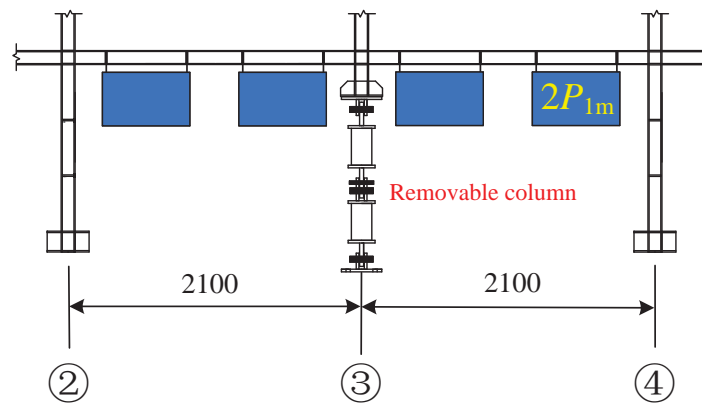
Fig.7 Removal column mechanism allowing quick removal by a pendulum hammer

mode, as stated in DOD 2013^[23] and GSA2003^[24]. In the present experiment, a special removal (dummy) column mechanism along with a pendulum hammer was devised to achieve a rapid removal of the target column, as schematically illustrated in Fig. 7.

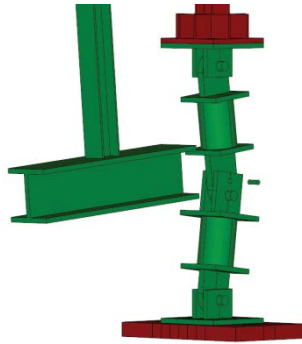
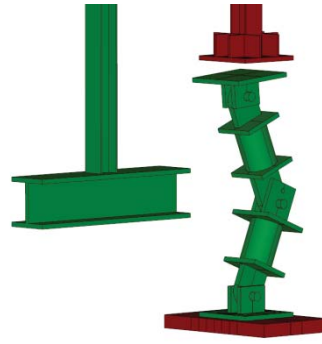
Fig. 9 Schematic of “column” removal process with a pendulum hammer

The removable column was made up by a three-hinged strut, as shown in the photos in Fig. 8. Prior to the actual test, the hinged strut was kept in a straight position to simulate the effect of the column by inserting a brittle (glass) locking rod through an additional hole at the middle hinge, making it effectively a fixed connection. Gravity loads were then applied through the holding baskets. During the test, the pendulum hammer was pulled to a designated position and subsequently released to strike the removable column at the middle position (as shown in Fig. 9a). As the middle hinge started to rotate, the glass locking rod was broken by the impact of the pendulum hammer (Fig. 9a), and this triggered the hinge mechanism and eliminated the vertical load carrying capacity of the removable column, and thus initiated the progressive collapse of steel frame specimens (Fig. 9b).

a. Breaking of the glass rod

b. Activation of the hinged mechanism

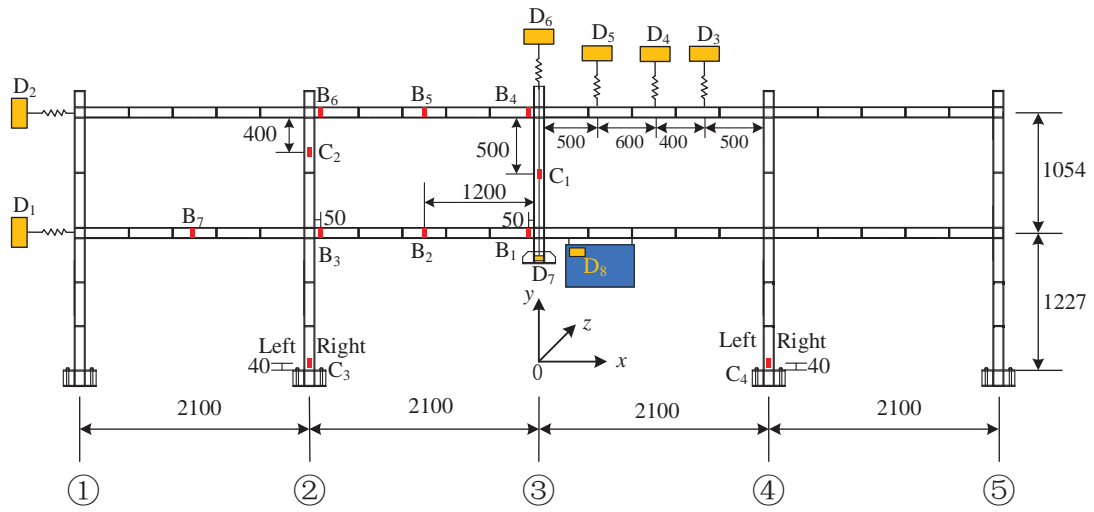
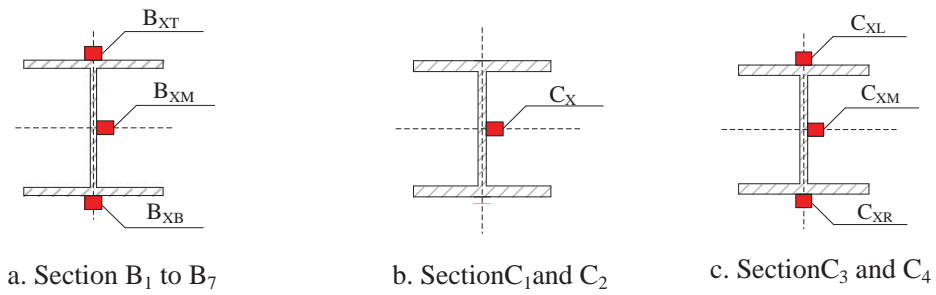
Fig. 10 Locations of strain and displacement measuring points (dimension unit: mm).

The instrumentation arrangement was similar for the three test experiments, as shown in Fig. 10. The instrumentation consisted of the following components.

(1) Strains gauges: For each specimen, 29 uniaxial strain gauges with a measuring range up to 50000 $\mu\epsilon$ were used to measure the strain at selected sections of the steel beams and at critical locations in the columns. The detailed locations of the strain gauges at the sections B₁ to B₇ of beams and sections C₁ to C₄ of columns are indicated in Fig. 10b. The measured strains can be used to calculate the internal forces in the beams and columns and to observe the development of catenary action in the beams during the progressive collapse of steel frames due to a column removal.

(2) Displacement transducers: Cable-Extension displacement transducers with a measuring range of 2000 mm were used to measure the displacements of the steel frame specimens. As shown in Fig. 10a, two displacement transducers, D_1 and D_2 , were used to measure the horizontal displacements at the side of the steel frame, while 4 displacement transducers, D_3 to D_6 , were installed along the central beams to measure the in-plane vertical deflections.

a. Arrangements of strain gauges and displacement transducers (unit: mm).

b. Detailed locations of strain gauges at the section level

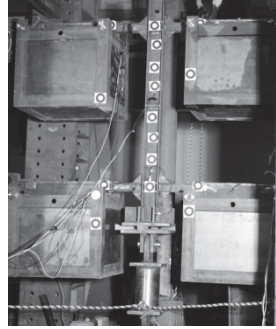
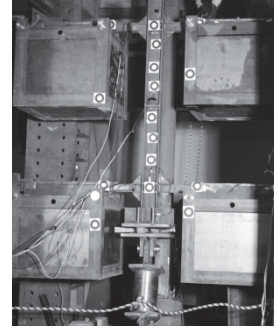
Fig.11 The removing process of removable column

From the analysis of the high speed camera records (Fig. 11), the effective column removal time can be identified based on the period between the moment when the pendulum hammer came into contact with the removable column and the moment when the column was completely disengaged. The results indicate that the time taken for the removable column to be removed, ΔT , was around 0.02 sec.

b. $t = 1/149\text{s}$ (removable column still engaged with the steel frame)

d. $t = 5/149\text{s}$ (collapse of removable column)

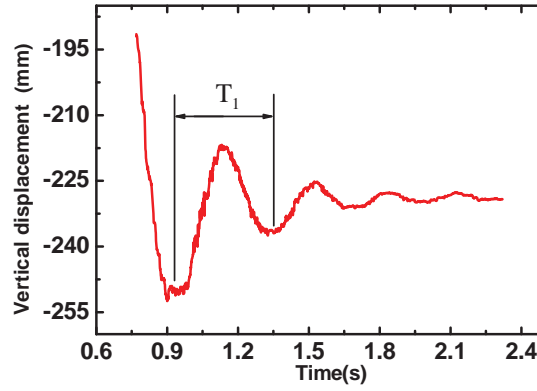
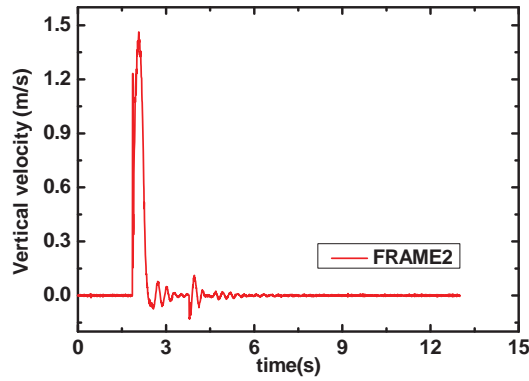
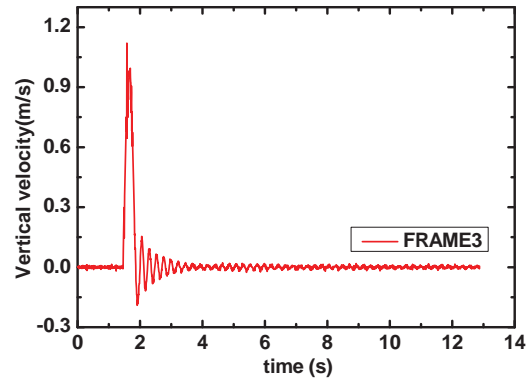
Fig. 12 Typical measured displacement / velocity time histories from the test frames

On the other hand, the natural period associated with the vertical response following the removal of the column can be determined by the dynamic vertical displacement measurement. The vertical displacement time history at the measuring point D₆ of FRAME3 after the column removal is shown in Fig. 12a. It can be seen that the dominant natural period T_1 was around 0.5sec. With a similar procedure, the dominant natural periods for the other two test framed were found to be 0.45 and 0.6 s, respectively. Therefore the column removal time ΔT was considerably smaller than the $1/10^{\text{th}}$ of the period T_1 . This indicates that the column removal setup successfully achieved the simulation of an instantaneous removal of column as specified by DOD2013 [23] and GSA2003 [24] for including realistically the dynamic effect on the progressive collapse of structures.

Fig. 12b shows the vertical velocity time histories at the location of the removed columns of FRAME2 and FRAME3 respectively. The maximum velocity at the measuring point D₇ was 1.5m/s and 1.1m/s for the two frames, respectively. These dynamic measurements demonstrate clearly the dynamic phase of the response after the removal of removable column.

a. Close-in of the displacement-time history measured at point D_6 (Frame 3)

b. Vertical velocity time histories at measuring point D_7

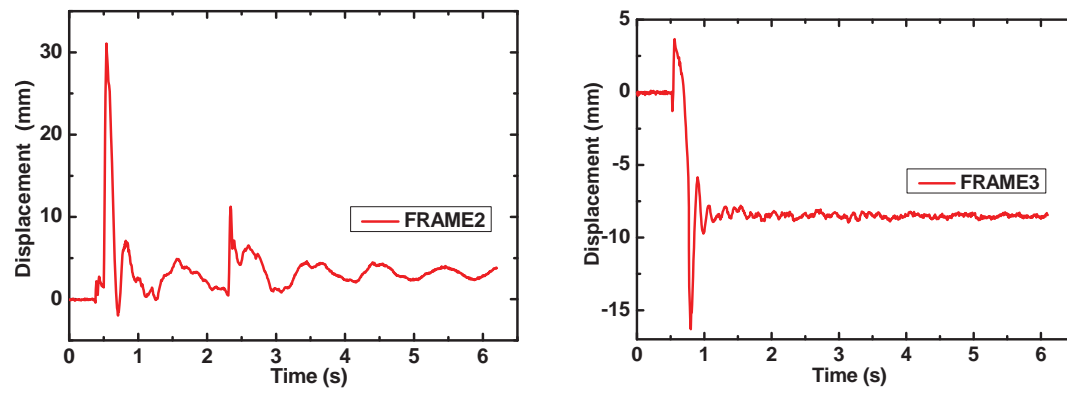
Fig.13 Out-of-plane displacement time histories of measuring point D₇

The effectiveness of out-of-plane support was checked by the displacement time histories at specific measurement points. In most of the cases the maximum out-of-plane displacement as measured at point D₇ (Fig. 13) after the column removal was less than 10 mm. This indicates that the out-of-plane supporting setup was effective in preventing the out of plane instability of the planar steel frame specimens.

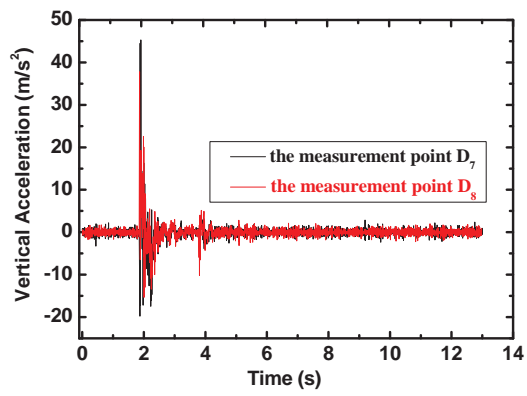
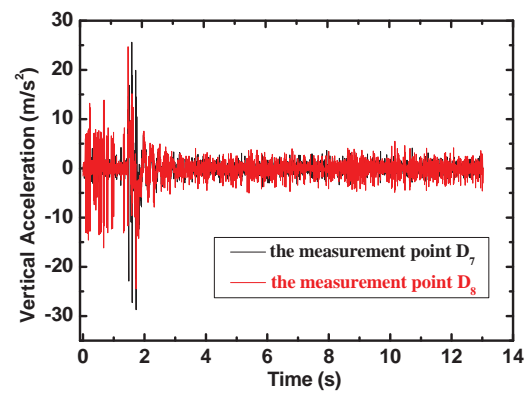
Fig.14 Vertical acceleration time histories of measuring points D₇ and D₈

To validate the effectiveness of the loading setup, measurements were taken of the vertical accelerations at the location of removed column (points D7) and at the top of the adjacent holding basket (points D8), as illustrated in Fig. 14. It can be seen that these vertical accelerations are in good agreement, indicating that the holding baskets moved synchronously with the steel frame after the removal of middle column.

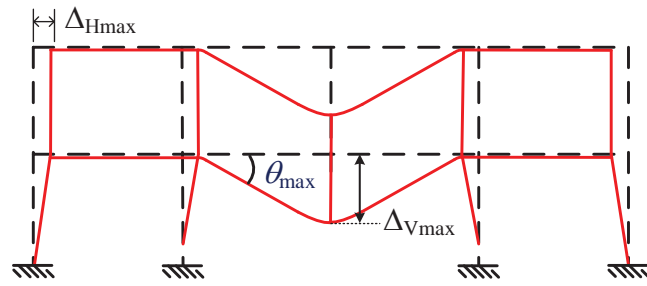
Fig. 16 Schematic diagram of displacement and rotation for the steel frame

A summary of the experimental results on the global deformation of the steel frames after the middle bottom column removal is listed in Table 4. The symbols are shown in Fig. 16, where $\Delta_{V_{\max}}$ is the maximum vertical displacement at the location of the removed columns, θ_{\max} is the maximum rotation at the other end of the beams adjacent to the removed column, and $\Delta_{H_{\max}}$ is the maximum inward horizontal displacement on the two sides of the steel frames. It should be noted that the rotation θ_{\max} is obtained by dividing the maximum vertical deflection $\Delta_{V_{\max}}$ by the respective

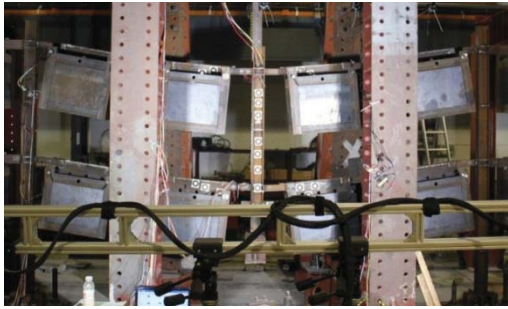
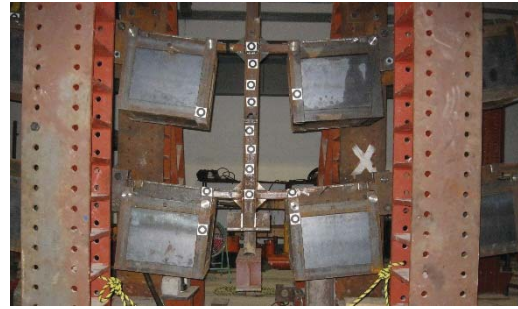
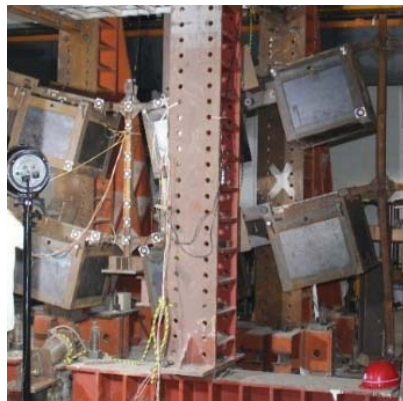
Fig. 17 Permanent deformation profiles of test frames

Fig. 17 shows an overall view of the deformed shapes of the steel frame specimens after the removal of the middle bottom column. FRAME 1 and 3 exhibited large permanent deformations, whereas FRAME2 (the strong beam-weak column frame) effectively failed as the columns adjacent to the removed column failed in bending and compression.

c. FRAME2 (middle and right photos show damages of columns)

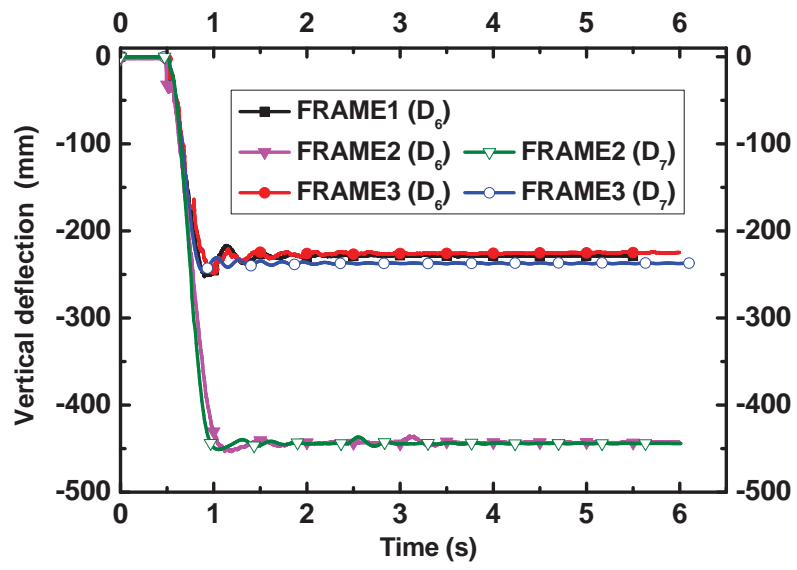
Fig. 18 Vertical deflection time histories (at Points D_6 and D_7 as shown in Fig.10)

The time histories of vertical deflections of the three steel frame specimens at the location of the removed column, namely Points D₆ and D₇ in Fig. 10, are shown in Fig. 18. The negative values represent the downward deflections, and the test started at around 0.5 s in the time axis. It can be seen that the maximum dynamic deflections were 252 mm, 454 mm and 249 mm for FRAME1, FRAME2 and FRAME3, respectively and the permanent deflections were 228 mm, 443 mm and 225 mm for the three frames, respectively. The vertical deflections measured by the displacement transducers (D₆) were very close to those measured by the high speed cameras (D₇), and this

demonstrates that both methods worked well in capturing the dynamic measurement of large deformations.

It is worthwhile to note that FRAME3 was subjected to an increase of about 20% in the gravity load as compared to FRAME1, while the middle bay beams and columns were of the same section sizes except that the connections in FRAME3 were strengthened, as can be seen in Fig. 2. From the measured responses it can be observed that FRAME3 experienced almost the same deflection time histories as FRAME1, and this suggested that by strengthening the connections the progressive collapse resistance of the steel frame was effectively enhanced.

FRAME2 had relatively small column sections, therefore, when it was subjected to the same gravity load as FRAME3, it exhibited an increase of almost 100% in the peak vertical deflection from that of FRAME3 under the middle bottom column removal scenario.

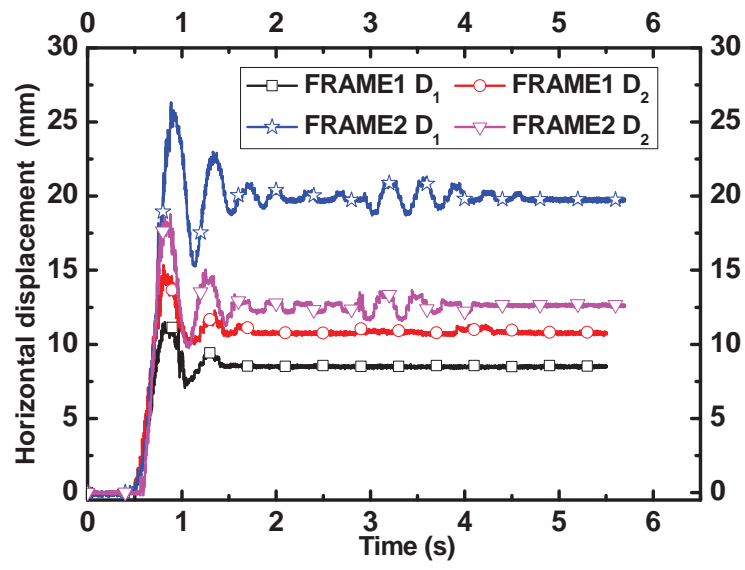
Fig. 19 Horizontal displacement time histories at side joints (points D₁ and D₂)

Fig. 19 shows the horizontal displacement time histories measured at first storey side joint and second storey side joint (Points D₁ and D₂ in Fig. 10) after the sudden removal of the first-storey middle column in FRAME1 and FRAME2. The dynamic maximum horizontal displacements at these points were 11.3 mm and 15.4 mm for FRAME1 and 18.5 mm, 26.4 mm for FRAME2, respectively, and the permanent horizontal displacements were 8.5 mm, 10.8 mm and 13 mm, 20 mm respectively. The storey drift angle of the remaining columns at the first story was approximately 0.01 rad in both frames.

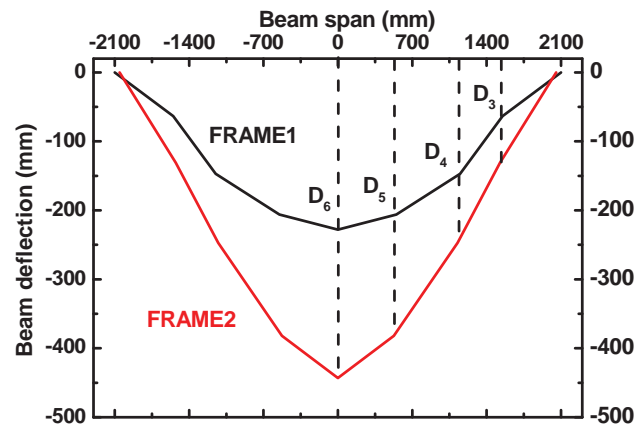
Fig. 21 Final displacement profiles of beams after removal of the middle column

Fig. 21 depicts the final displacement profile of the beams in the middle bay of FRAME1 and FRAME2. It can be observed that the deflection profiles of the beams tend to change from a largely bending mode (FRAME1) to a three-hinge mode (FRAME2) as the final deflection increased.

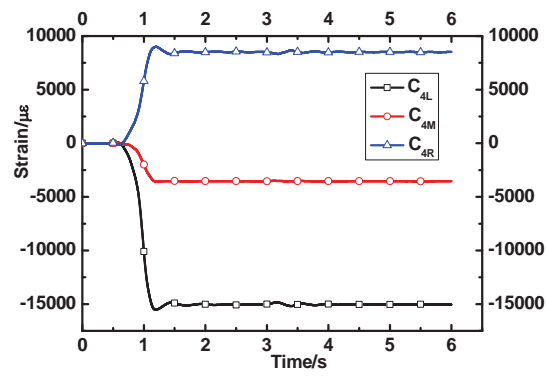
Fig. 23 Strain time histories at column section C₄ of FRAME2

After the removal of the middle column at the first storey, the strain time histories at this column bottom section for FRAME2 are shown in Fig. 23. It can be observed that much larger tensile strain in the right flange of column developed at the section C₄ than that at section C₃. The final strain at the above-mentioned locations of section C₄ for FRAME2 (the strong beam-weak column frame) were -15555 $\mu\epsilon$, 8205 $\mu\epsilon$, -3745 $\mu\epsilon$, respectively. These strains demonstrate that the column at section C₄ was primarily subjected to bending moment after the removal of the middle column and was well into the plastic stage. This indicates that FRAME2 collapsed due to the failure of the columns adjacent to the removed column in bending and compression.
