### **Experimental test on a fibre-reinforced scaled cross vault subjected to in-plane shear displacements at the springings**

Baraccani, S, Zauli, L, Theodossopoulos, D & Silvestri, S 2020, 'Experimental test on a fibre-reinforced scaled cross vault subjected to in-plane shear displacements at the springings', *Construction and Building Materials*, vol. 265. <https://doi.org/10.1016/j.conbuildmat.2020.120305>

# **Experimental test on a fibre-reinforced scaled cross vault subjected to in-plane shear displacements at the springings**

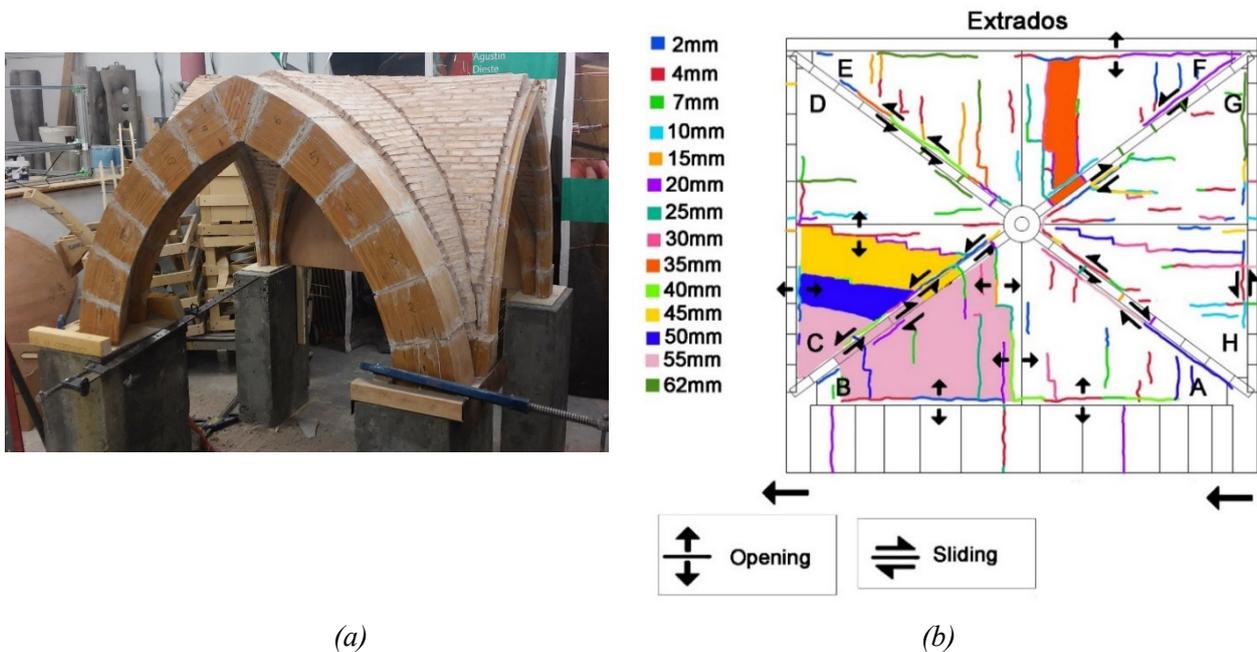
**Fig. 1:** (a) The unreinforced scaled cross vault model, (b) extrados crack patterns at the main steps of lateral displacement of the two front supports [8].

The physical model used throughout this series of tests was built using timber bricks and lime mortar mix [33]. The geometry of the cross vault is characterised by transverse arches span equal to 0.88 m, nave arch span equal to 1.10 m, and global rise around 0.76 m (Figure 1a). Subjecting this model earlier to in-plane shear displacement with no reinforcement highlighted that failure occurred essentially at 2.7% spread of the nave arch span (Figure 1b). This is in good agreement with results on similar cases available in the scientific literature [34], [35], [36]. More extensive insight to the experimental performance of the model can be found at the companion paper [8].

Figures 1b and 4 compare the crack patterns of the vaults in the unreinforced and reinforced configurations. It is clear that, in the unreinforced model, the cracks are almost uniformly distributed over the vault surface, whilst, in the reinforced one, the cracks developed only in the corner areas and no cracks occurred in the central portion of the vault where the fibres were placed.

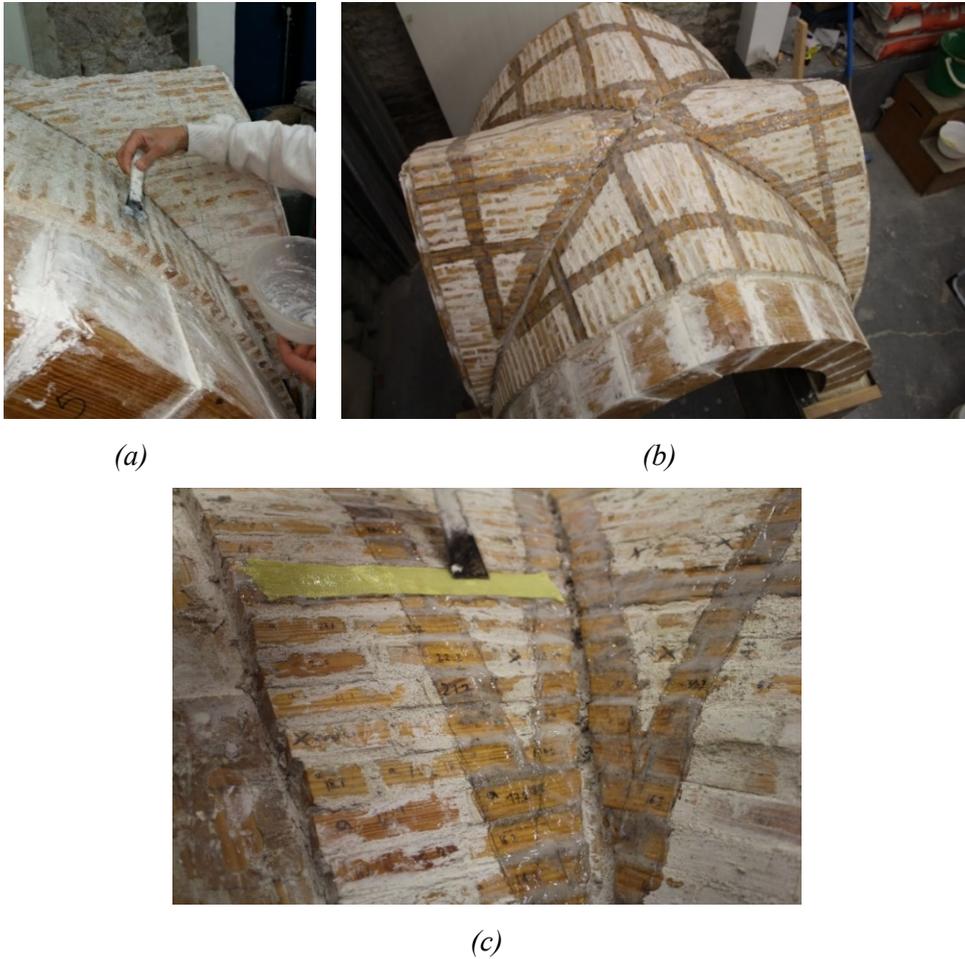
**Fig. 2:** (a) First layer, (b) Third Layer, (c) Fourth layer.

To fix the fibres to the timber bricks, a resin mix was prepared with (i) epoxy hardener, (ii) EL2 laminating epoxy, and (iii) fumed silica (introduced as extra material to increase stiffness). A typical proportion for the application was: three parts of Laminating epoxy, one part of epoxy hardener and a ratio of 2% - 3% (by weight) of fumed silica. First, two layers (Figure 2a) of a very viscous mixture were applied to homogenize (fill possible discontinuities) and prime the extrados of the bricks (provide a base level surface). Then, once dried, after 60-90 minutes, a third layer (Figure 2b) of epoxy was spread and the Kevlar aramid fibres were immediately positioned. Finally, a fourth layer of epoxy covered the fibres to obtain final saturation (Figure 2c). All these steps were carried out to guarantee adherence of the fibres to the structure.

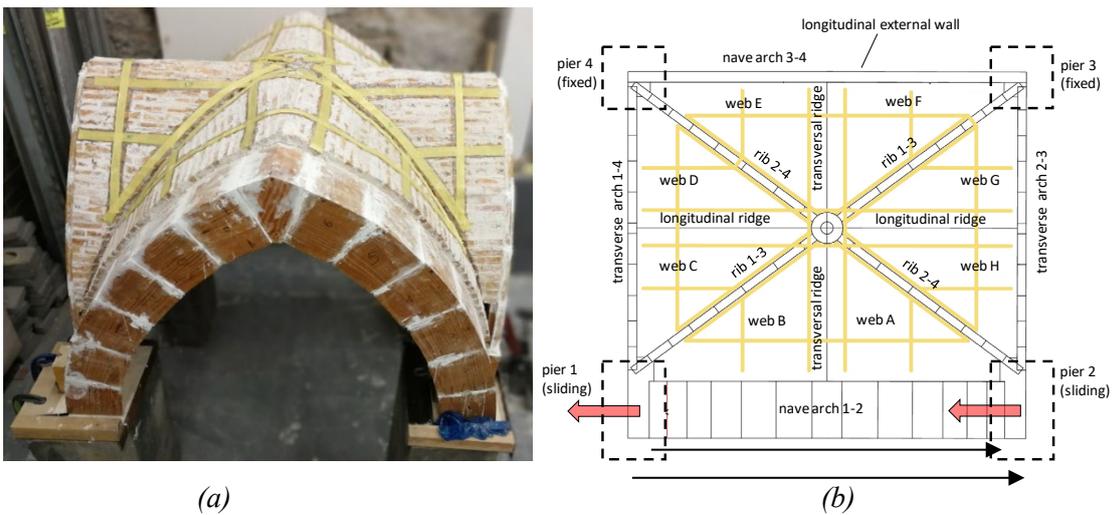
**Fig. 3:** (a) The reinforced model. (b) Plan view of the model with the fibre bands and the nomenclature of the structural elements.

The final result is shown in Figure 3: the fibres are located in the areas of the vault where the largest number of cracks was detected during the test on the unreinforced model [8]. The ends of the fibre bands did not reach the springings and the four perimeter arches, to assess the effectiveness of interventions in actual masonry vaults where the bands are not connected to the perimeter. This occurs in some vaults that have an incoherent solid fill in the corner areas and vertical masonry walls on the transverse arches, which prevent the application of reinforcement across them as their architectural integrity should be preserved by means of light, reversible and non-destructive interventions. Further

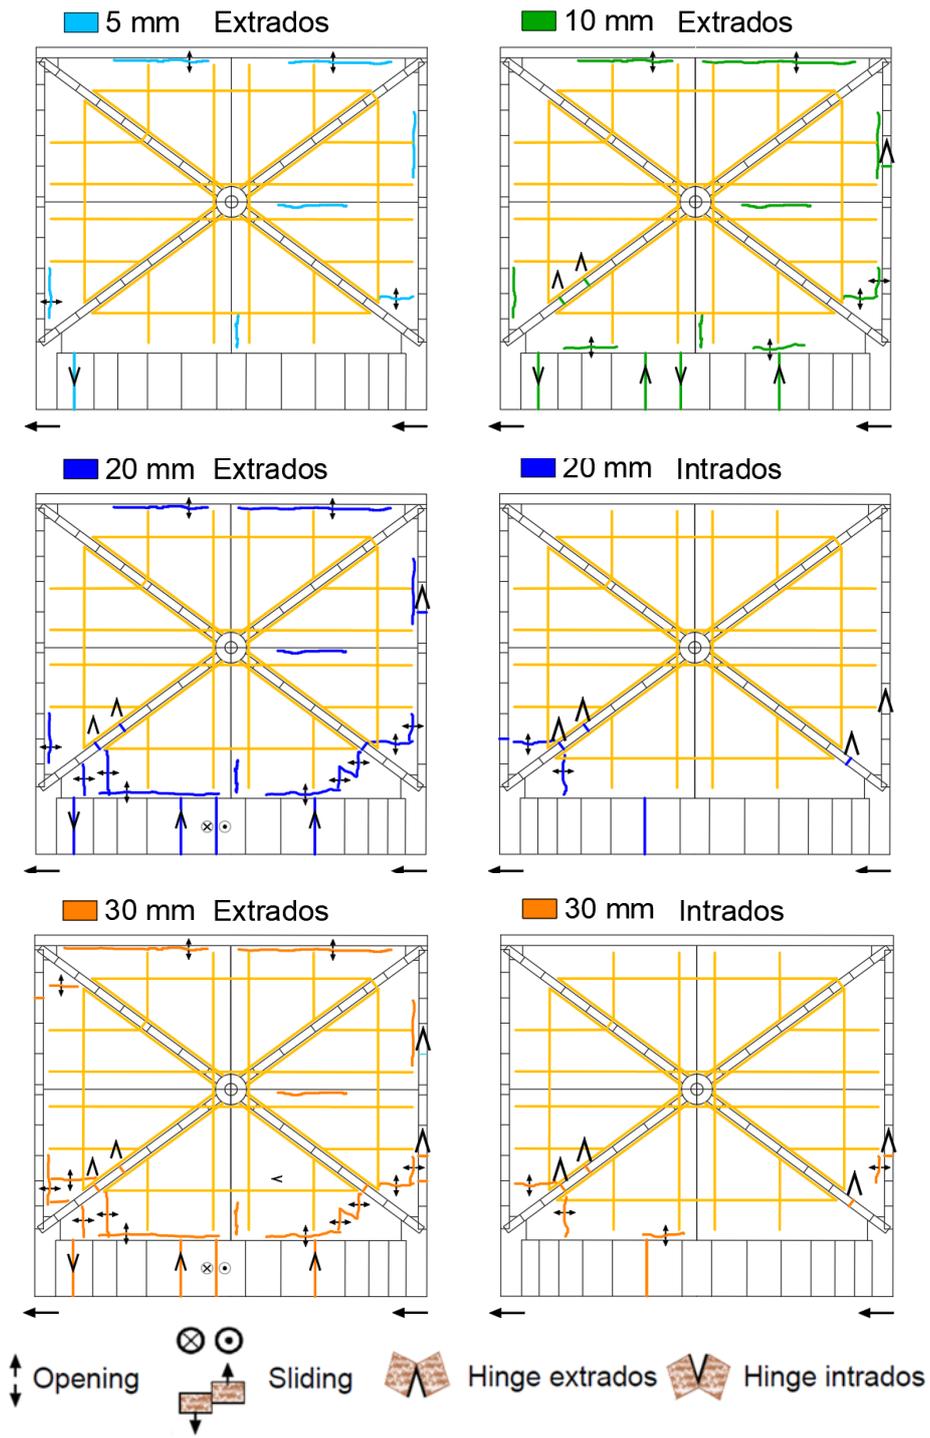
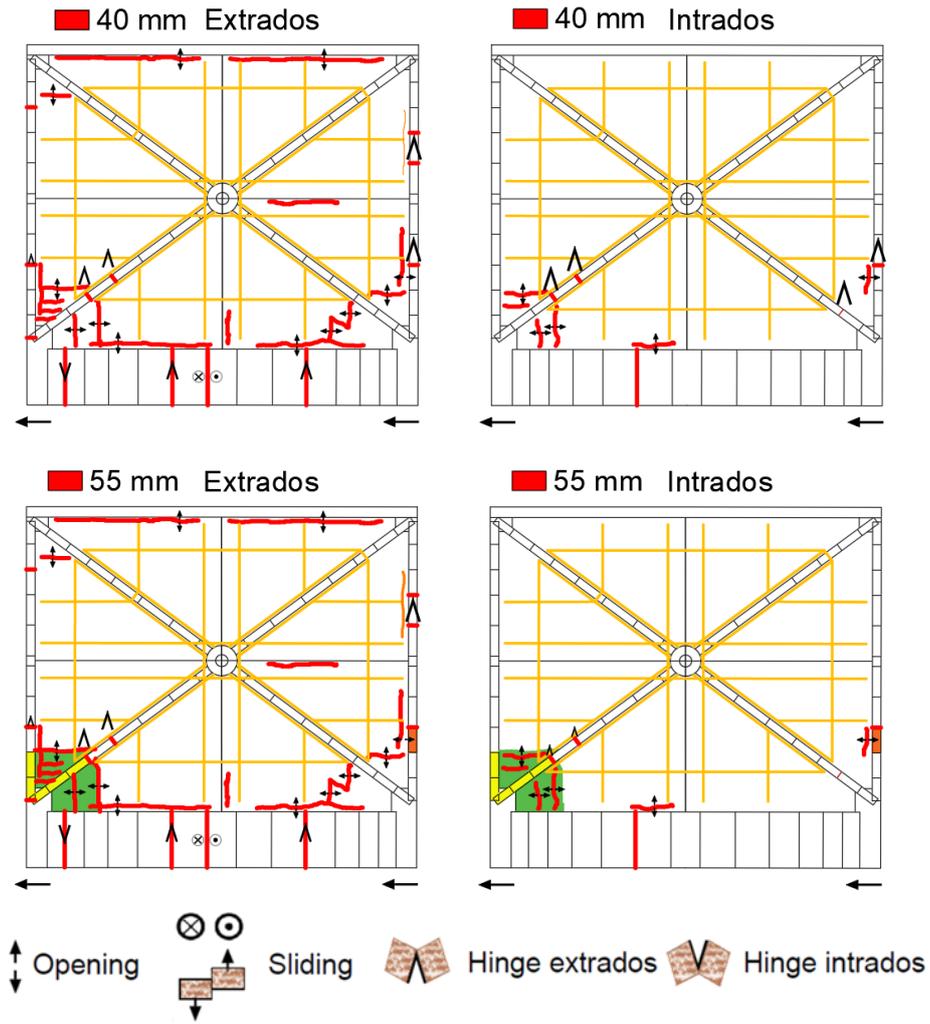
*Fig. 4: Crack pattern evolution and collapse condition.*

The crack pattern was observed on the extrados and the intrados after every spreading increment. In order to simplify the comprehension of the cracks' development, different colours are used for each step and thicker lines are adopted to represent the width of each crack (Figure 4). The detailed description of the cracking pattern is as follows:

- at the 5 mm stage of shear displacement, only cracks at the extrados were detected. The first, small, cracks initiated along the edge 3-4 and the transverse arches. A small fracture at the extrados appeared in the nave arch 1-2 near pier 1;

- the crack pattern at 10 mm showed the spreading of the perimeter cracks along the arches, while new cracks formed between the nave arch 1-2 and the two front webs A and B. Additional cracks appeared between voussoirs on the extrados of the nave arch 1-2. The diagonal rib 1-3 displayed the formation of two small hinges at the extrados with opening detectable at the intrados. From these first steps, it is clear that the cracks concentrated in the unreinforced portions of the model;

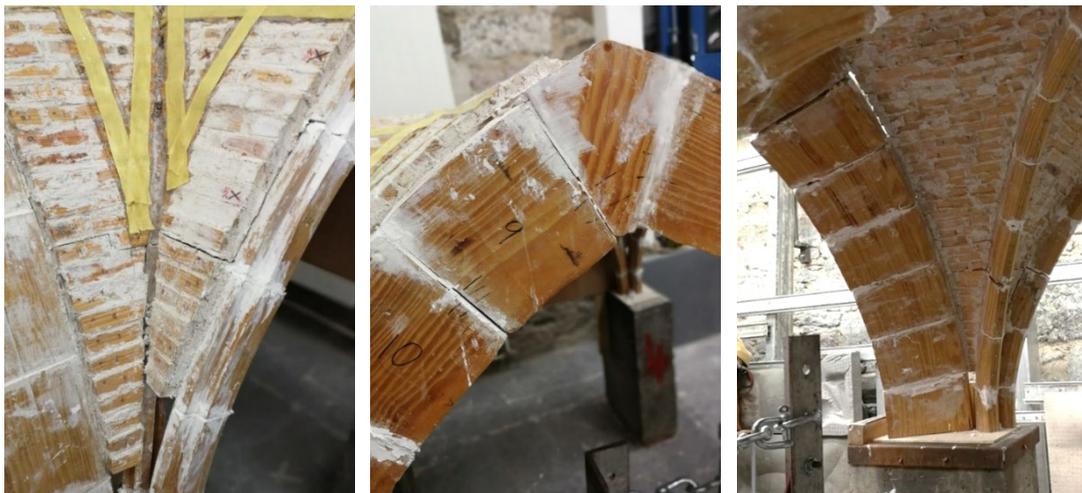
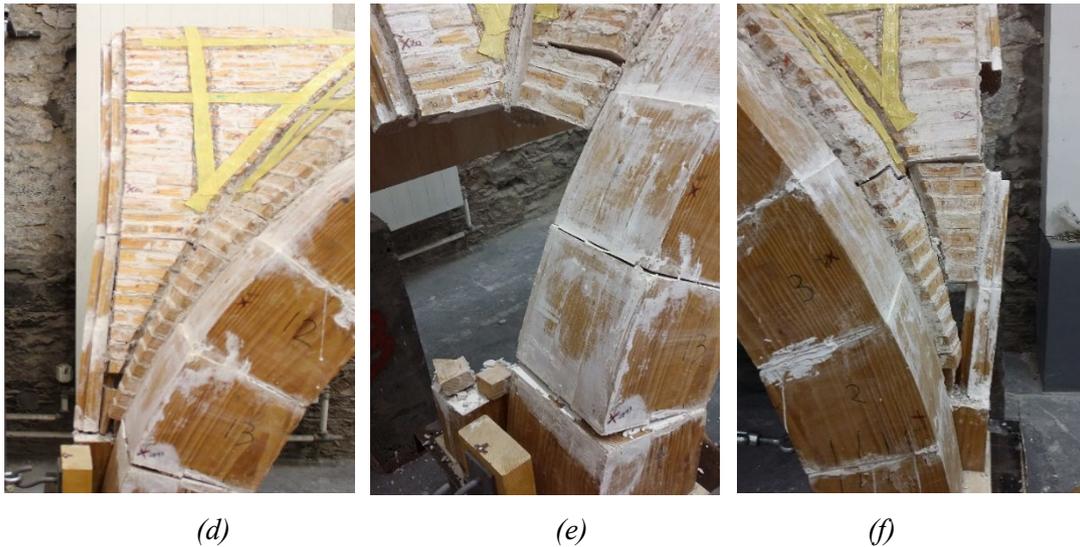
**Fig. 5:** (a) Extrados cracks in the corner area close to pier 2. (b) Downwards sliding of the voussoir at the left of the keystone of nave arch 1-2. (c) Intrados cracks in the corner area close to pier 1. (d) Undamaged strengthened portion of the vault (webs B and C). (e) Collapse of the unreinforced corner area around pier 1. (f) Collapse of one voussoir of the transverse arch 2-3.

- at 20 mm, small cracks appeared at the extrados in both corner areas close to the sliding piers 1 and 2 (Figure 5a). The first cracks appeared at the intrados in web B and C close to the rib 1-3 where the fibre-bands ends. One of the existing extrados cracks in the left-hand side of the nave arch 1-2 increased until one voussoir started to slide downwards with respect to the adjacent one (Figure 5b);

- at 30 mm, the cracks along the wall edge 3-4 propagated and reached the two corner areas, involving also a small crack at the extrados of web D. The sliding voussoir of the nave arch 1-2 continued to move, followed by the whole left-hand side of the arch. At the intrados new cracks appeared between web A and the nave arch 1-2, and between web H and transverse arch 2-3;

mechanism of the model started forming, defined by the dislocation of the voussoir of the nave arch 1-2 and the hinge on the intrados of the diagonal rib 1-3 (Figure 5c);

- for the successive displacement stages (45 and 50 mm) more damage occurred, especially in the unreinforced corner areas, but still the central strengthened portion of the vault remained undamaged (Figure 5d);
- at 55 mm, i.e. the last stage before collapse of the whole vault, the unreinforced corner area around pier 1 (webs B and C) started to collapse, involving voussoirs of the transverse arch 1-4 and the diagonal rib 1-3 (Figure 5e). In addition, one voussoir of the transverse arch 2-3 fell down (Figure 5f).

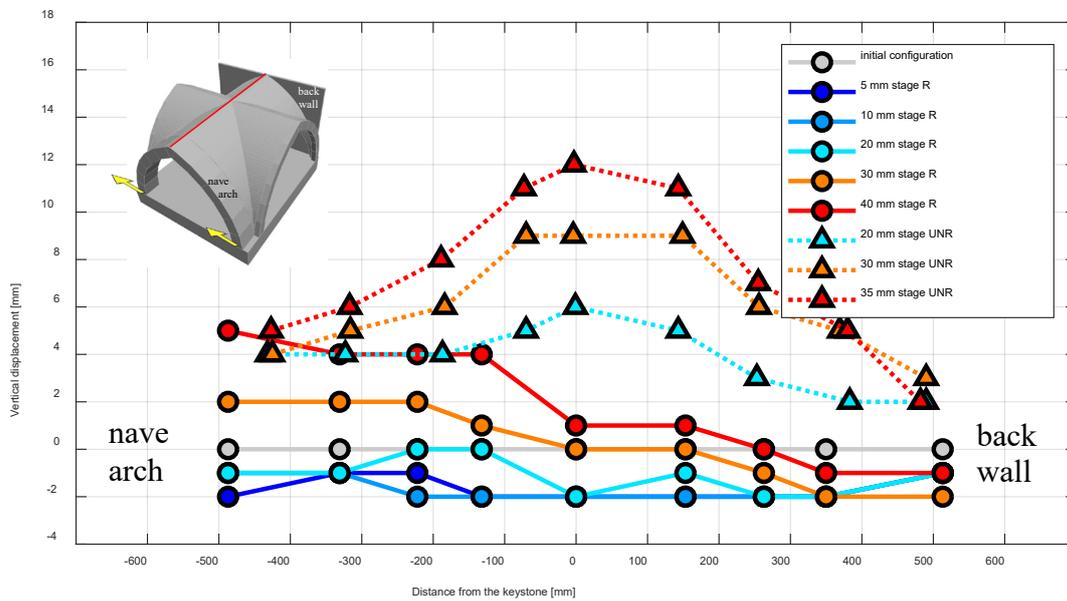
*Fig.6: Comparison of the vertical deflections of the transverse ridge for the unreinforced and reinforced models.*

Figure 6 shows the vertical deflections of the transverse ridge with respect to the initial horizontal configuration (R - solid lines and UNR - dotted lines). In the reinforced case, after an initial general downward settlement of maximum 2 mm at the 5 mm, 10 mm and 20 mm stages of shear displacement, the global behaviour looks quite asymmetrical for the 30 mm and 40 mm stages. The points close to the back wall show small downward deflections, whilst the points close to the nave arch show large upward displacements up to 2 mm at the 30 mm stage and 5 mm at the 40 mm stage. The front portion, where the imposed shear-displacement is applied, lifts up.

The comparison of the two models, indicates that in the unreinforced case the behaviour is basically symmetrical across the ridge and the maximum deflection is reached at the keystone (around 12 mm). On the contrary, in the reinforced case the behaviour is almost asymmetrical and the most significant

deflection, although much less here (6 mm, i.e. half of the UNR maximum), is reached by the point on the nave arch.

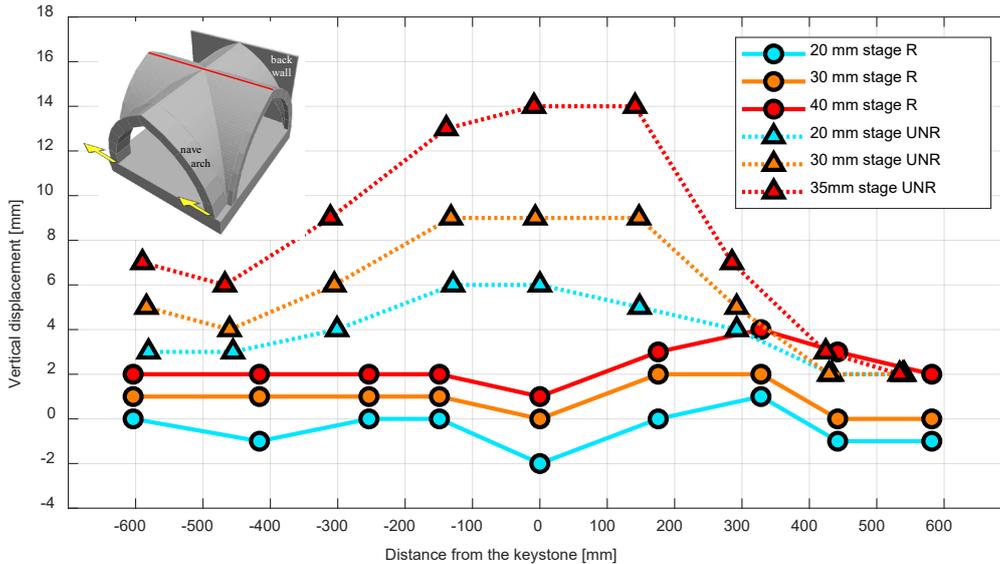
*Fig. 7: Comparison of the vertical displacements of the longitudinal ridge for the unreinforced and reinforced models.*

Figure 7 shows the vertical deflections of the longitudinal ridge with respect to the initial horizontal configuration at selected displacement stages. In the reinforced case, as already observed for the transverse ridge, also the longitudinal ridge displays an initial downward displacement (again up to 2 mm) at the first stages (up to the 20 mm stage) and does not show a constant trend during all stages. At the 30 mm and 40 mm stages, the longitudinal ridge slightly rises; the maximum value is about 4 mm. It is evident that the displacements of the reinforced model are smaller than in the unreinforced model. The latter shows a clear symmetrical uplift of the central portion of the vault, up to 14 mm, whilst the former an upward movement of its portion closer to the transverse arch 2-3 around 2 – 4 mm.

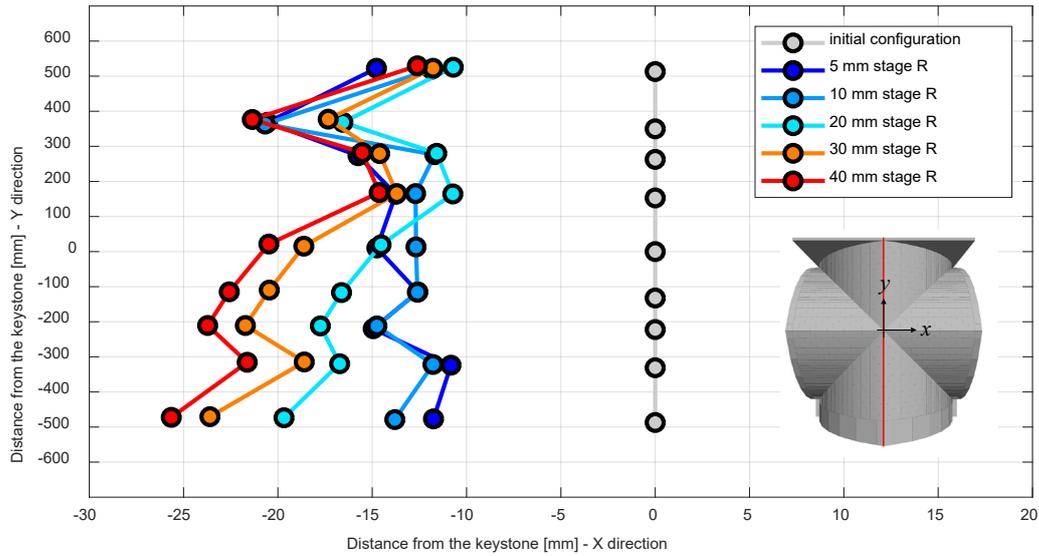
**Fig. 8:** Horizontal displacements of the transverse ridge (plan view).

It is important to study also the horizontal displacements of the transverse ridge with respect to the initial horizontal configuration, as a more direct effect of the in-plane shear displacement (Fig. 8). In general, the ridge seems to follow the imposed shear movement with larger displacement of the points close to the nave arch, up to 20-25 mm at the 30 mm and 40 mm stages, as expected due to the fact that this area is spreading. The recorded values of the displacements indicate that, at the first stages of shear movement (5 and 10 mm), the displacement of the transverse ridge is larger than the one imposed at the springings, whilst at the last stages (20, 30 and 40 mm) the displacement at the top is of the same order of magnitude as the imposed one at the bottom. The deformed shape clearly displays a hump, which is most probably due to the opposition provided by the compressed diagonal rib 2-4 and the surrounding webs D and E (Figure 9).

The difference (around 5 mm) between the lateral displacement of the last point of the transverse ridge at  $y \cong -500$  mm (as measured from the keystone) and the second last point at  $y \cong -300$  mm is consistent with the cracks that started developing at the 10 mm stage between the nave arch and the reinforced vault (Figure 4). All the more reason, the same consideration applies for the other side of the vault close to the back wall, which immediately detached from the reinforced vault even from the 5 mm stage (Figure 4): a final 10 mm difference can be observed between the points at  $y \cong +500$  mm and at  $y \cong +350$  mm from the keystone.

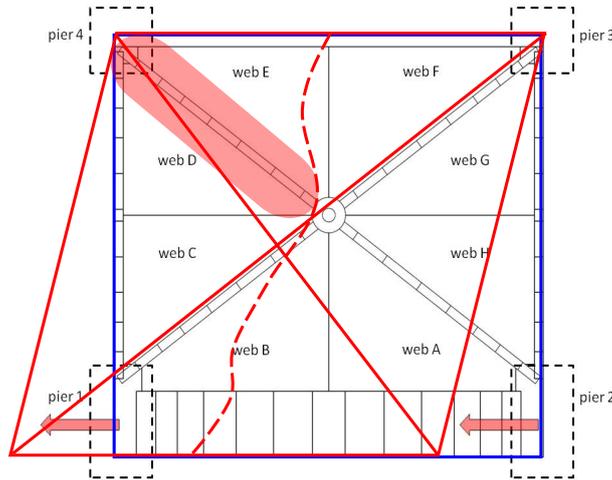
**Fig. 9:** Interpretation of the strut opposition provided by diagonal rib 2-4.

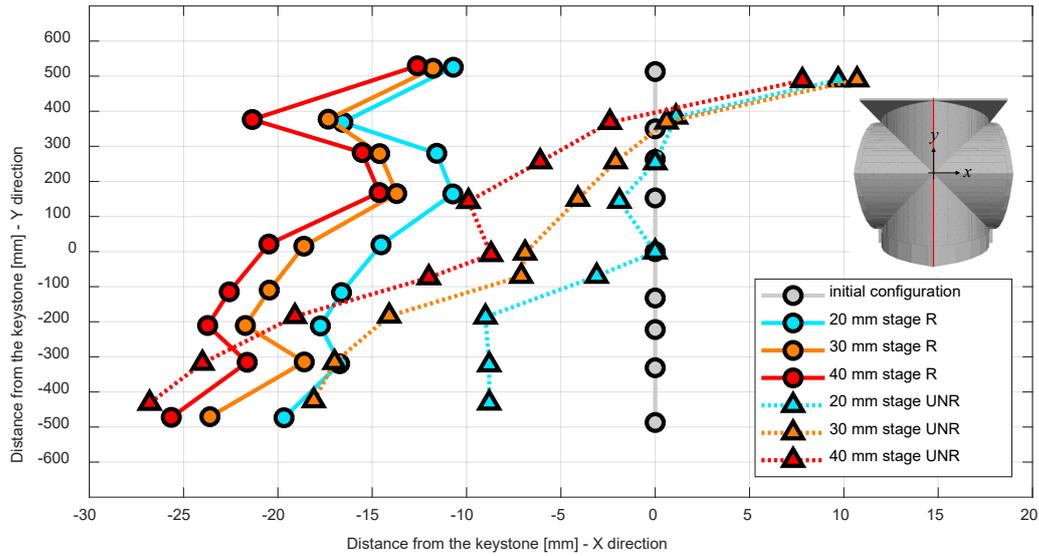
*Fig. 10: Comparison of the horizontal displacements of the transverse ridge for the unreinforced and reinforced models.*

Figure 10 compares the horizontal displacements of the transverse ridge for the two models. In both cases, the general lateral movement follows the imposed displacements at the springings with the largest displacements in the front side (nave arch), where a maximum value of around 25 mm was achieved. However, in the unreinforced case, the lateral movement is basically characterised by a global rotation of the transverse ridge towards a final diagonal configuration before the total collapse of the vault. On the contrary, in the reinforced case, the reinforcement makes the whole webs move as a block and the lateral movement is mainly described by a lateral (almost uniform, as compared with the unreinforced case) global translation that can occur due to the detachment of the bricks from the back wall and the frontal nave arch.

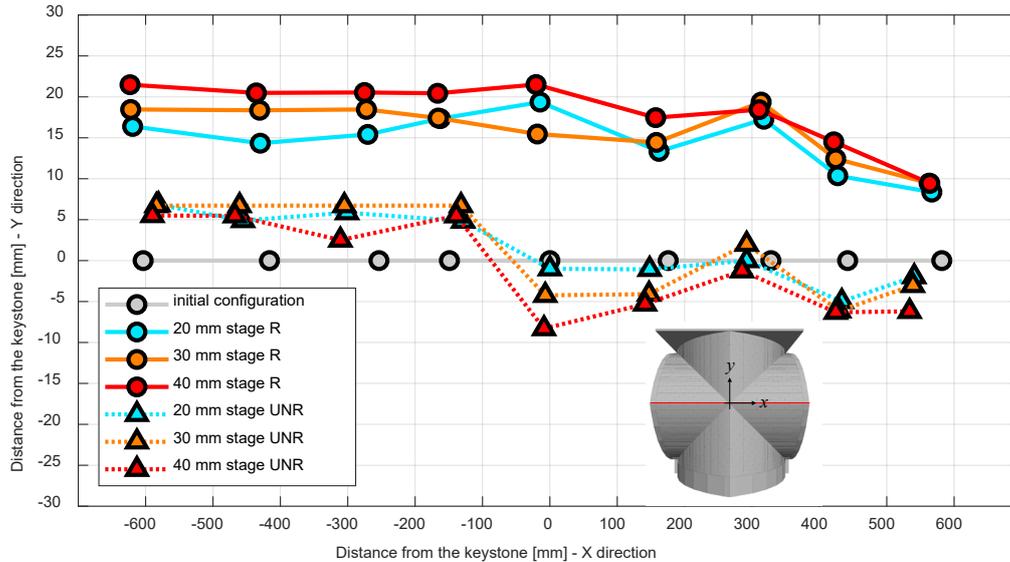
*Fig. 11: Comparison of the horizontal displacements of the longitudinal ridge for the unreinforced and reinforced models.*

Figure 11 shows the horizontal displacements of the longitudinal ridge at selected shear displacement stages. In the reinforced case, the deformed shape consists of a roughly uniform translation towards the back wall. In more detail, the left portion of the longitudinal ridge moves slightly more than the right portion, maybe due to the fact that webs D and E are compressed and thus may shorten in plan. This last observation is also consistent with the hump characterising the deformed shape of the transverse ridge, detailed in Figure 9. The comparison of the two models indicate that in the unreinforced case the lower stiffness of the vault allows larger deformations to happen, so the left portion of the ridge moves towards the back wall and the right one opposite, with high concentration of strain and damage around the key-stone. On the contrary, in the reinforced case, the higher stiffness of the vault provided by the fibres make the ridge move together towards the back wall.

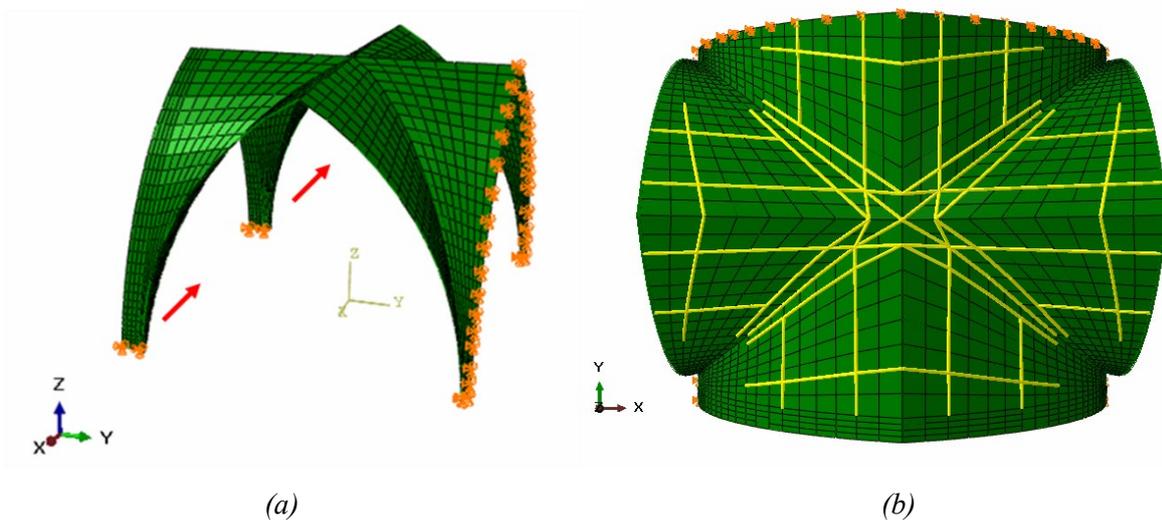
**Fig. 12:** (a) 3D-view and (b) plan view of the numerical model of the vault without and with FRP reinforcement.

The FE model used for the numerical non-linear analysis of the reinforced vault is the same as the one developed for the unreinforced vault (Figure 12a), described in the companion paper [8] and the Abaqus® [45] software was used. To represent the FRP reinforcement strips on the extrados surface, truss elements, characterised by the geometric and material properties described in sections 3 and 4, were added to the shell elements of the webs, by making reference to the nodes of the mesh and trying to match at best the exact location of the reinforcement strips (Figure 12b). The shearing deformation was applied with staged displacements imposed in piers 1 and 2 along the negative X direction until 40 mm.

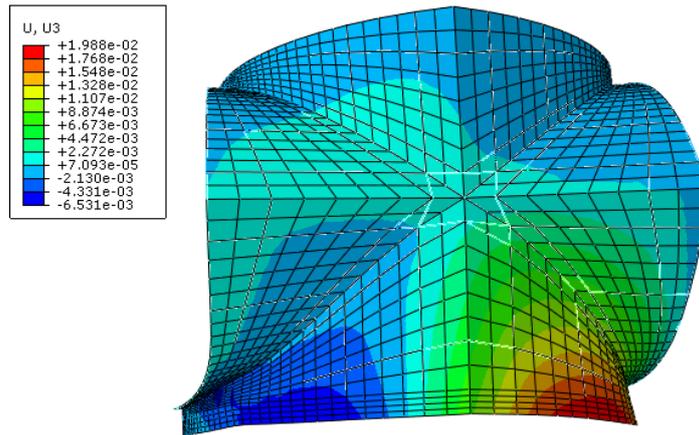
**Fig. 13:** Contour map of the vertical displacements [m] in the FEM reinforced model (40 mm lateral displacement stage).

Figure 13 shows the vertical displacements contour maps for the reinforced vault, whilst Figures 14a and b provide comparison between these data and the experimental ones. It can be noticed that:

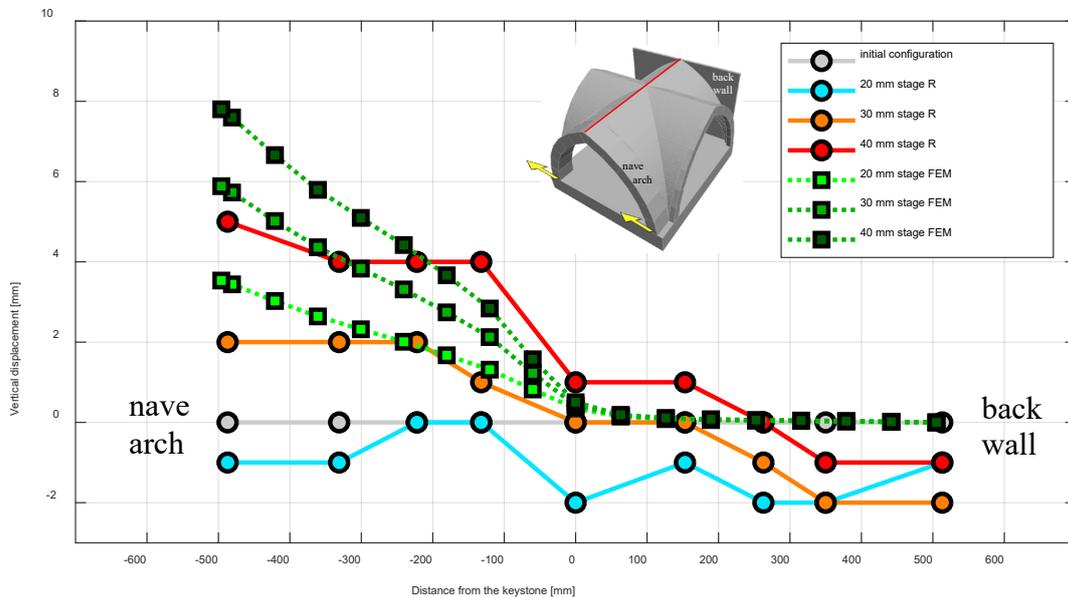
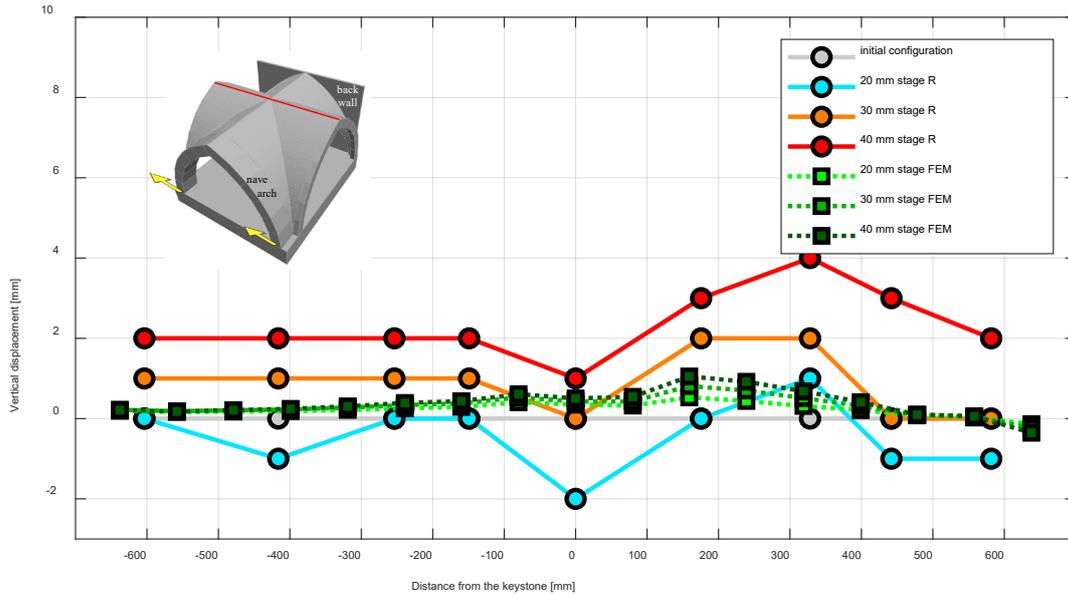
**Fig. 14:** Vertical displacements of (a) the transverse ridge and (b) the longitudinal ridge for the reinforced model: FEM numerical and experimental results.

- for large shear displacement stages (e.g. 30 and 40 mm), the qualitative response (upward movement of the points close to the nave arch) and the order of magnitude (around 5 mm) of the vertical displacements of the transverse ridge are well captured (Figure 14a). The vertical movements of the points close the back wall receive the effects of the boundary conditions (fixed restraints on the back perimeter arch, as per Figure 12), whilst the real vault experienced small downward movements;

- for large shear displacement stages (e.g. 30 and 40 mm), the qualitative response (upward movement) of the longitudinal ridge is captured (Figure 14b). From a quantitative point of view, due to the relatively small values of these displacements, this numerical model is not able to provide the order of magnitude;

- as it could be easily expected due to the unavoidable randomness of the real vault response to small displacement action, for the 20 mm stage, the numerical model cannot reproduce the experimental response at that stage but does simulate the qualitative response at larger displacements for both the transverse ridge and the longitudinal ridge.

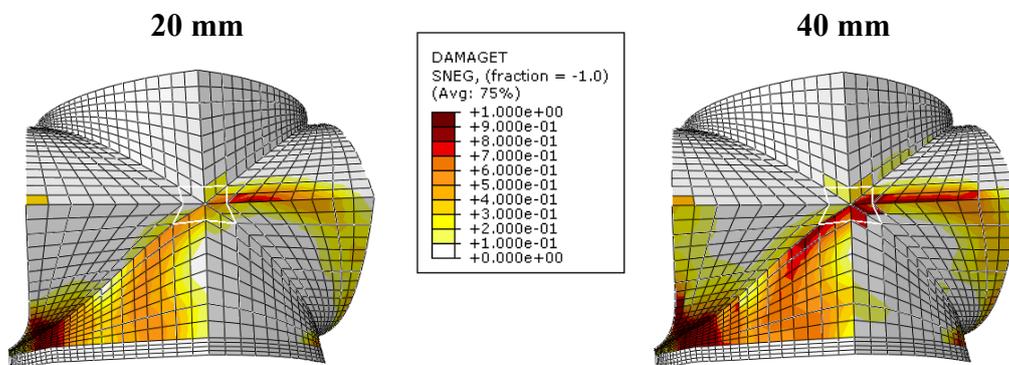
**Fig. 15:** Non-linear static damage contour plots in the FEM model.

The non-linear analysis using the Concrete Damage Plasticity model allows the tension damage variable (DAMAGET) contour plots to be obtained for the different shear displacement applied. Two illustrative plots are reported in Figure 15. The numerical results are in good agreement with the damage detected in the corner areas, capturing the damage occurred in the unreinforced lower part of the left front webs, as highlighted in Figure 5e. However, the numerical model indicates damages along the longitudinal ridge close to the key-stone that were not observed in the physical test. This may be due to the size and the shape of the shell elements near the keystone, that create a singular point characterised by sharp edges that may provoke stress concentrations in the numerical model. In the real vault model, the keystone is characterised by smooth curvatures (compare Fig. 2b with Fig. 12a).
