### The catastrophic repairs of Holyrood Abbey church in 1760

## The catastrophic repairs of Holyrood Abbey church in 1760

### Abstract

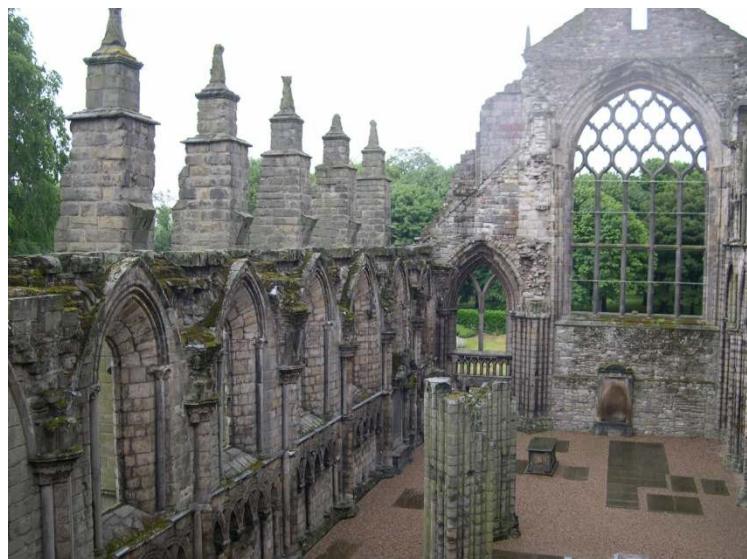
*Figure 1. The current state of the abbey church of Holyrood (2010) following no major interventions after the collapse of 1768*

The examination of the remains (Fig. 1, 2 and 16) and the report by W. Mylne immediately before the collapse (see appendix and Mylne 1766) may offer more clues on the dynamic of the collapse. The study of the surviving piers shows a few distortions that are remnants from the collapse but their cross section was not weakened from the 1633 and 1687 fittings any more particularly compared to the South arcade (certainly, these are the piers that survived the collapse). It is not certain whether the demolished ones are those that gave way or where most of debris fell. The damage appears to have occurred closer to the West façade (which as seen later had to be strengthened in 1626), and at higher level as the towers had to be removed by Mylne, while the East gable (much less robust than the West front, but also rebuilt in 1626) was not damaged much. Most probably all loose fabric was removed immediately after the collapse as there were no funds for consolidation. It is also probable some damage must have happened during demolition as well.

in 1795 and was rebuilt in 1816 (Robertson and Crae 2005). Damages on the internal face of the North walls (Figs 1, 2) are spread across the upper levels (around the windows mainly), and a few more severe ones can be detected closer to the W end, like some missing shafts on the piers and lower blind decorative arcades.

Most of the debris was cleared afterwards by W. Mylne, while this probably continued until 1856 (Robertson and Crae 2005). In the discussion about the necessary works (Exchequer Court 1769), he is asked to build up most of the windows and the stair door, for safety reasons, while he was allowed to sell any valuable remaining dressed stone. Special mention is also made on the flagstones that survived the fall of the roof to be put carefully aside. No mention is made on structural repairs, but all loose vaults are taken down, including the entire North aisle, but the outer wall survives to the height of the lancet windows (Figs. 1, 2, 16).

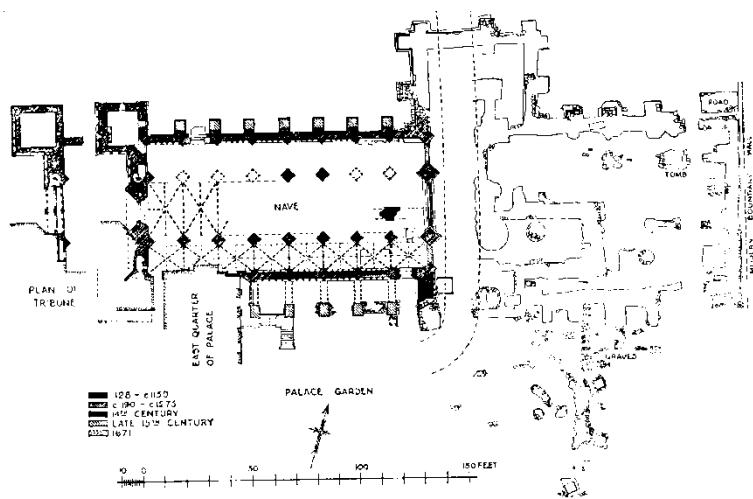
Figure 2. Plan of the development of the abbey (Oldrieve 1911)

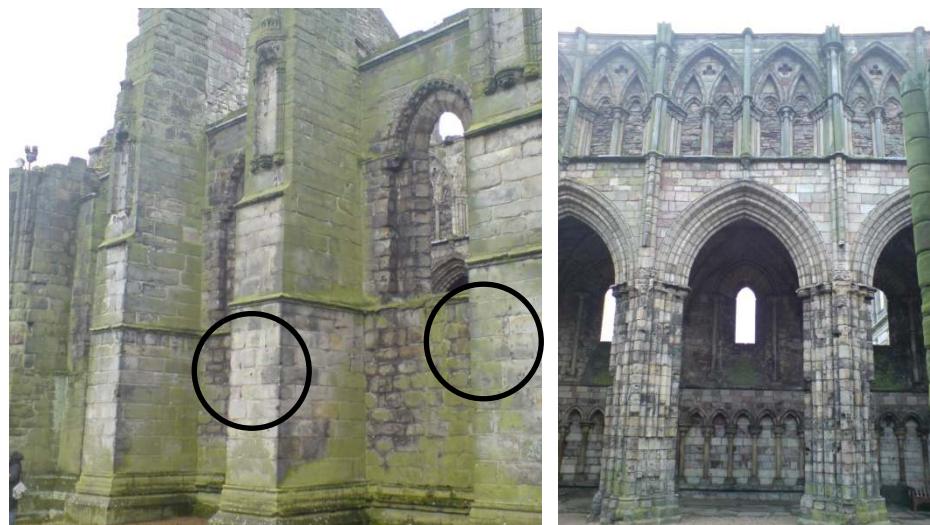
*Figure 3. Evidence of gunfire damage at the exterior (from the 1544 invasion) and deep cuts on the shafts of the piers for the insertion of pews at the interior during the extensive refurbishments of 1633 and 1670.*

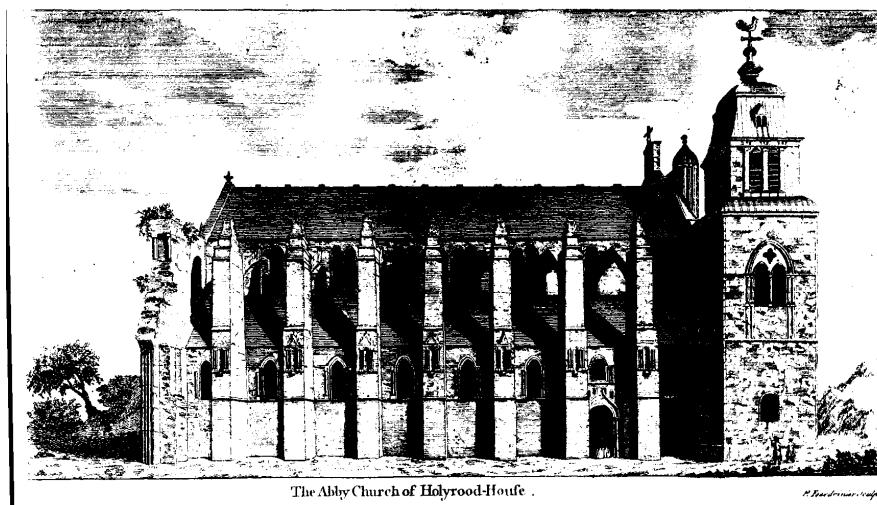
*Figure 4. The abbey church in 1753, showing some of the decay that required the intervention in 1760 (Maitland 1753)*

were probably deemed to be safe (Fig. 4) and this reduced the budget. No major replacement of the aisle roofs is mentioned in the 19<sup>th</sup> and 20<sup>th</sup> century and their condition is still quite good (Fig. 6).

In addition to these estimates, an inspection of the roof of the remaining S aisle shows the covering is stone tiles (Fig. 5). It is highly probable the nave roof had originally the same covering (Fig. 4), which could have been simply re-located after the repair. If flagstones were used on the other hand, no mention is made in any of the Exchequer minutes that the stone tiles were carefully stored, although they could have been re-used in Edinburgh Castle (the Great Hall, for example).

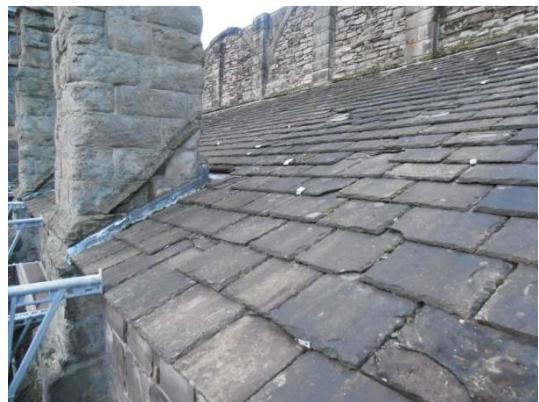
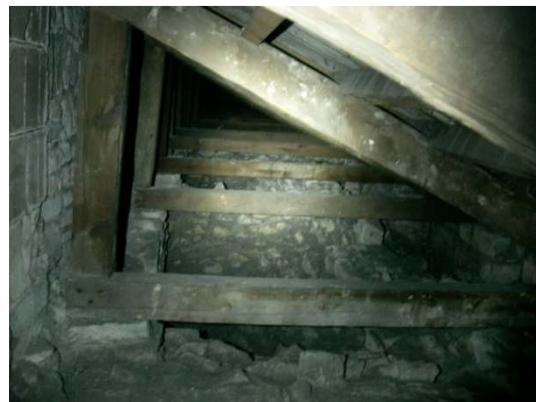
*Figure 6. Aisle roof: Covering with stone tiles, similar to what probably used to cover the nave, and internal view of the intrados space (taken in Summer 2013).*

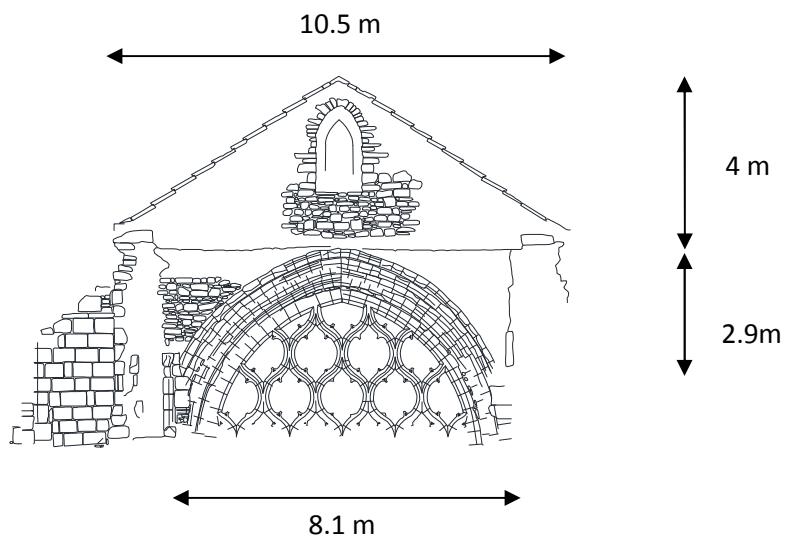
*Figure 7. Survey of the East gable (Robertson and Crae 2005) and dimensions of the nave vault*

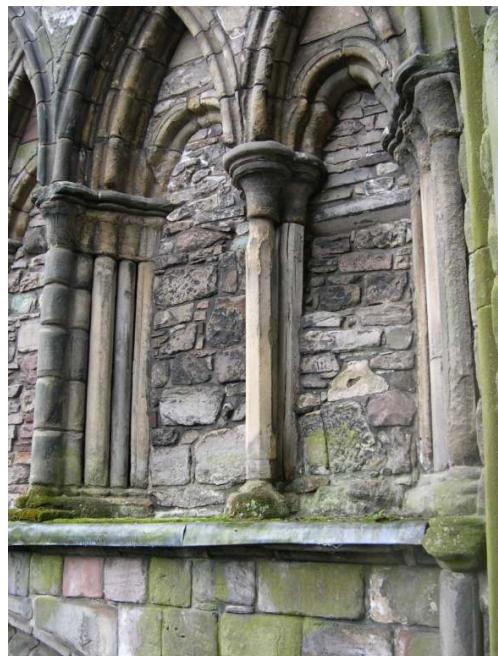
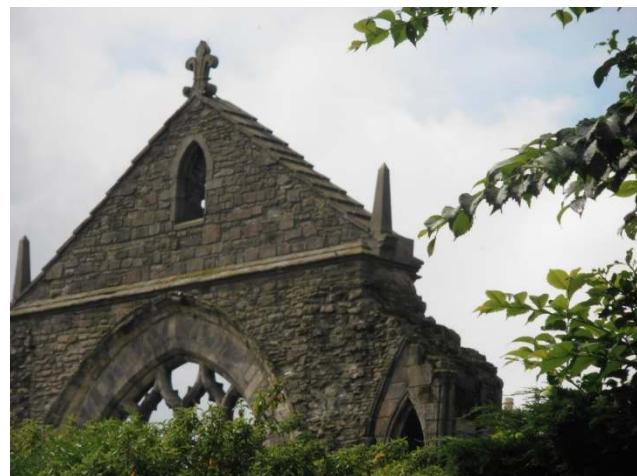
*Figure 8. Remains of the Douglas and McPherson project at the rubble stonework blocking the openings of the triforium (item 8 in Table 1) and possibly the coping stones at the W gable window (but not the obelisks and fleur-de-lis finial).*

Following the collapse, few remains survive from the repair project. The triforium windows ("where the Stone Roof of the Isles is to join to the side walls of the Main Body of the Church") were blocked with "Rubble Building" (Fig. 8) during that project (item 8 in table 1). If the estimated area of the openings is 60% of the corresponding band of the triforium, this is then  $(38.7 * 2.2)*2*0.6 = 102\text{m}^2$  = 127 sq yards = 4 roods and 6 yards, which is close enough to 4 Roods 26 yards mentioned in Table 1. Coping stones are still fixed along the W gable which together with the obelisks at the base of the gable may have been an attempt to visually tidy up the edge of the renovated roof, especially when seen against the original pinnacles over the piers of the flying buttresses.

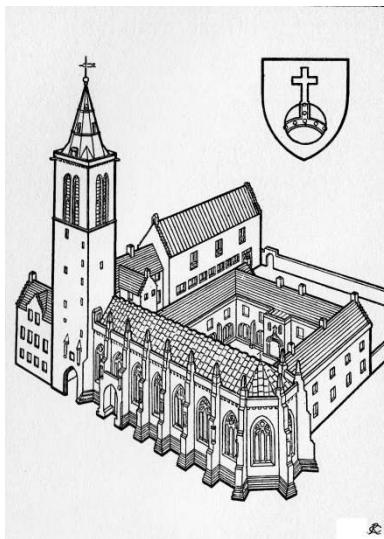
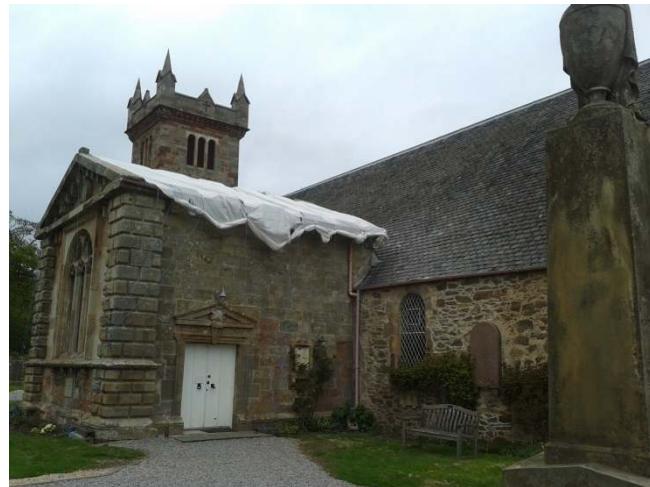
*Figure 10. St. Salvator's Chapel in St. Andrews University before the forced collapse of the roof in 1773 (Cant 1956) and Dirleton Aisle (East Lothian), built in 1664.*

This is in a clear contrast to British empiricism. No similar spatial or structural complexity is observed in British architecture of the time, with vaults even being misunderstood (Fig. 10) and mostly new barrel vaults would be built for bridges as Piranesi's engravings for the construction of Robert Mylne's Blackfriars Bridge during construction in 1764 show.

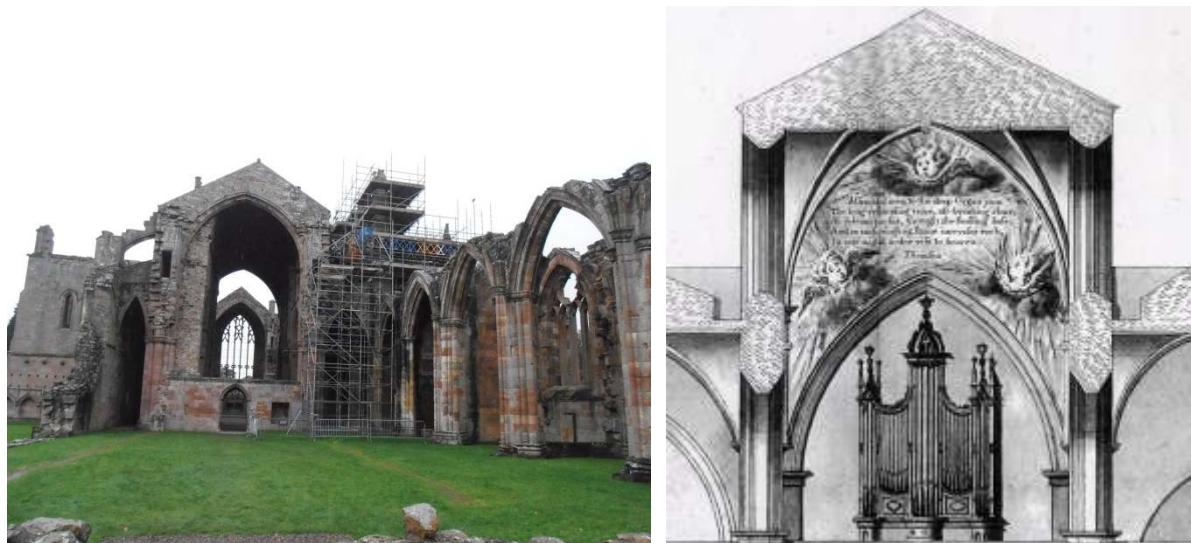
*Figure 11. Misinterpretations of vault design in post-reformation Scotland: the barrel vault that replaced the nave cross vaults in Melrose ca 1621 and James Craig's design of the King's Seat in St. Giles, Edinburgh in 1777 (NMR catalogue number C 96508 PO)*

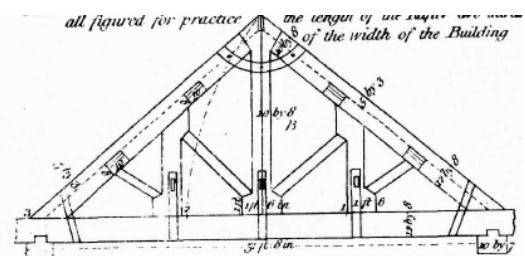
*Figure 12. Form of 18C king post trusses from William Pain (1794)*

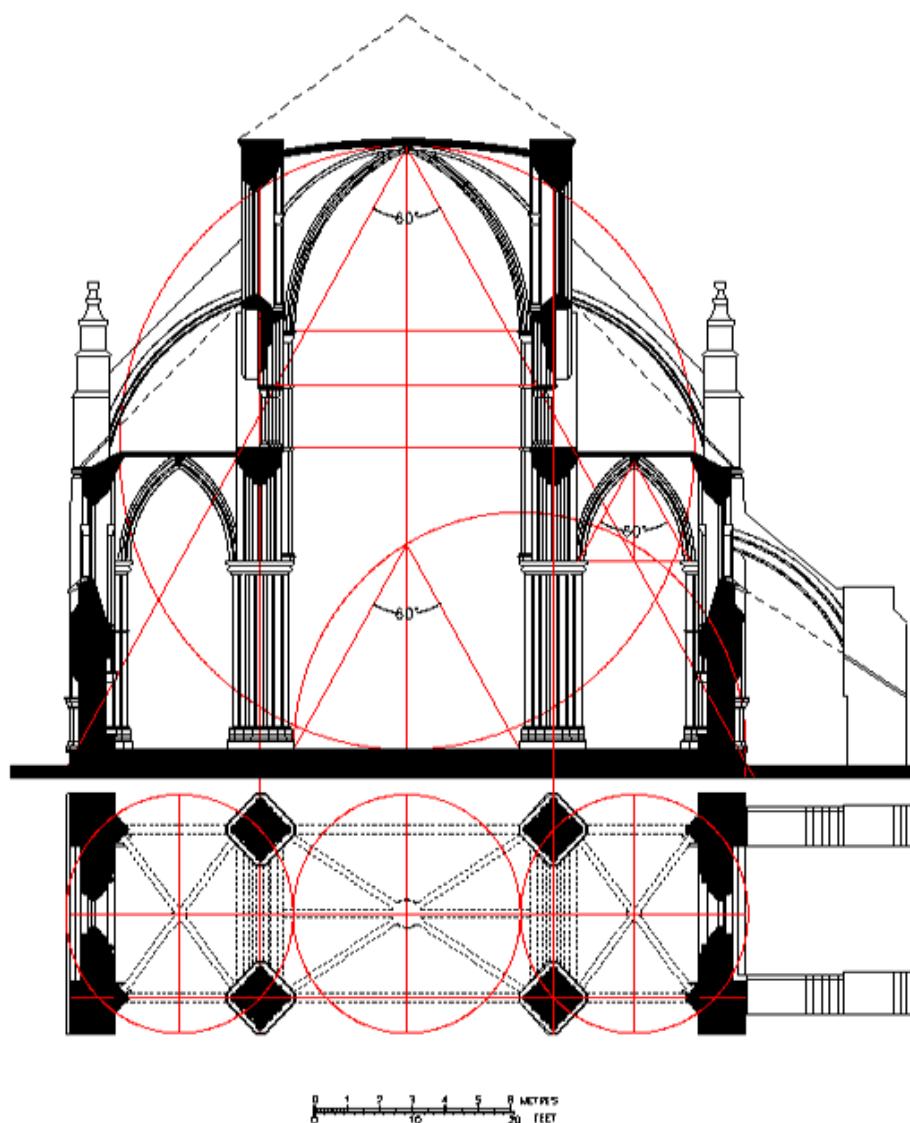
Figure 14. Hypothesis on the original configuration of the nave, considering a sexpartite one for the high vaults (Theodosopoulos et al 2003)

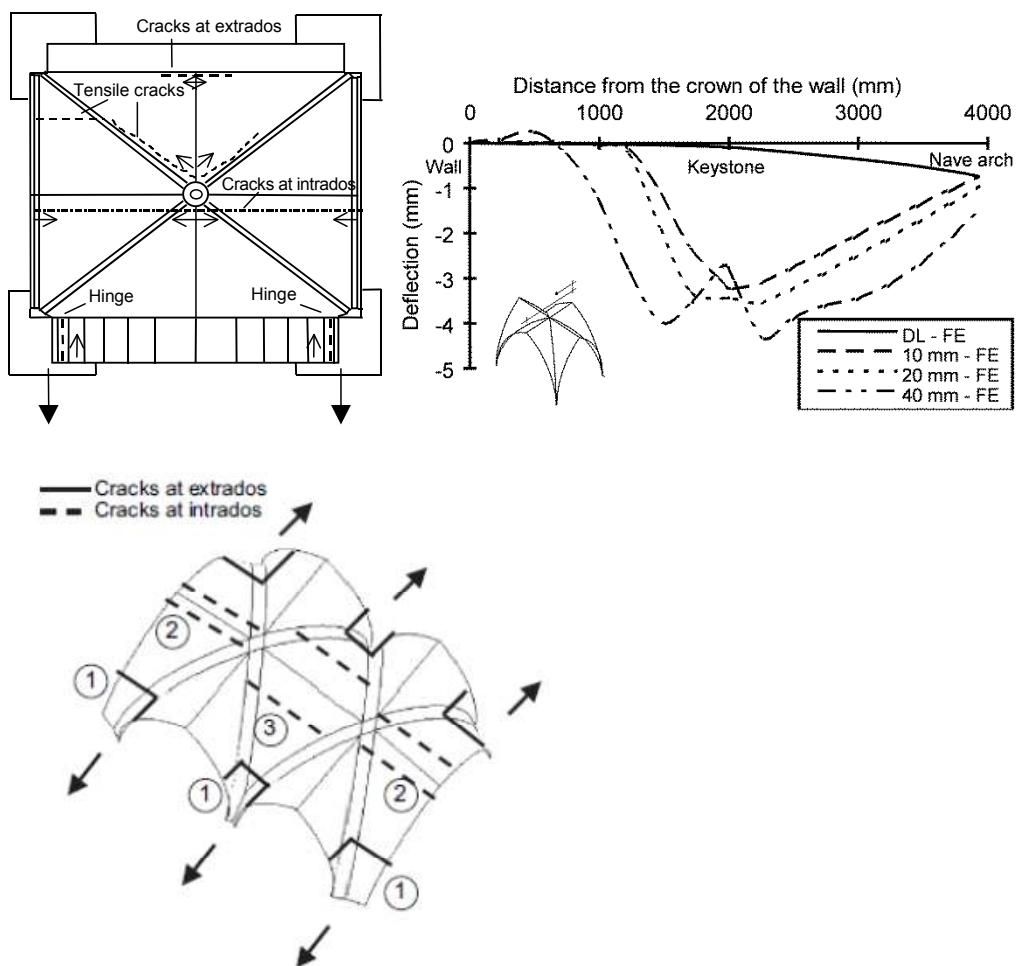
*Figure 15. The crack pattern of an experimental model simulating the aisle vaults in Holyrood at 30mm support spread; the deflections of the symmetry axis of a FE model of the aisle (Theodosopoulos et al 2003); and crack pattern on a typical nave vault from Durham Cathedral (Theodosopoulos 2008)*

Earlier experimental and numerical analysis of the collapse mechanism of the aisle vaults due to lateral support spread (Theodosopoulos 2001, 2003, 2008) indicated the limits of this instability (135mm or 1/28 of the transverse span 3.8m). The ensuing failure pattern of the aisle (Fig. 15) is caused by the development of a mechanism formed by three hinge lines along the wall, longitudinal axis and back ribs, and the base of the nave arch. A similar pattern characterises the nave vaults (longitudinal and nave arch cracks), as the simulation of the ones in Durham (Theodosopoulos 2008) indicate they can fail numerically at 330mm symmetric spread (or 1/34 of 11.2m span).

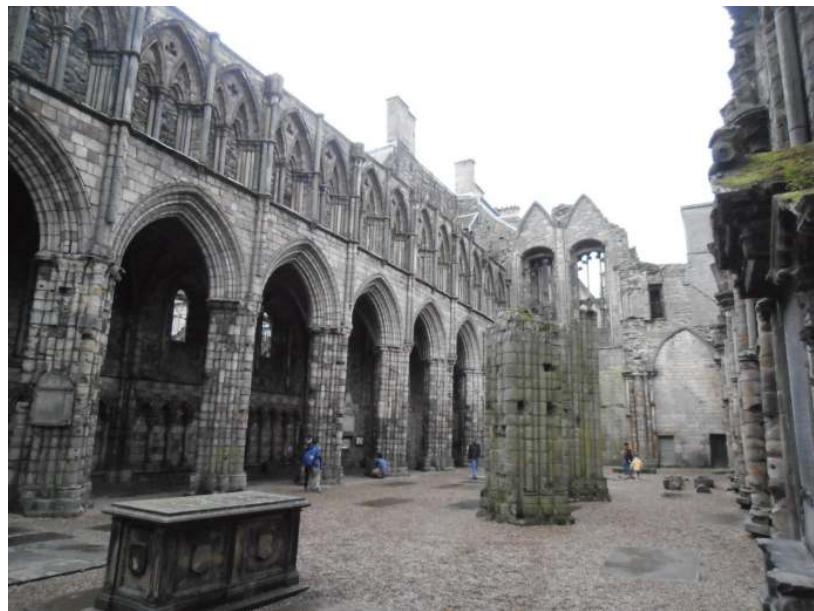
*Figure 16. The Abbey church ruins today (2010), showing the two surviving piers of the North arcade.*

It is difficult to trace the dynamic of the collapse from the condition of the floor as most of the slate slabs (measuring about 3 x 4 ft) were removed (Fig. 16) and only a few survive towards the East window (confirming potentially that the primary damage happened away from that delicate area). Eventually however the un-braced and exposed East window would be blown down during a storm
