Experimental study of tunnel segmental joints subjected to elevated temperature

Experimental Study of Tunnel Segmental joints Subjected to Elevated Temperature

Zhiguo Yan^{a,b,c}, Yi Shen^{a,b,c}, Hehua Zhu^{a,b,c}, Yong Lu^d

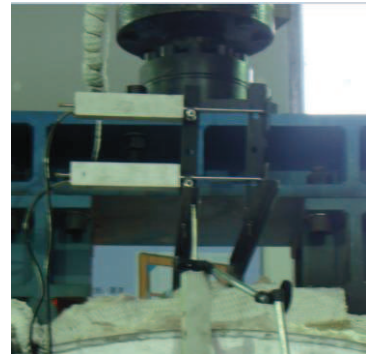
Principle

Test set-up

Fig.4. Measurement of opening angle of the lining joints

unexposed surface (in mm); ΔL_1 and ΔL_2 are the displacement increments of the first and the second LVDT, respectively (in mm); H is the thickness of the tunnel linings (in mm). It should be noted that the joint rotation and gap openings inferred from Eq. 2 included also the differential strain deformation between the inner and outer sides of the specimens over the measuring length. But relatively speaking these strain deformations were generally small as compared to the deformations at the joint gap and therefore they are neglected.

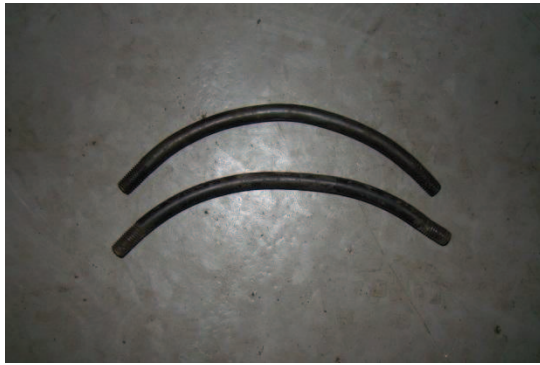
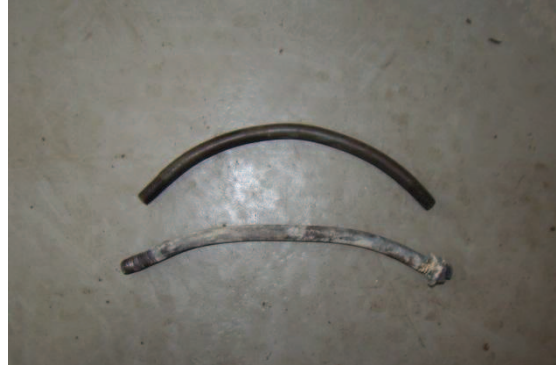
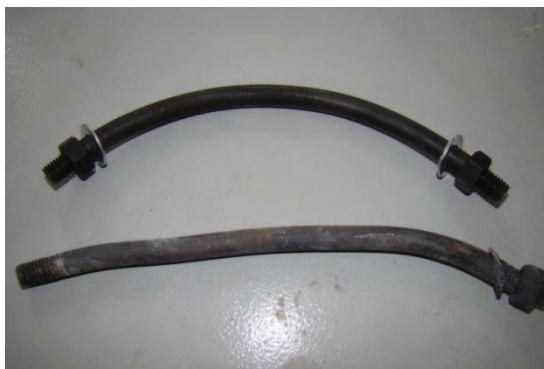
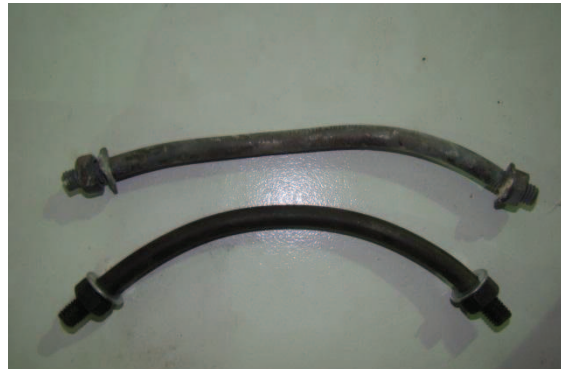
Fig.8. Comparison between deformed and original bolts from the specimens involving joint concrete failure

Three basic modes govern the failure of specimens, namely a) yielding of the joint bolts, b) failure of concrete at the joint, and c) failure of the segment. **A summary of the individual failure modes of all test specimens is given in Table 5.** As far as failure due to yielding of joint bolts is concerned, the failure of the bolts in the ambient cases and that in the under-fire cases exhibited rather different final patterns. The comparisons between the deformed bolts and un-deformed bolts in ambient and under-fire cases are illustrated in **Fig.8**. The bolts of HFRC specimens were highly oxidized and reacted chemically with the concrete contacting with it during fire. This resulted in the bolt showing light grey colour after the test. For cases with concrete failure occurred at the joint, the final distortions of the bolts were severe, as shown in **Fig.8**.

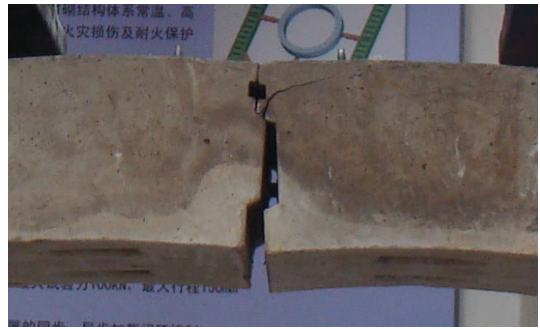
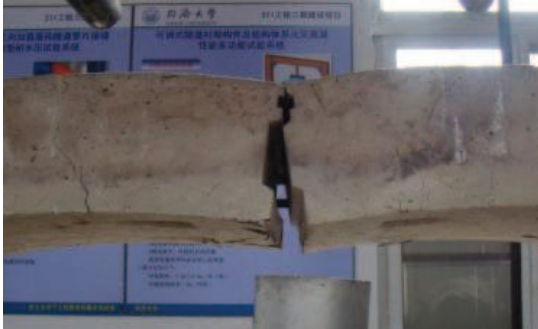
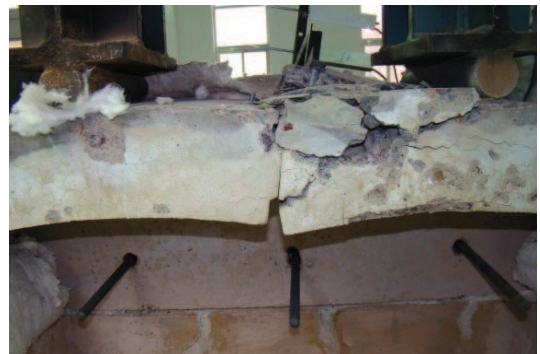
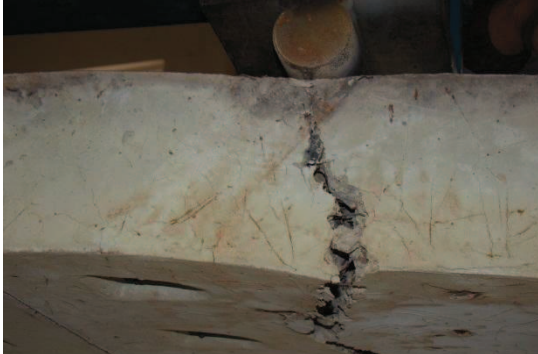
(c) Joint bolts yielding (RCJ2)

(d) Joint bolts yielding (HFRCJ2)

(g) Joint concrete failure (RCJ4)

(h) Concrete fracture (HFRCJ4)

Fig.9. Failure modes of specimens tested at ambient temperature and under fire

For another two pairs of specimens which were also tested under elevated temperature but with different levels of axial forces, namely RCJ2 & HFRCJ2 and RCJ4 & HFRCJ4, Fig.15 shows the vertical load vs. vertical displacement and joint bending moment vs. joint rotation relations. The corresponding final failure patterns are shown in Fig.9 (c), (d), (g) and (h). The results are summarized and discussed in what follows.

For specimen RCJ2 which was under a reduced axial force of 20 kN, the response was dominated by the bending rotation at the joint, and consequently the failure was due to yielding of the bolts. The achieved load capacity in terms of the bending moment at the joint was 6.14 kN.m, which was markedly lower than that of RCJ3 due apparently to the lower axial force while in the tensile flexural failure mode. Comparing to the predicted bending strength of the joint section under ambient temperature, i.e. 8.2 kN.m, there was a decrease of about 25%, and this is consistent with the observation from the comparison between RCJ3 and RCJ1 such that the reduction of the strength of the bolts under the elevated temperature was directly responsible for the reduction in the flexural strength under fire. The response in specimen HFRCJ2 with axial force of 20 kN also appeared to have been governed by the bending-rotation of the joint and no fracture occurred in the

Specimen RCJ4 under an increased axial force of 60 kN exhibited a markedly increased resistance capacity as compared to RCJ2 of 40 kN under the same fire condition, with a maximum vertical load of 140 kN comparing to 90 kN, or maximum joint bending moment of 15.26 kN.m comparing to 9.04 kN.m. Whereas this was clearly attributable to the general effect of increased axial force resulting in a reduced tension demand on the bolts, it is interesting to note that the bending capacity exceeded even the predicted joint bending strength under ambient temperature by a significant margin, and the final failure mode shifted to a compression failure at the joint. One possible explanation is thought to be related to the load induced thermal strain (LITS) effect, such that the higher level of compressive stress caused an extra compressive strain due to LITS. The increased compressive strain would have delayed the development of tensile stress in the bolts during the mechanical load phase under fire, while the compressive stress on the compression zone intensified. This resulted in an overall increase of the bending capacity, but at the same time led to accumulation of higher compressive strain on the top side of the joint section, leading eventually to a compressive bending failure of the joint. **This phenomenon is worth further investigation in subsequent studies.**

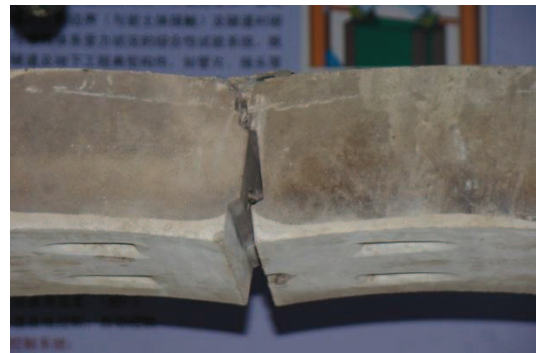
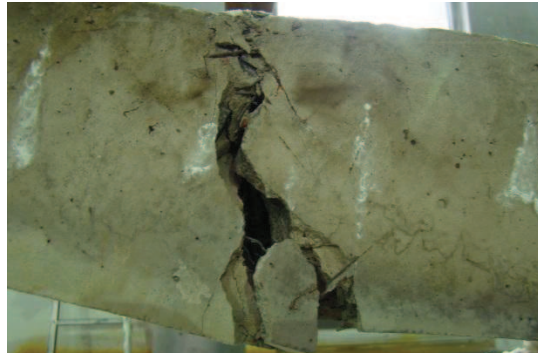
(e) Joint bolts yielding (RCJ3)

(f) Concrete fracture (HFRCJ3)

Specimen RCJ3 is directly comparable to the reference specimen RCJ1 as the mechanical loading conditions were the same except the fire effect. Similarly HFRCJ3 can be compared with HFRCJ1 directly. **Fig.14** shows the relationships of vertical load vs. vertical displacement and joint bending moment vs. joint opening gap for the two specimens. The final failure patterns are shown in **Fig.9 (a), (b), (e) and (f)**.

Under the elevated temperature, specimen RCJ3 exhibited generally similar load-deformation behaviour as RCJ1 and the failure mode was also dominated by yielding of the bolts at the joint until the concrete on the compression edge at the joint region crushed. The loading capacity was governed by the maximum bending moment at the joint, which was 9.04 kN.m as compared to 11.38 kN.m in RCJ1, showing a decrease of about 20%. This decrease of the bending moment capacity may be explained by the reduction of the yield strength of the bolts under the fire effect. According to the temperature measurements discussed in Section 3, the temperature at the location of the bolts during the

Specimen HFRCJ3 performed poorly under fire, and the maximum load capacity in terms of the bending moment developed at the joint location was only 3.45 kN.m as compared to 8.68 kN.m in specimen HFRCJ1 under ambient temperature. The failure mode was controlled by the rupture failure of the HFRC section, which was similar to the failure mode of HFRCJ1. However, the HFRC section had no main steel rebar, so when the section cracked and the thin steel fibres were exposed to high temperature, the bending capacity quickly diminished resulting in an accelerated failure of the specimen.

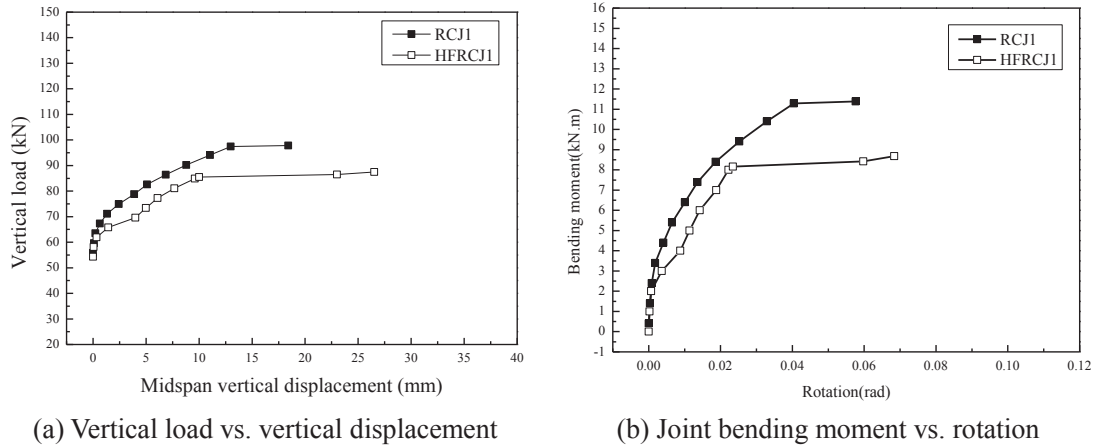
Fig.10. Load vs. deformation curves for RCJ1 and HFRCJ1 (ambient temperature and $P_H=40$ kN)

Fig.9 (a) and (b) show the failure modes of the two specimens. The relationships of vertical load vs. vertical displacement at the joint, and bending moment vs. gap opening are

illustrated in **Fig.10 (a)** and **(b)**. Specimens RCJ1 exhibited a behaviour which was clearly dominated by the bending-rotation at the segment joint, and failed at the joint due to yielding of the curved bolts. As stretching and yielding of the bolts continued, the compression zone reduced, leading to crushing of the top edge concrete at the final stage (**Fig. 9 (a)**).

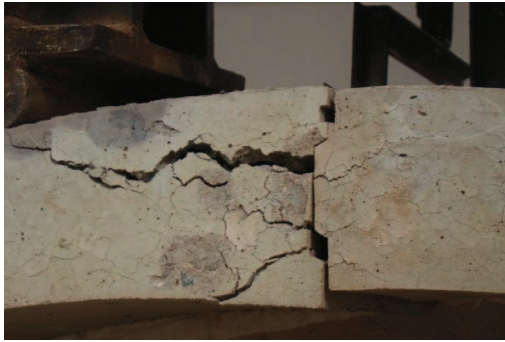
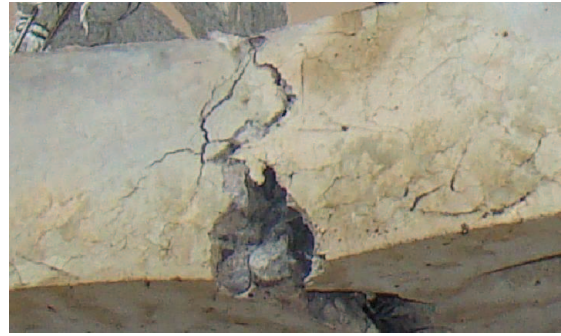
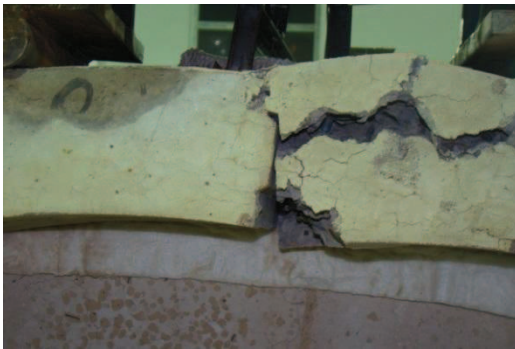
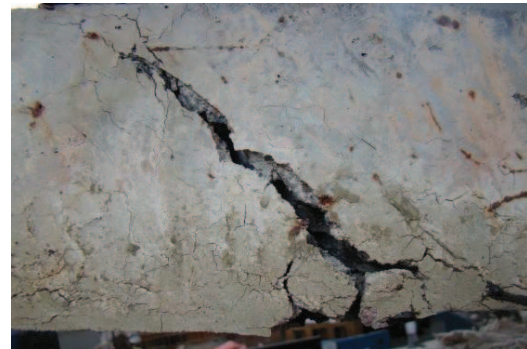
(a) Joint concrete failure (RCJ5)

(b) Concrete fracture (HFRCJ5)

(c) Joint concrete failure (RCJ6)

(d) Concrete fracture (HFRCJ6)

Fig.18. Failure modes of specimens from post-fire loading tests

The final failure patterns from post-fire loading tests are shown in **Fig.18**. The severer degradation in specimen RCJ5 at the joint region is clearly noticeable. Although specimen RCJ6 also failed eventually in compression at the joint region, the much less degradation in the compressive concrete from the heating, as also visible from the photo (**Fig. 18(c)**), helped the specimen to show a much higher resistance capacity. The failure patterns in the HFRC specimens tend to show some combined effects and this may be attributed to the characteristics of the HFRC sections in association to the higher uncertainties involved in the ultimate strength as discussed earlier in Section 4.2.
