Behaviour of a masonry arch bridge repaired using fibre-reinforced polymer composites

Behaviour of a Masonry Arch Bridge Repaired Using Fibre-Reinforced Polymer Composites

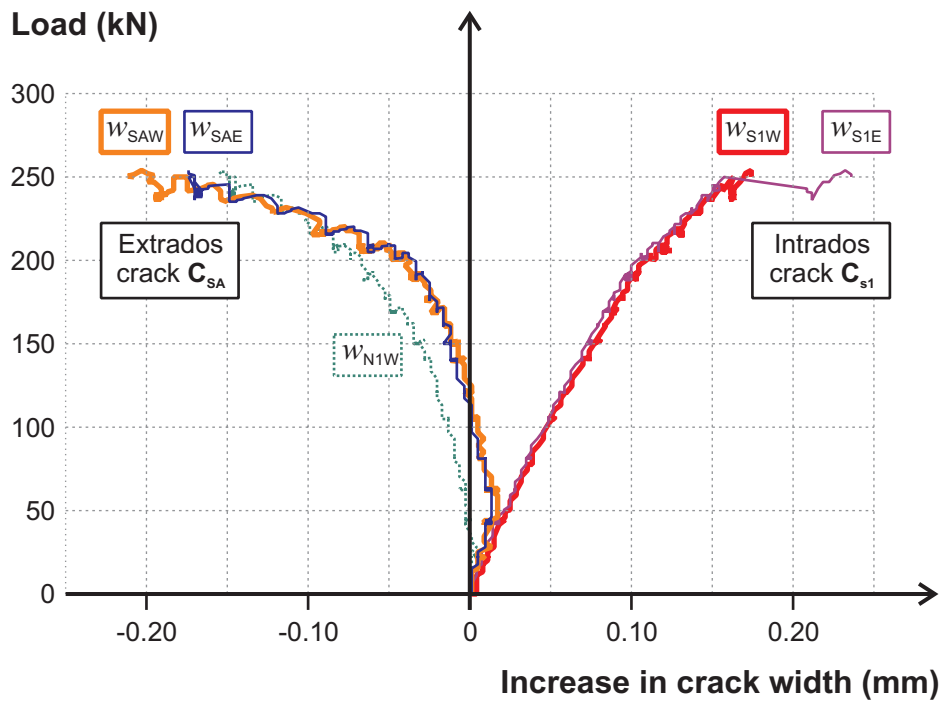
(b) South Arch

As the load was increased above 50kN (the approximate unstrengthened arch capacity), extrados crack C_{SA} started to close up (Fig. 8b), and the formation of a second extrados crack C_{SC} was observed (Fig. 11b). This modified four-hinge mechanism is consistent with the distributed extrados cracking seen in the north arch. The FRP remained in compression at extrados crack C_{SA} throughout the test (Fig. 9b).

The equal crack widths to either side of the arch (Fig. 8b) and similar FRP strains at the different plates (Fig. 9b) indicate uniform load carrying across the width of the arch. Fig. 8b also shows that the width of the intrados crack C_{N1} on the north arch reduced as the south arch was loaded, indicating some interaction between the two arches. The north arch was severely damaged after FRP debonding failure and contained wide cracks during the south arch test, so it is not surprising that it was much more sensitive to load than the south arch.

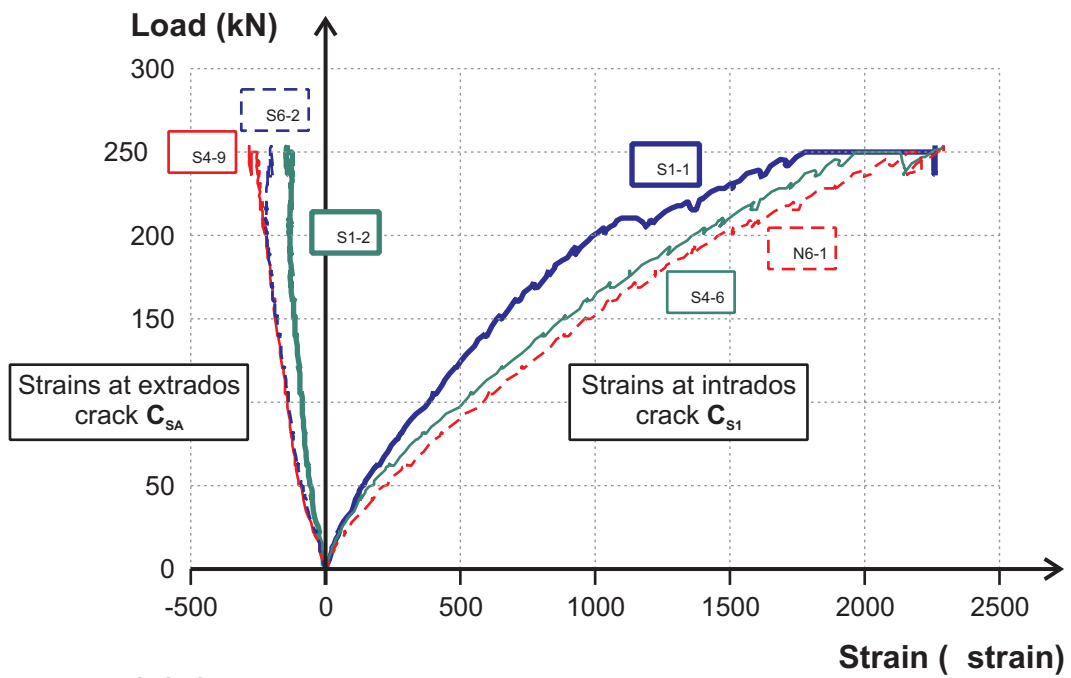
(b) South Arch

- The first significant debonding event occurred at a load of 250kN, when plate P_{S2} debonded over a short length to either side of the two intrados cracks (C_{S1} and C_{S2}). The extent of debonding at this stage is shown in Fig. 14; the other five FRP plates remained bonded to the masonry. Debonding was accompanied by a drop in the load-displacement response (Fig. 7b), an increase in crack opening on the east side of the arch (Fig. 8b), and an increase in the strain in plate P_{S1} (Fig. 9b), which picked up some of the load shed by plate P_{S2}.

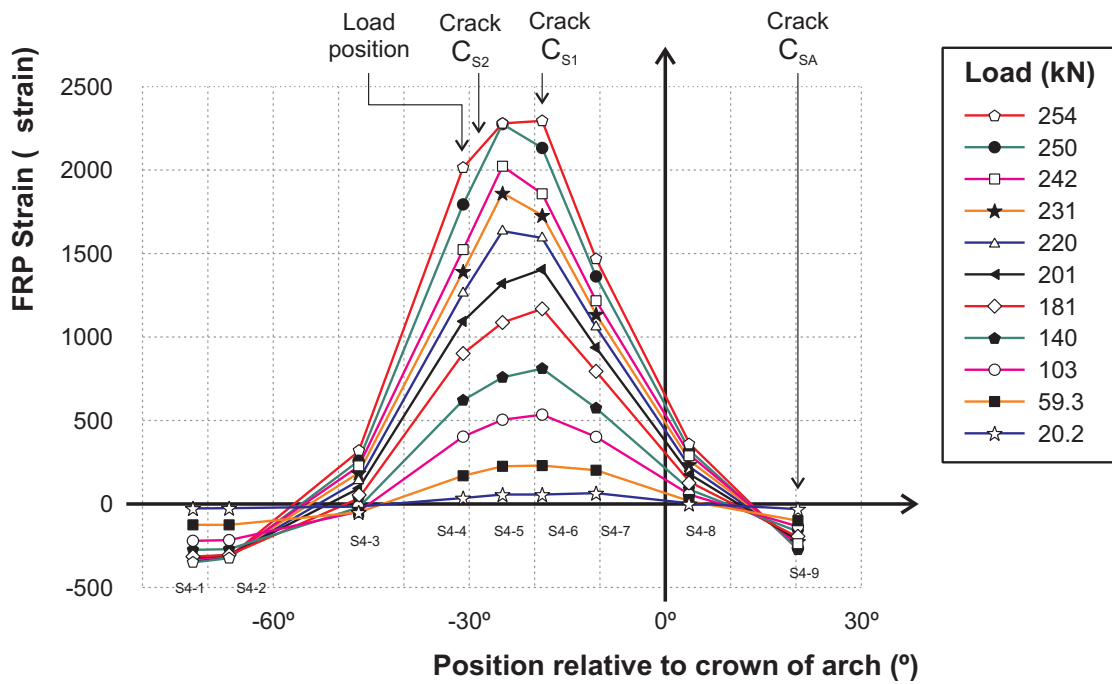
(b) South Arch: Plate P$_{S4}$

- The capacity of the strengthened arch was reached at 254kN, when debonding occurred along a substantial length of all of the FRP plates. It was not possibly to determine whether failure initiated in one plate in particular; all six plates appeared to debond simultaneously. However, the strain profile (Fig. 10b) shows that the peak FRP strain at the intrados crack did not increase as the load was increased from 250 to 254kN, and that the debonded region expanded to either side. Failure of the FRP strengthening caused a sudden increase in deflection and a drop in the load carried by the arch (Fig. 7b).

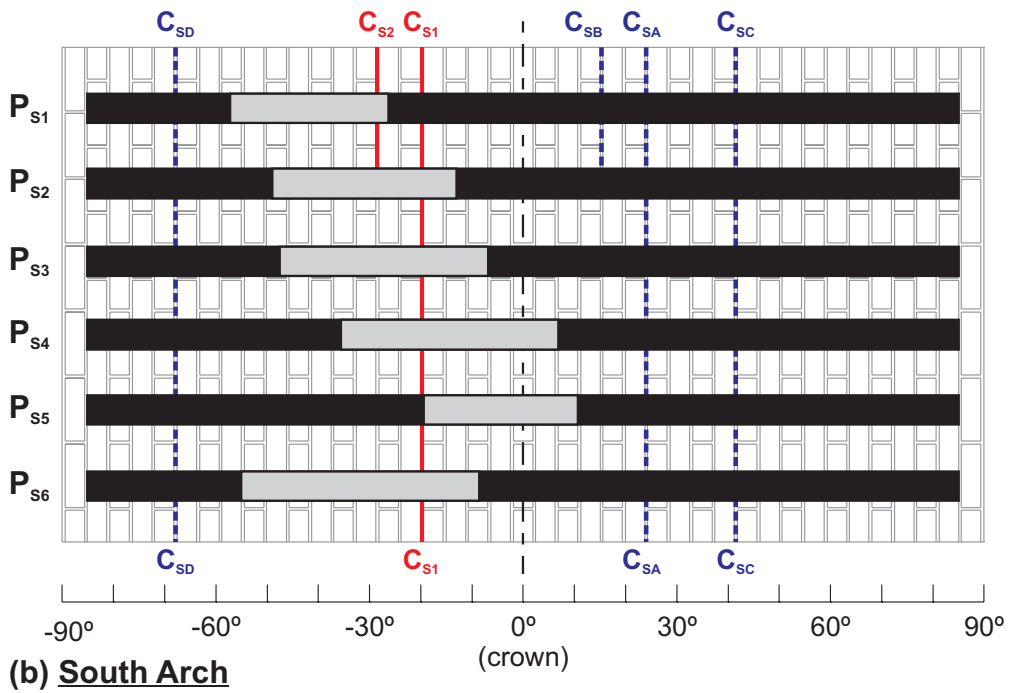
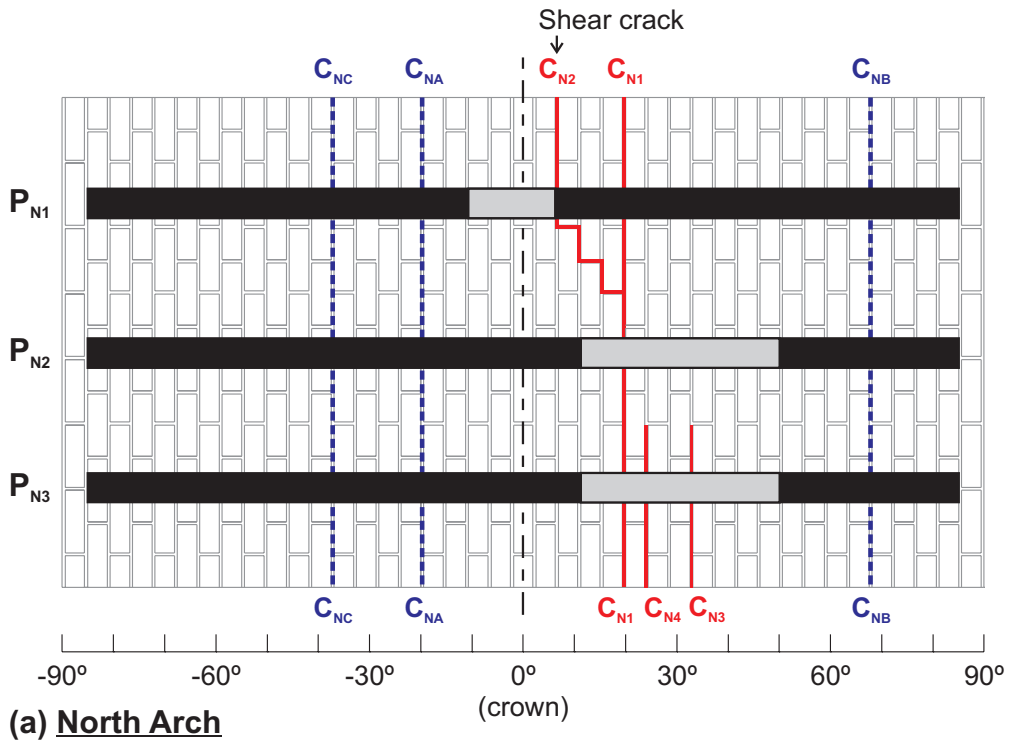
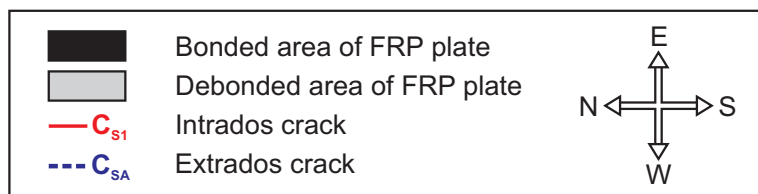
At plates P_{N2} and P_{N3}, debonding occurred on both sides of the flexural intrados crack C_{N1} (Figs 11a & 12). On the east side of the arch (plate P_{N1}), however, a shear crack formed through the masonry at the crown of the arch, which joined the intrados crack C_{N1} between plates P_{N1} and P_{N2} (Figs 11a & 12). This shear crack caused plate P_{N1} to debond from the masonry on only one side of the crack, in a peeling mode that was compatible with the shear deformation across the crack (Fig. 13a).

The details of the masonry cracking and FRP debonding varied across the width of the arch, as shown in Figs 11b & 15. (It was not possible to determine the full extent of the extrados cracks C_{SC} and C_{SD} as they were beneath the sand fill). Flexural cracking of the masonry led to failure at plates P_{S1}, P_{S2}, P_{S3} & P_{S4} (the east and centre of the arch), where the FRP debonded on both sides of the critical crack. The debonded length was approximately the same at all of these positions. Plate P_{S4} (typical of debonding across a flexural crack) is shown in Fig. 13b.

Figure 11 - Developed plan view of the arches showing crack locations in the masonry and the extent of debonding after failure of the strengthening system

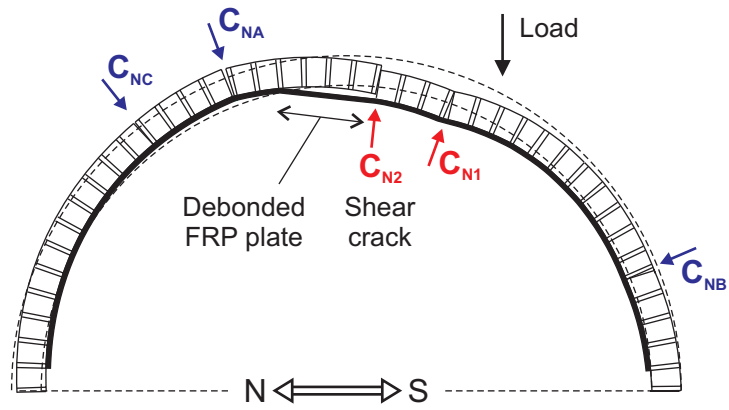
(a) Plate P$_{N1}$

Figure 12 - Sections along the FRP plates in the north arch, showing the failure mechanism post peak load

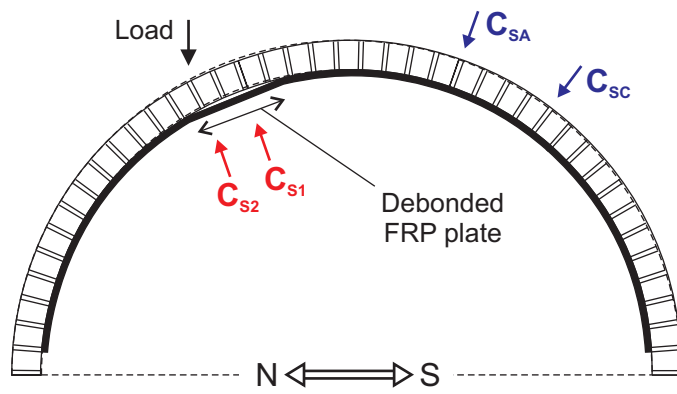
Figure 14 - Plate P$_{S2}$ on the south arch after initial debonding (250kN)

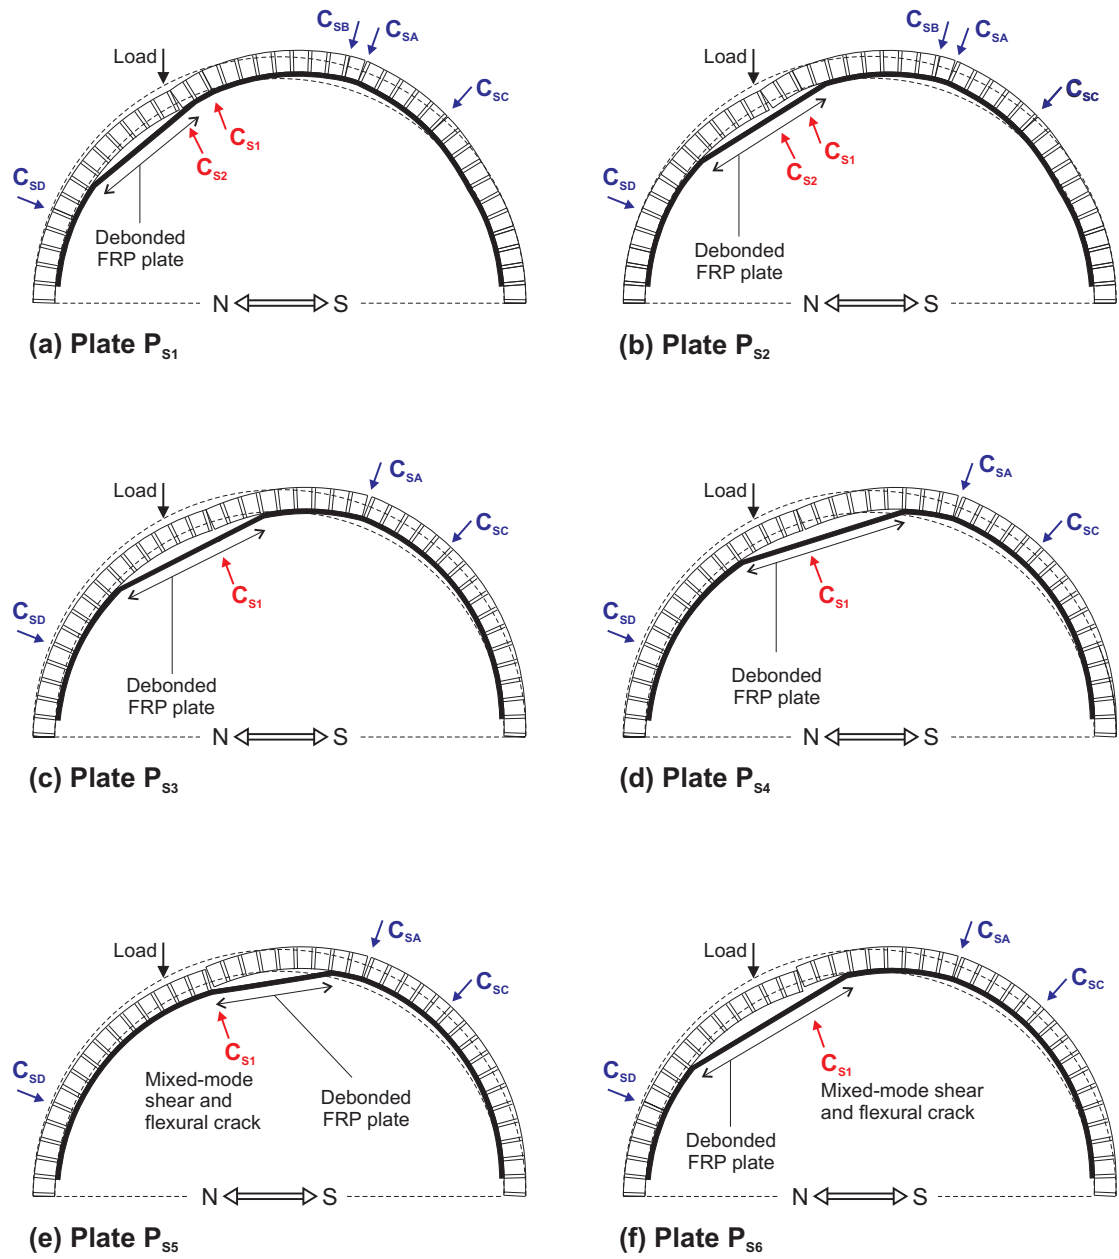
Figure 15 - The deformed shape of the south arch and position of FRP post peak load

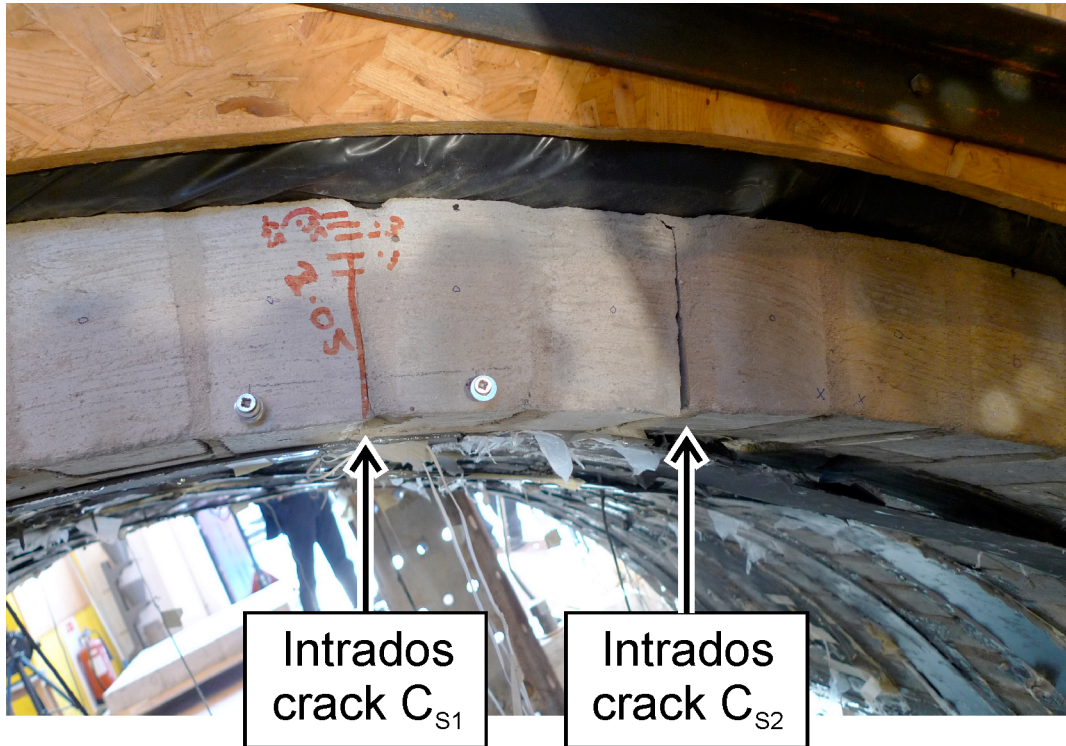
At 210kN, a new intrados crack C_{S2} formed in the arch two bricks away from the original crack C_{S1} on the east side of the arch (Figs 11b & 16). The crack could be seen to cross the first two strengthening plates (P_{S1} & P_{S2}), and was not present under the two western-most plates (P_{S5} & P_{S6}), but it was not clear whether the crack extended across the two central plates (P_{S3} & P_{S4}) because it was not safe to inspect the underneath of the arch at these high load levels. The formation of this intrados crack increased the rate of strain increase in plate P_{S1} (which bridged the new crack) with loading (ε_{s1-1} in Fig. 9b) and increased the rate of crack closure (Fig. 8b). The former phenomenon is consistent with the findings of recent research that shows that the bond resistance is increased when an FRP plate bridges multiple cracks in a concrete beam [33,34]. The location of the peak strain in plate P_{S4} shifted towards the new crack at the same time, suggesting that the new crack may have extended under this plate.

On the west side of the arch, failure was due to a combined flexure-shear failure deformation along crack C_{S1}, as shown in Fig. 17. Consequently, P_{S5} debonded from the masonry on one side of the crack by peeling; P_{S6}, however, debonded to either side of this mixed-mode crack.

Figure 16 - Intrados cracks C_{S1} and C_{S2} on the east side of the south arch, following the formation of crack C and closing up of C_{S1}

Figure 17 - Mixed-mode flexural and shear failure at intrados crack (C_{S1}), on the west side of the bridge

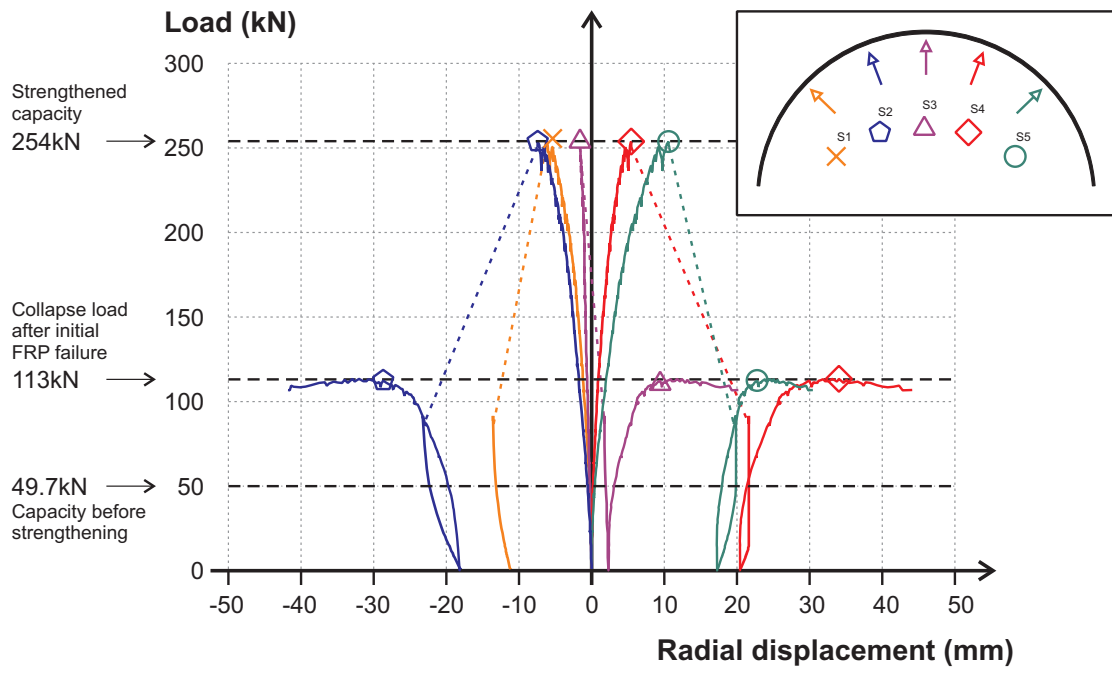
Figure 18 - Load vs. radial displacement curves for the south arch, including the collapse test after debonding failure of the FRP strengthening

The arches were completely unloaded after the debonding failure of the FRP strengthening so that the instrumentation could be removed. The south arch was reloaded to determine its collapse mode and strength. Digital image correlation (using geoPIV software [35]) was used to determine the radial deflections at the same positions as the displacement gauges (except for δ_{S1}, which was not visible behind the loading frame), allowing the load-deflection response of the arch to be plotted in Fig. 18.

The FRP plates debonded from the arch over a considerable length when the strengthening failed (Fig. 11), but they still remained attached. During the collapse test they acted as ties that bridged the cracks in the masonry and contributed to the load carrying capacity of the arch. The debonded length of the FRP ties increased as the arch was re-loaded, accompanied by the opening of hinge cracks with the masonry. The FRP tie action allowed the arch to carry 113kN, substantially higher than the strength of the arch prior to strengthening (49.7kN). Large deformations were observed at this load (Fig. 18), during which the FRP ties gradually debonded from the masonry arch.
