Fire Resistance Tests on Thin CFRP Prestressed Concrete Slabs

Cristian Maluk[1,*], Giovanni Pietro Terrasi[2], Luke Bisby[1], Alex Stutz[2], Erich Hugi[2]

[1] School of Engineering, The University of Edinburgh, UK

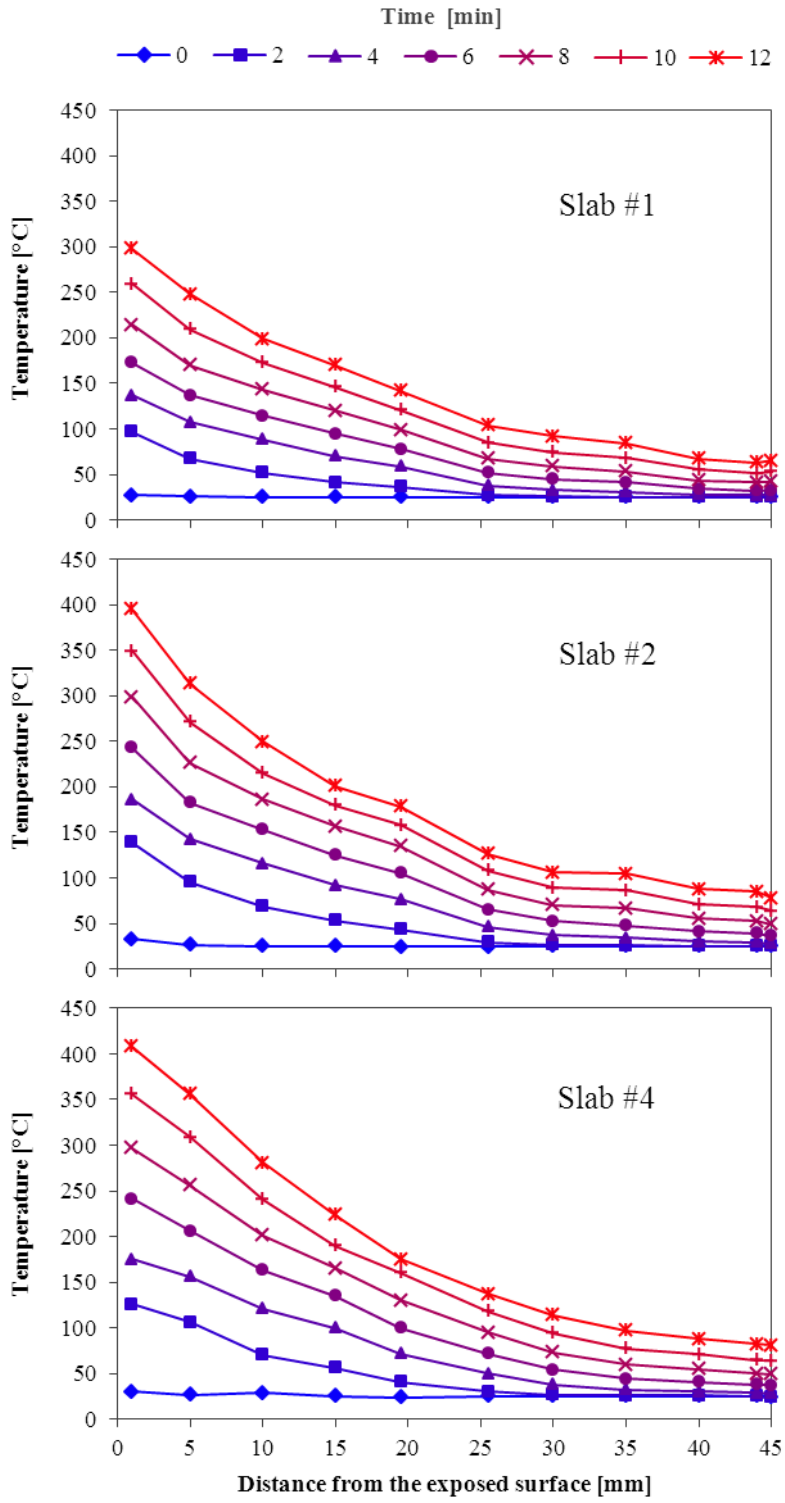
Considerable variation of through-thickness temperature distributions was observed for slabs with equivalent thickness, possibly demonstrating poor homogeneity of the thermal exposures for slabs tested simultaneously during a single furnace test; this is despite the temperatures measured by the plate thermometers complying with the test standard. Figure 13 suggests a more rapid through-thickness temperature increase for 45 mm thick slabs positioned near the centre of the furnace, slabs #2 and #4, relative to Slab #1 positioned near the edge of the furnace (see Figure 7). A similar, however less severe, comparison is shown in Figure 14 for Slab #3, positioned at the centre of the furnace, and Slab #5, positioned near the edge of the furnace.

Figure 13 – Midspan through-thickness temperature distributions for 45 mm thick slabs at 2 minute intervals during the first 12 minutes of the furnace test.

412 Slab #2 failed after 12 minutes, whereas the virtually identical Slab #1 failed due to loss of
413 anchorage after 42 minutes of fire exposure (refer to Table 1); Figure 13 shows that Slab #2
414 experienced more rapid heating during the early stages of the test. This suggests a possible
415 important influence of the time-history of through-thickness temperatures on the occurrence
416 of heat-induced concrete spalling [11]. For instance, Slab #2 spalled when the measured
417 temperature 1 mm from its exposed surface was 400°C, while for Slab #1 the temperature at
418 the same location was only 300°C. The possibility that this was due to misplacement of

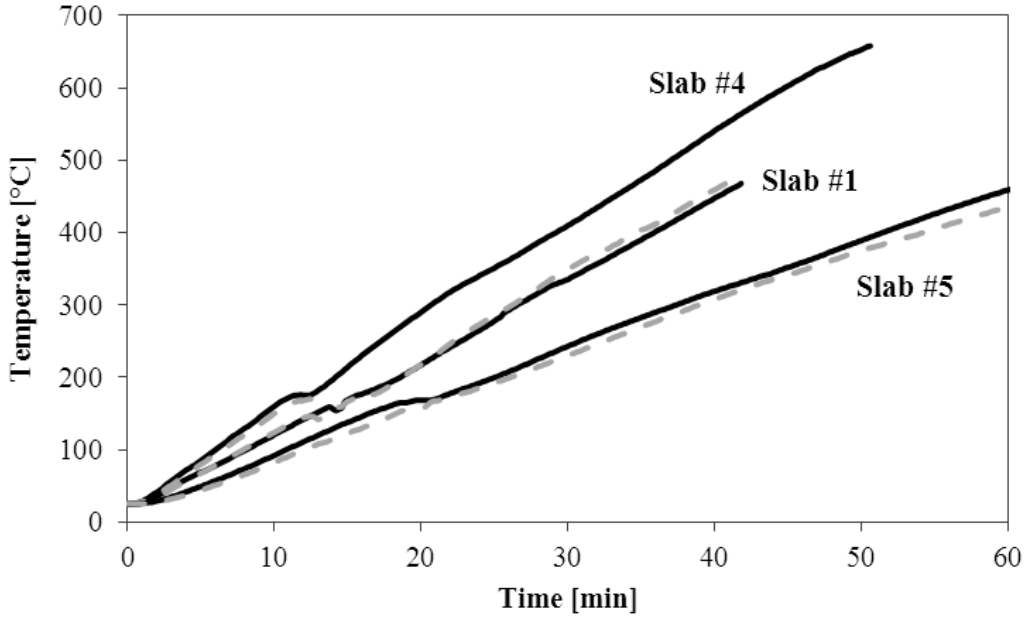
Figure 15 shows a comparison of the temperature of the CFRP tendon at midspan and at 400 mm from the end of the slab (still within the heat exposed zone of the slab, see Figure 2) for slabs #1, #4, and #5 (all of which failed due to loss of anchorage). Figure 15 suggests that the temperature of the CFRP tendons was essentially constant over the exposed length of the slabs. It is noteworthy that thermocouples were placed along the lower edge of an interior CFRP tendon, and therefore recorded the temperature at the interface between the tendon and the concrete, rather than the temperature of the CFRP itself. Due to the low thermal inertia of

Figure 15 – Comparison between temperatures of the CFRP tendons measured at midspan (continuous line) and at 400 mm from the end of the slab (segmented line) for slabs #1, #4, and #5.

450 • *The first longitudinal cracks were observed at the unexposed surface* – This occurs when
451 temperature of the CFRP tendons at midspan was between 320 and 390°C (refer to
452 Figure 15), regardless of the temperature in the unheated overhangs (e.g. 200 mm from
453 the end of the slab, refer to Figure 16). Longitudinal splitting cracks were first observed
454 at the unexposed surface (i.e. top surface), near the midspan region (see Figure 20).

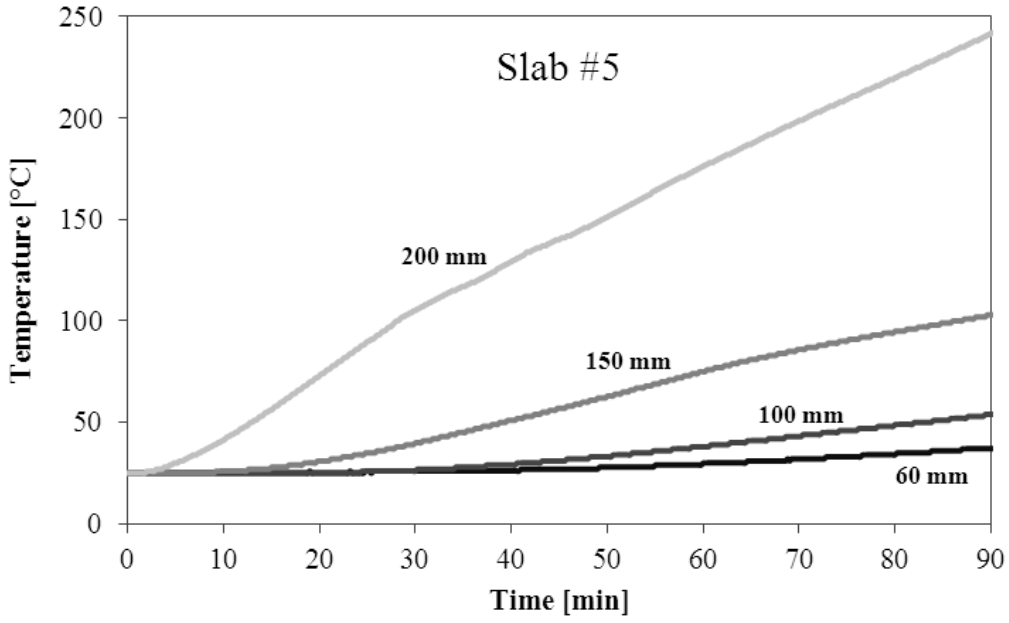
Figure 16 shows a comparison of the temperatures measured in the anchorage zone for Slab #5, demonstrating the effectiveness of maintaining a 'cool' anchorage zone when designing for unheated overhangs.

Figure 16 – Typical temperature within the unheated overhang for a central CFRP tendon (Slab #5, 60 mm thick), for distances of 60, 100, 150, and 200 mm from the end of the slab.

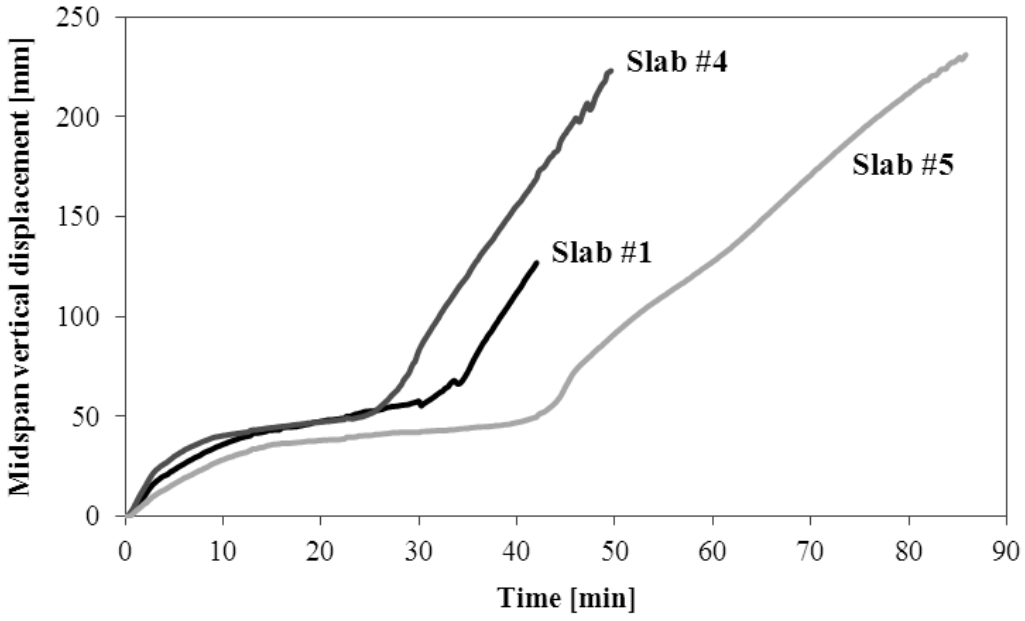
Figure 17 shows the time-history of midspan vertical displacements for the slabs that failed due to loss of anchorage. During the early stages of the test, midspan deflections were induced predominantly by thermal bowing. During this stage an obvious influence of the slabs' thickness was observed [37]; wherein thicker slabs experienced less vertical midspan deflection due to lower thermally induced curvatures. Comparison of midspan deflections for slabs #1 and #4 (both 45 mm thick), during the first 10 minutes of the tests, shows that the more rapid increases of through-thickness temperature (observed for slab #4, refer to Figure 13) resulted in a more rapid increase in midspan deflection due to thermal bowing (see Figure 17). For slabs #1, #4, and #5, all of which failed due to loss of anchorage, a clear change of slope in the time-history of midspan deflections, presumed to be associated with loss of anchorage, was observed (discussed later).

392 **Figure 17 – Time-history of midspan vertical displacement measurements for all slabs that failed due to**
393 **loss of anchorage (slabs #1, #4, and #5).**

439 Figure 17 shows the time-history of midspan deflections for slabs #1, #4, and #5 all of which
440 failed due loss of anchorage. While deflections at an early stage of the test were governed by
441 thermal bowing of the test specimens, the observed increase in the rate of midspan deflection
442 slope is thought to be linked to loss of anchorage (i.e. tendon slip).

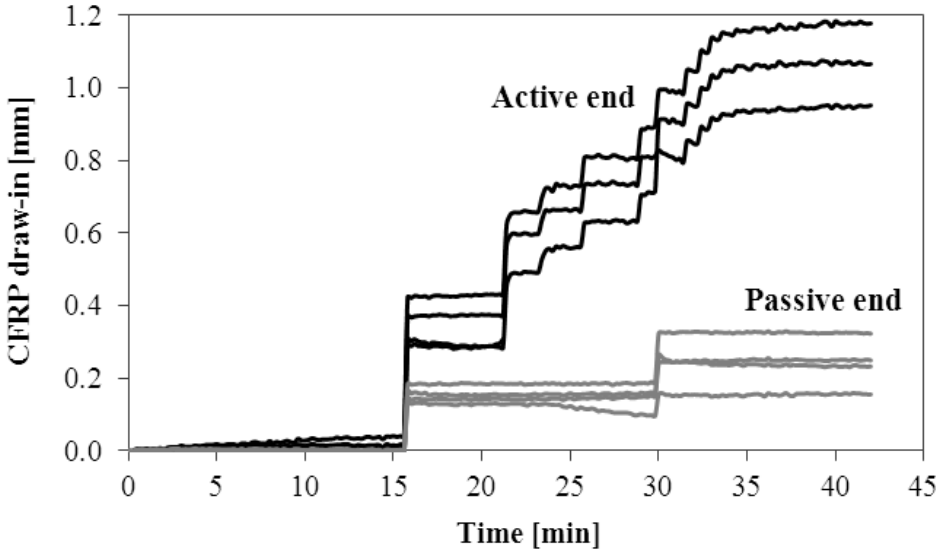
395 Draw-in measurements were taken for all four CFRP tendons at both ends of slabs #1, #2,
396 and #3. Unfortunately, because slabs #2 and #3 failed catastrophically at an early stage of the
397 test due to explosive concrete spalling, no useful draw-in measurements were recorded for
398 these slabs. For Slab #1 however, tendon draw-in measurements were taken until failure, at
399 42 minutes from the start of the test as shown in Figure 18. While no attempt was made to
400 quantify the relationship between draw-in measurements and the failure mechanism of Slab
401 #1, a qualitative analysis considering draw-in measurements, loss of anchorage, and failure is
402 presented later.

404 **Figure 18 – Draw-in measurements for tendons at the active and passive ends of Slab #1 during testing.**

Figure 18 shows draw-in measurements for CFRP tendons in Slab #1, evidencing that draw-in initiated 16 minutes from the start of the test; at both the active and passive end of the slab. Thereafter, draw-in progressively increased only at the active end up to 30 minutes from the start of the start when a sudden increase in draw-in was measured at the passive end; around the time at which an increase in the rate of midspan vertical displacement was observed for Slab #1 (refer to Figure 17).

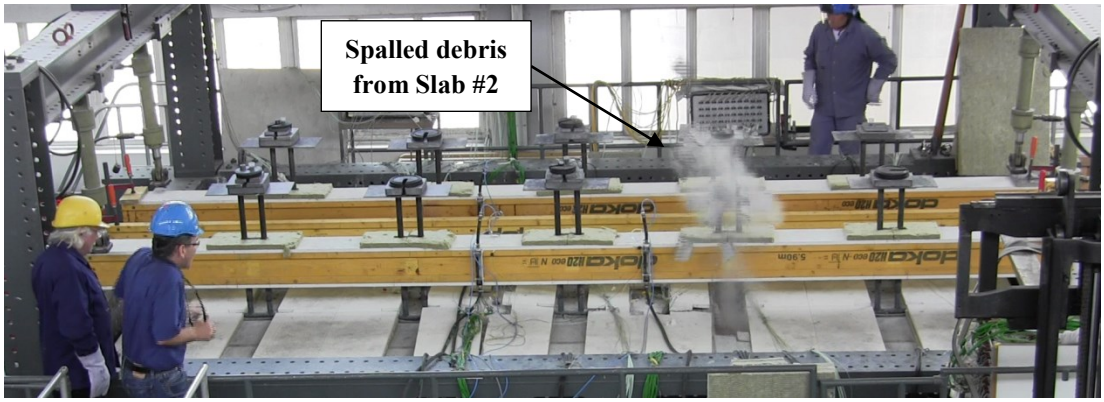
407 Failure of slabs #2 and #3 was driven by the occurrence of single explosive concrete spalling
408 events, 12 and 22 minutes from the start of the test, respectively (refer to Table 1).
409 Immediately after spalling, each of these slabs suffered catastrophic failure and collapsed into
410 the furnace. Video stills recorded during testing showed the moment at which spalling
411 occurred (shown for Slab #2 in Figure 19).

Figure 19 – Explosive spalling and immediate collapse of Slab #2 at 12' 37''.

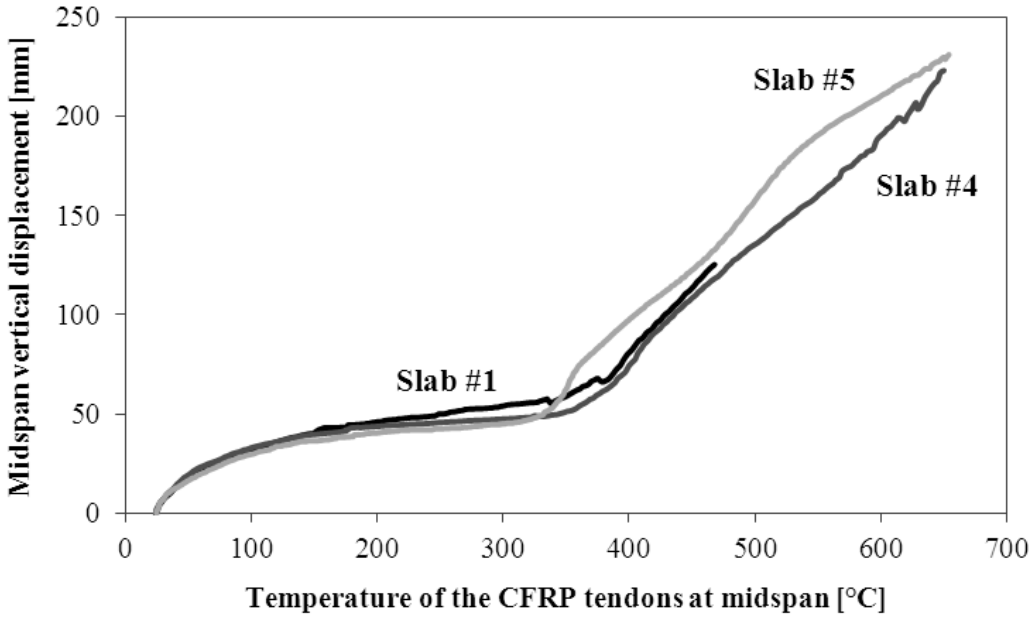
Interestingly, the time-history of midspan vertical displacement directly correlates with the temperature of the CFRP tendons at midspan (see Figure 21), rather than temperature in the unheated overhangs. This physical mechanism is thought to be associated with heat-induced reduction for strength and stiffness of the epoxy resin within CFRP tendons; since the epoxy resin is essential for anchorage to be maintained [4], and moreover for preserving interaction and stress transfer between individual carbon fibres. Thermogravimetric analysis performed by the authors on these particular CFRP tendons showed that decomposition of the epoxy resin rapidly initiates at around 290°C [4]; in accordance with the temperature of the CFRP tendons at midspan for which an increase in midspan vertical displacement was observed (refer to Figure 21).

Figure 21 – Variation of midspan vertical displacement with temperature of the CFRP at midspan.
