The Dalmarnock Fire Tests on a Cast Insitu Concrete Structure

TG 4.3 *fib* 2007 THE DALMARNOCK FIRE TESTS ON A CAST INSITU CONCRETE STRUCTURE

Keywords: test, compartment fire, structural response

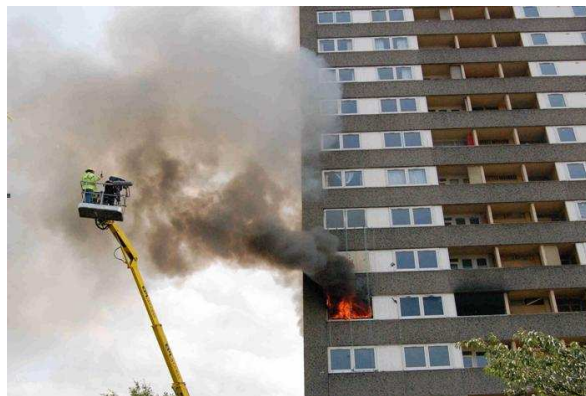
Figure 1: Dalmarnock fire test one seen from outside 18.5 min into the fire

Test One, took place on the fourth floor of a 23 storey cast in situ concrete structure as can be seen in fig 1. Figure 2 shows the layout of the flat in which Test One was conducted. The experimental compartment was the living room of the flat. It was approximately 17 m² in plan containing two door ways, one led to the flat corridor and the second to the kitchen, it also contained a set of windows in the west facing wall. The north and west walls of the compartment were external. The south and east internal walls segregated the experimental compartment from bedroom one and the kitchen respectively.

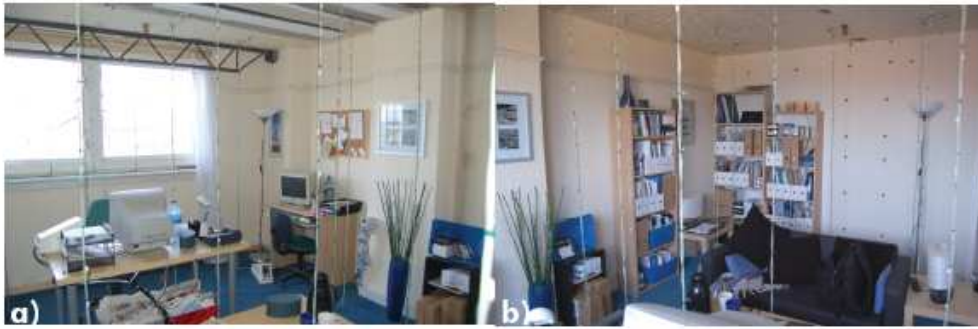
Figure 3: Fuel distribution in compartment fire test

All furniture and fittings were removed from the flat (with the exception of embedded units in the kitchen). The room was furnished as a typical living room/home office. Figure 3 indicates the general fuel layout. The main sources of fuel were three book shelves in the north east corner of the compartment, loaded with books, magazines and plastics. Just in front of the sofa was a polyurethane sofa. Some computers, desks and chairs were located towards the front of the compartment.

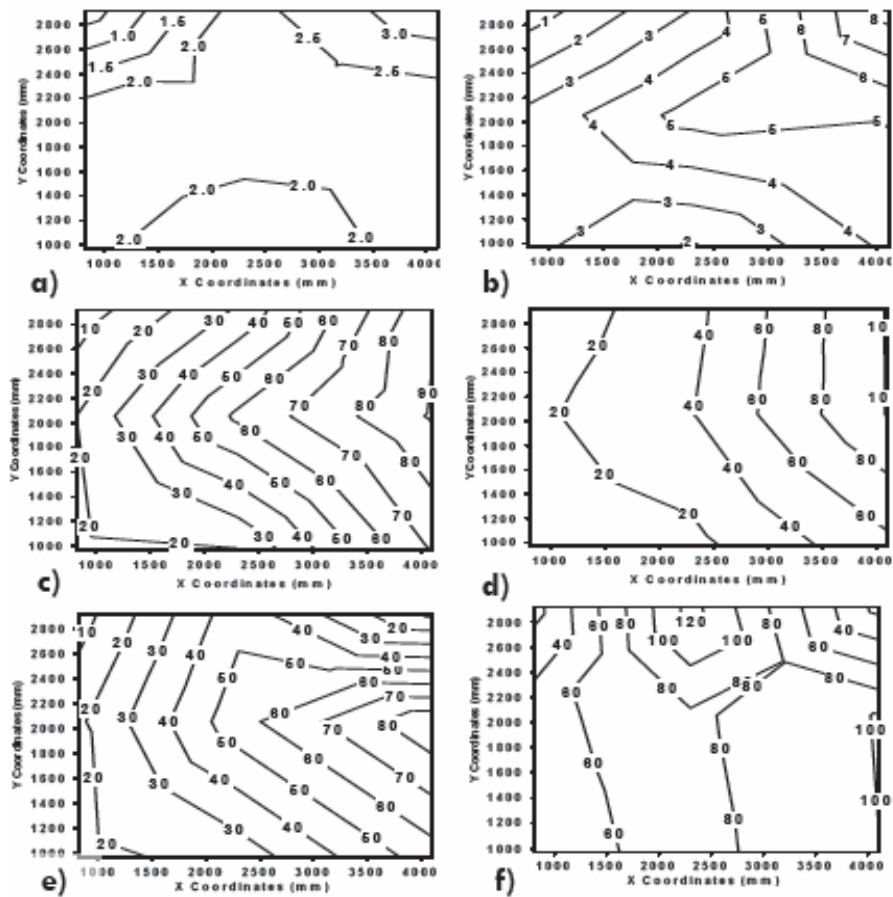
Figure 7: Contour plots of heat flux (kW/m^2) incident on the compartment ceiling at selected time steps a) 201s, b) 251s, c) 351s, d) 420s, e) 661s and f) 901s

Nine heat fluxes were located on the compartment ceiling in an approximate grid layout (see fig 4) and spaced so as to give a global perspective of heat flux distribution to the ceiling. To demonstrate the evolution of incident heat flux over time contour plots have been created for selected time steps in fig 7. Coordinates in fig 7 are taken from the global system outlined in fig 4. The pattern of heat flux development over time correlates closely with changes in gas phase temperatures. Between Fig 7b and 7c an almost ten fold rise is seen in incident heat flux to the ceiling, these time steps correlate to the pre and post flashover periods. The peak incident heat flux is located towards the NE corner of the compartment where the greatest fuel concentration was located, a shift in location of the peak heat flux occurs between Fig 7e and Fig 7f when the ventilation conditions in the compartment changed.

Such details of thermal exposure to a structural element are lost when an assumption of average or uniform heating is taken. In both the standard temperature-time curve and the parametric fire curves provided in Eurocode 1 [2] an average temperature is assumed for the whole compartment. It is obvious from the thermal variations seen in fig 7 that depending on the spatial location of an element, these average curves may over or under predict the thermal severity that structural element is subjected to.
