Fire Resistance Tests on Thin CFRP Prestressed Concrete Slabs

Maluk, C, Terrasi, GP, Bisby, L, Stutz, A & Hugi, E 2015, 'Fire Resistance Tests on Thin CFRP Prestressed Concrete Slabs', Construction and Building Materials, vol. 101, no. Part 1, pp. 558-571. https://doi.org/10.1016/j.conbuildmat.2015.10.031

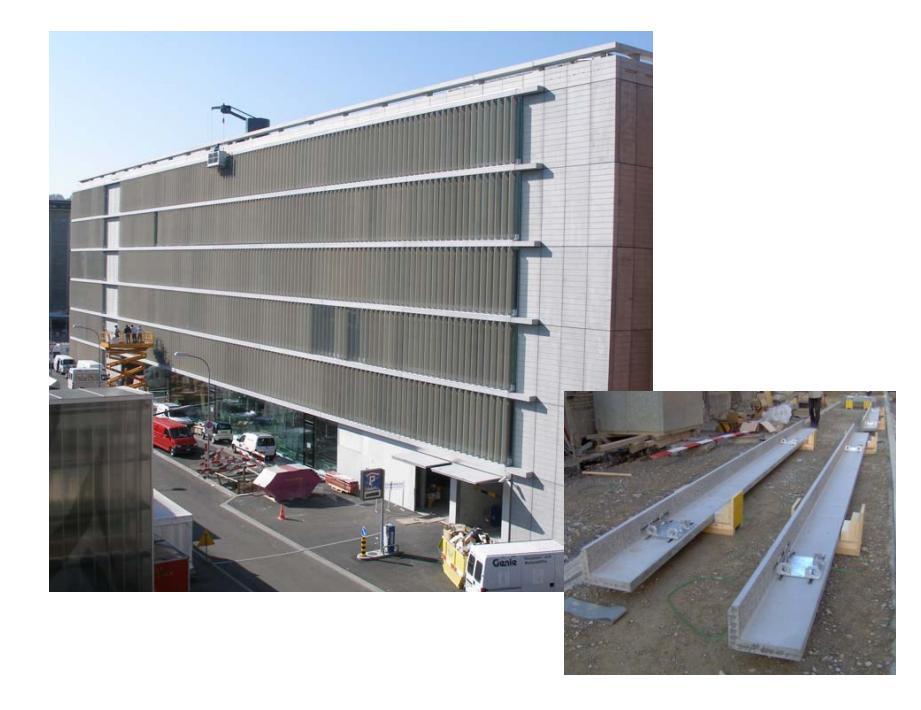
- 27
- Figure 1 Application of CFRP prestressed concrete L-shaped beams for structural façade elements in
 Zurich, Switzerland [1].
- 30

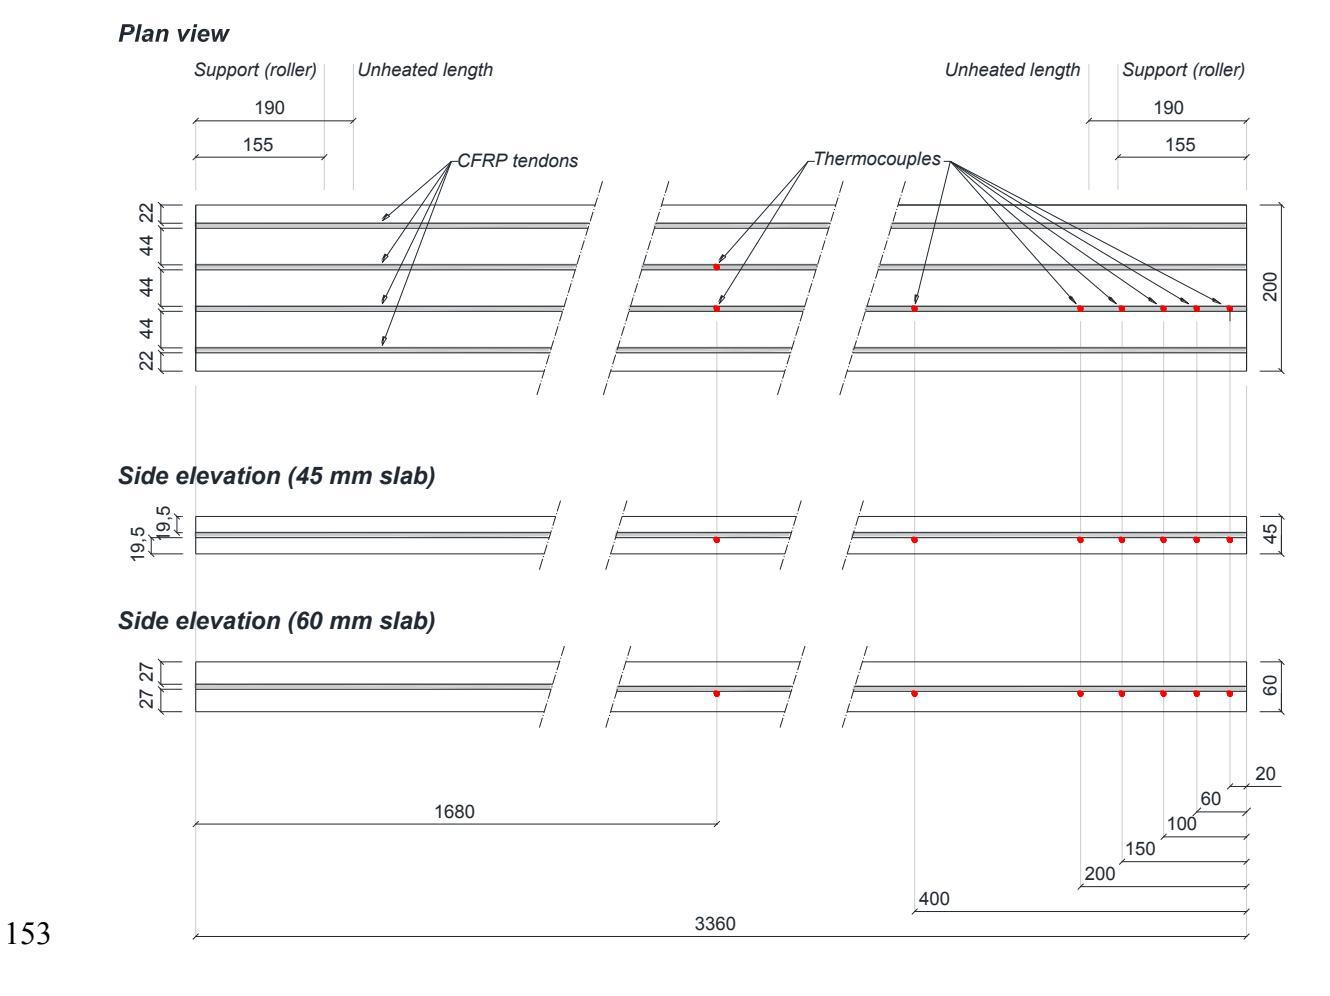
154Figure 2 –Plan view and side elevations for slabs 45 and 60 mm thick, also showing thermocouples155position (CFRP grids in the anchorage zones are not shown).

The tested slabs were similar to those used by the authors in prior research [10]. Their overall length was 3360 mm (see Figure 2) and they were prestressed with four circular pultruded, quartz sand-coated CFRP tendons stressed to an initial prestress level of 1,000 MPa. Initial prestress level was calculated based on the gross cross-sectional area of the tendons; i.e without considering the layer of sand coating (refer to Section 3.2.2 of this paper). It is noteworthy to point out that for prestressed concrete elements, the ends the slabs are commonly labelled as active end (stressing end) and passive end (dead end).

226 The setup of the specimens was aimed at assuring one-sided heating from below, so the sides 227 of the specimens were fully insulated. The heating regime was executed according to the 228 requirements of the standard time-temperature curve [32]. Since no clear influence of an 229 unheated anchorage length in excess of 160 mm had been observed during a prior series of 230 furnace tests performed by the authors [10], it was decided to maintain a constant but 231 conservative (and essentially arbitrary) unheated anchorage length of 195 mm for all five 232 specimens (refer to Figure 2). Thus, the overall exposed length of the 3360 mm long slabs was 2970 mm. 233

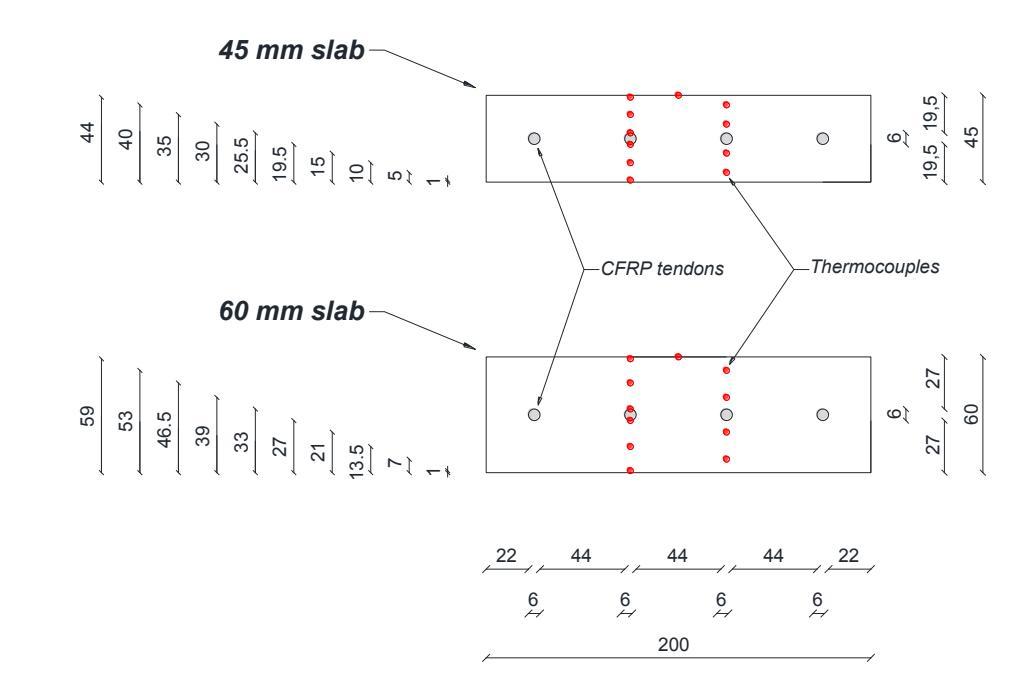
Figure 3 – Cross section for slabs 45 and 60 mm thick, also showing thermocouples position.

All CFRP tendons were located at the slab mid-depth, with a tolerance of ± 2 mm, to obtain a nominally concentric prestressing force (see Figure 3). The slabs were 45 or 60 mm thick (refer to Table 1), leading to clear concrete covers to the prestressed CFRP reinforcement of 19.5 mm and 27 mm, respectively. All slabs were 200 mm wide. Lateral clear concrete cover at the slab edges was 22 mm in all cases, with a tendon-to-tendon clear spacing of 44 mm (see Figure 3).

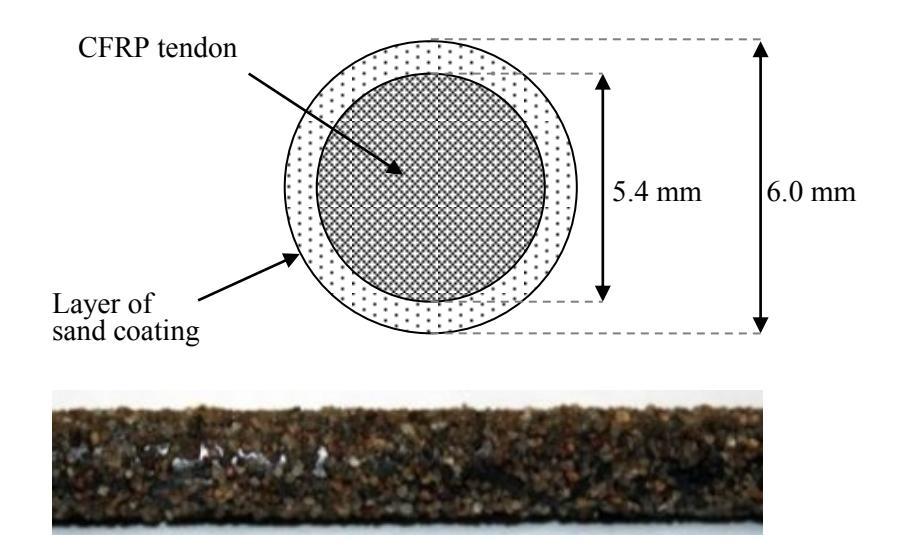
182 Figure 4 – Cross section schematic and photo of the CFRP prestressing tendon used in the current study.

The pultruded uniaxial CFRP tendons used herein were made from Tenax UTS carbon fibres, at a fibre volume fraction of 64%, and Bakelite 4434 epoxy resin. Their design tensile strength was 2,000 MPa, with a design elastic modulus of 150 GPa [35] and a characteristic ultimate strain of 1.33%. The quartz sand coating applied after the initial pultrusion process had an average grain size of 0.5 mm and was bonded using the same epoxy resin to promote a strong bond. The gross (or net) diameter of the CFRP tendons was 5.4 mm and the total diameter, including sand coating, was approximately 6.0 mm (see Figure 4).

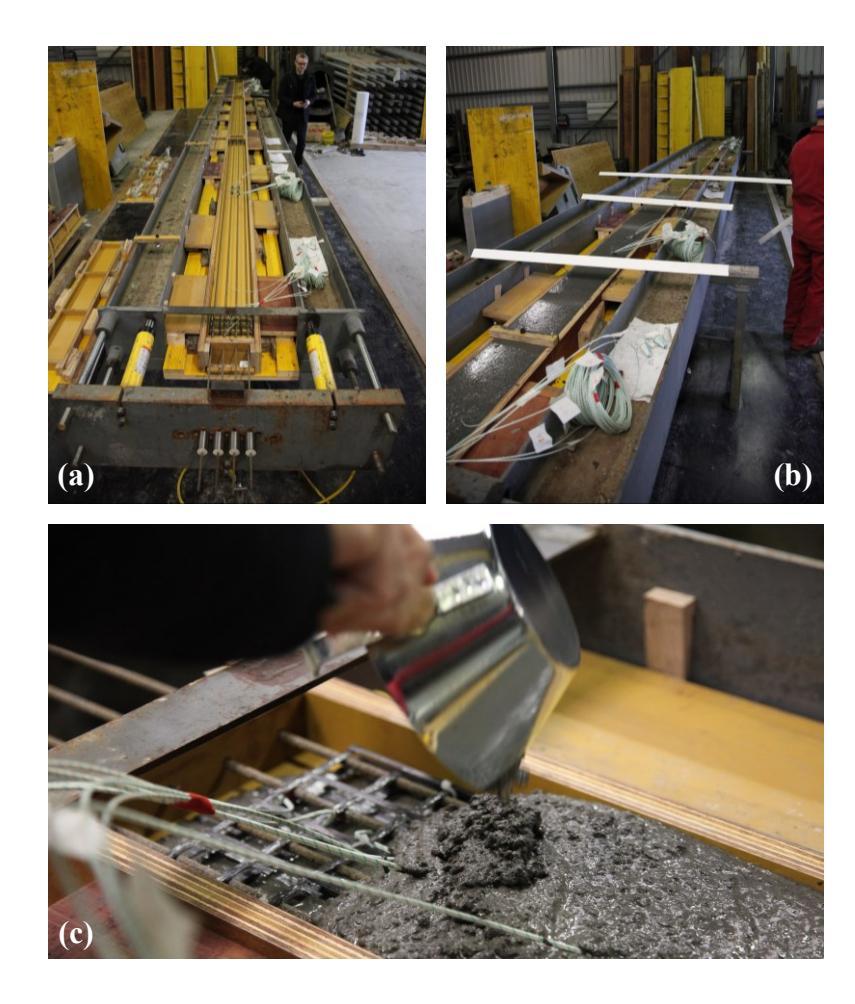
Figure 6 – Photographic sequence showing (a) prestressing bed and formwork prior to casting, (b) casting
 procedure of large-scale specimens, and (c) close-up during casting of the anchorage zone (with CFRP
 grids and thermocouples).

The formwork (i.e. prestressing bed) allowed for simultaneous casting of three prestressed 195 196 slabs at one time (see Figure 6). The mixing and casting procedure was performed according 197 the exacting standards for typical precast concrete elements fabricated by the industrial 198 partner (a Swiss precast company). After casting, slabs were covered with polyethylene 199 sheeting for 72 hours before the prestress was transferred and the forms stripped. The slabs 200 were cured in a moist condition under polyethylene sheets for a further five days, and were 201 then left to cure under ambient conditions for 1.5 months in the production hall of the precast 202 company before being delivered to the Empa Fire Testing Laboratory where they were stored 203 indoors until testing. Slabs were tested at an age of 5.2 months (testing authorities typically 204 prescribe a minimum age of 3 months for furnace testing of concrete [32]). Cube and cylinder 205 specimens were also cast to determine compressive and splitting tensile strength, as well as 206 average moisture content at the time of testing.

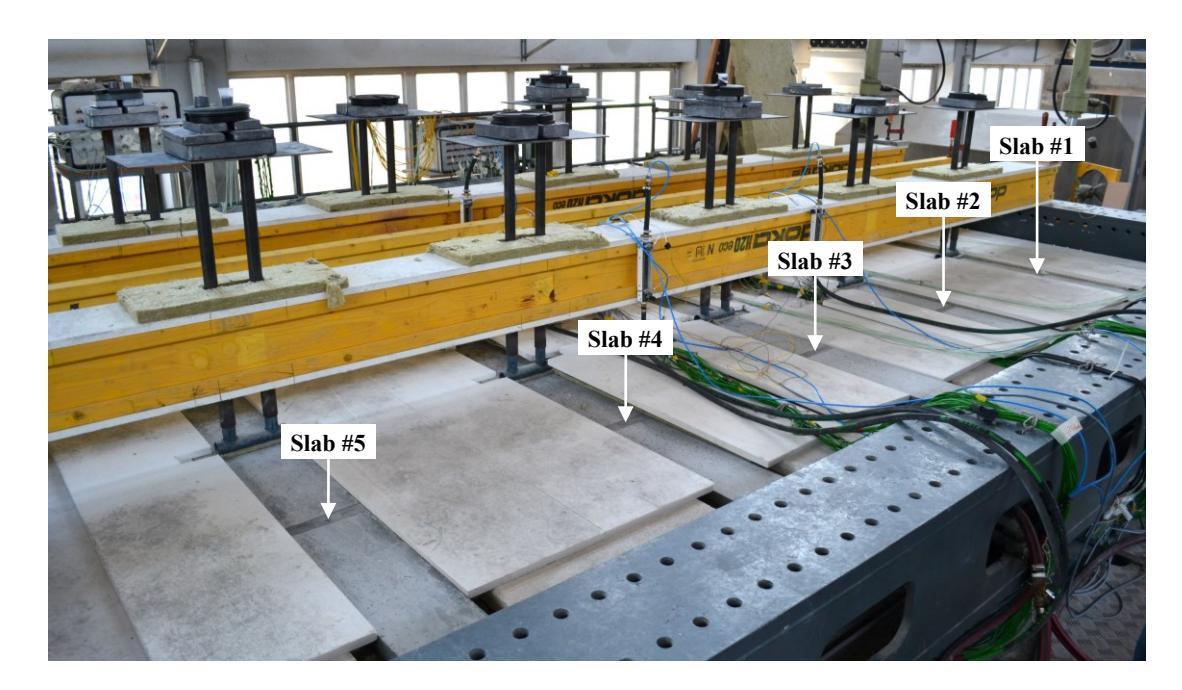
Figure 7 – Photo of the fire resistance test setup showing positions of the respective slabs and sustained
 loading technique used.

A large-scale furnace test (standard fire resistance test) was performed at Empa's Fire Testing Laboratory in Dubendorf, Switzerland. The five specimens described previously were simultaneously loaded and exposed to a standard fire (see Figure 7) using a floor furnace [32].

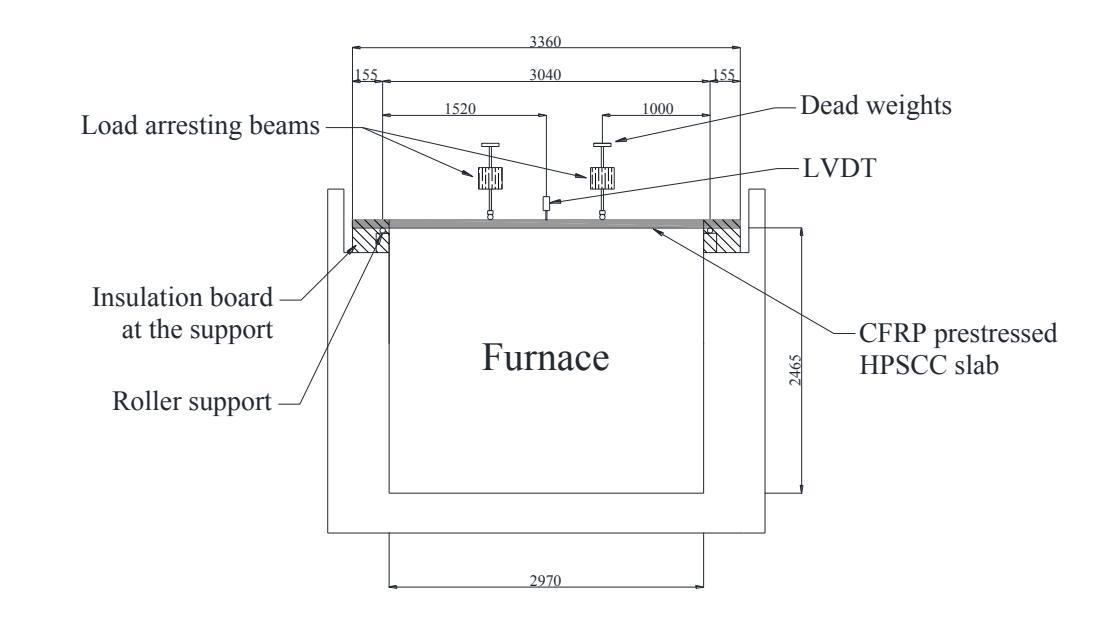
Figure 8 – Test setup, loading, and selected instrumentation for the fire resistance test (side elevation).

Sustained mechanical loading was applied to simulate an in-service condition for the slabs, in simply-supported four-point bending. End supports (rollers) were placed 155 mm from the slabs' ends, leading to a structural span of 3050 mm (see figures 8 and 9). The applied load was designed to be sufficient to achieve decompression at the extreme tension fibre within the constant moment region (i.e. $\sigma_{c,bottom} = 0$ [MPa]); this corresponds to a typical design service load condition for a façade element of this type in a real building [1]. Loading was imposed 30 minutes prior to start of heating. Prestressing losses due to elastic shortening, shrinkage and creep of the concrete were considered and calculated based on results from prior experimental studies performed for similar HPSCC mixes [36]. Total prestressing losses ($\Delta \sigma_p^{Total}$) were calculated as:

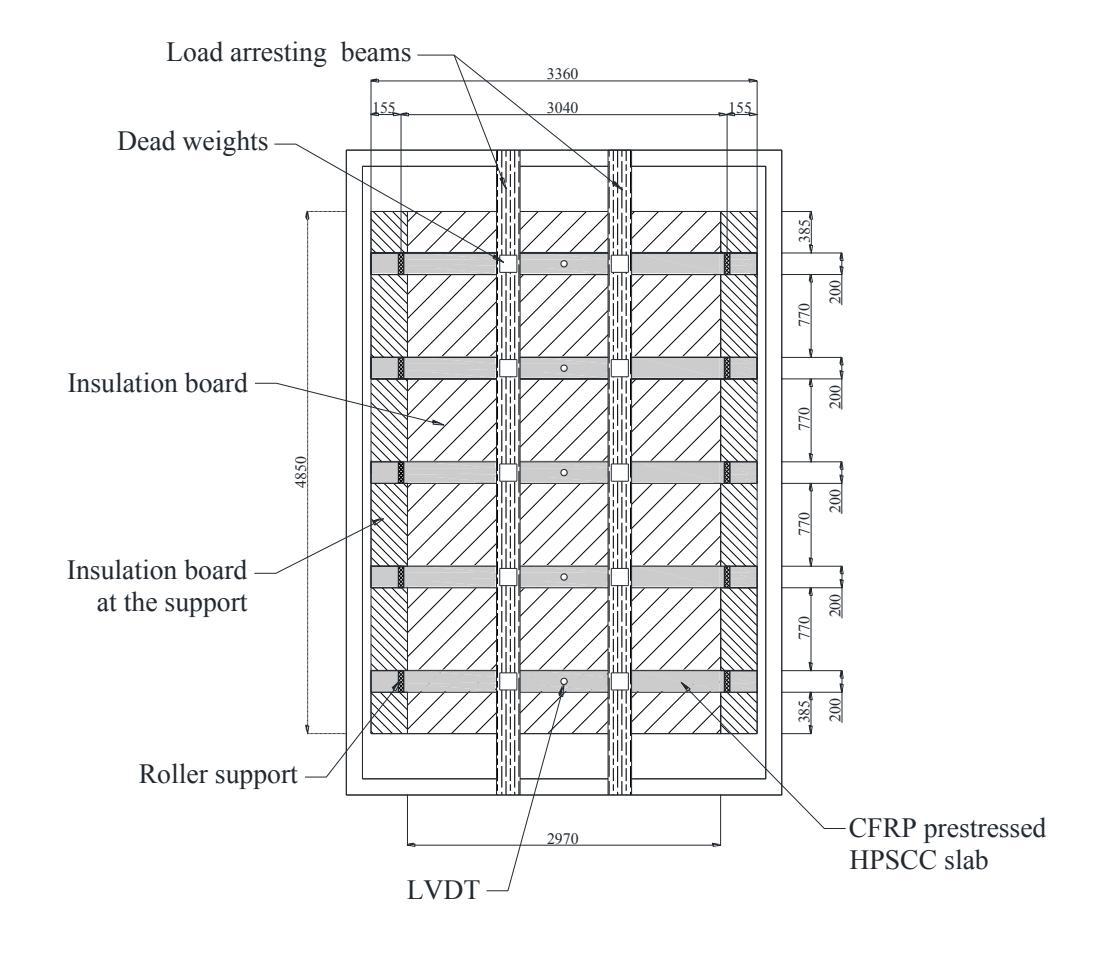
Figure 9 – Layout of test specimens during the fire resistance test (plan view).

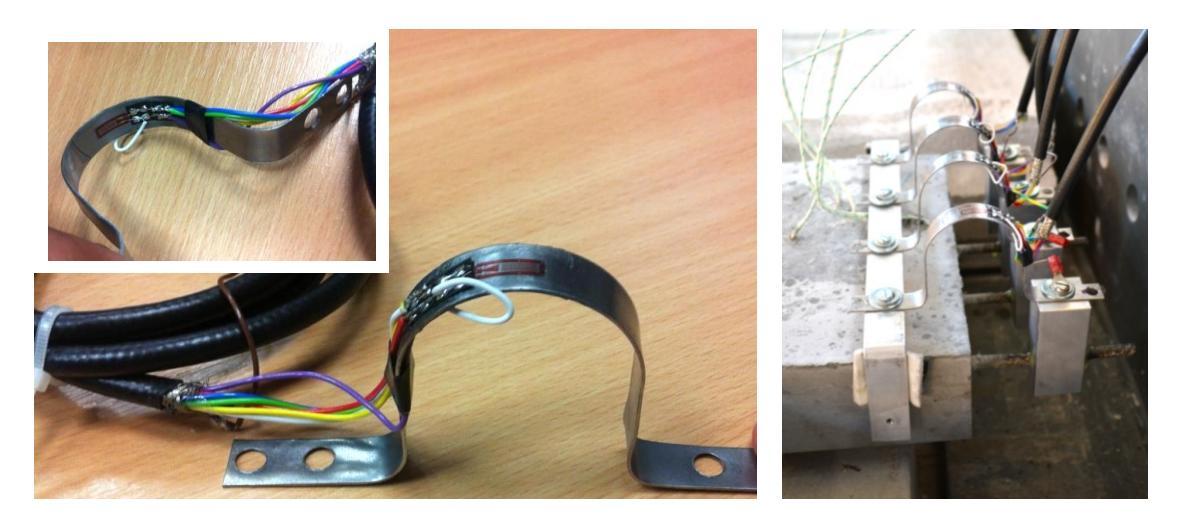
308Figure 10 – Custom-fabricated 'pi-gauges' (left) and gauges installed for measuring tendon draw-in for309all four tendons at one end of Slab #1 (right).

295 Draw-in gauges - Aiming to measure possible draw-in of the CFRP tendons during • 296 testing due to loss of anchorage from heating or splitting cracking of the anchorage zones 297 high accuracy yet economical, semi-disposable custom-built "pi" displacement gauges 298 (pi-gauges) were designed and fabricated for the project described herein (one of these 299 gauges is shown in Figure 10). These were placed at either end of the slabs (active and 300 passive ends). These 'pi-gauges' consisted of foil strain gauges applied to a piece of 301 curved spring steel, which when flexed due to deformation could be correlated to 302 displacement. To obtain the required accuracy of the instruments, the gauges were 303 designed with a half-bridge connection with strain gauges placed on the top and bottom of each pi-gauge (see Figure 10). The pi-gauges were calibrated over a displacement range of ± 4 mm. Draw-in measurements were performed for all four CFRP tendons, at both ends of slabs #1, #2, and #3 (refer to Table 1).

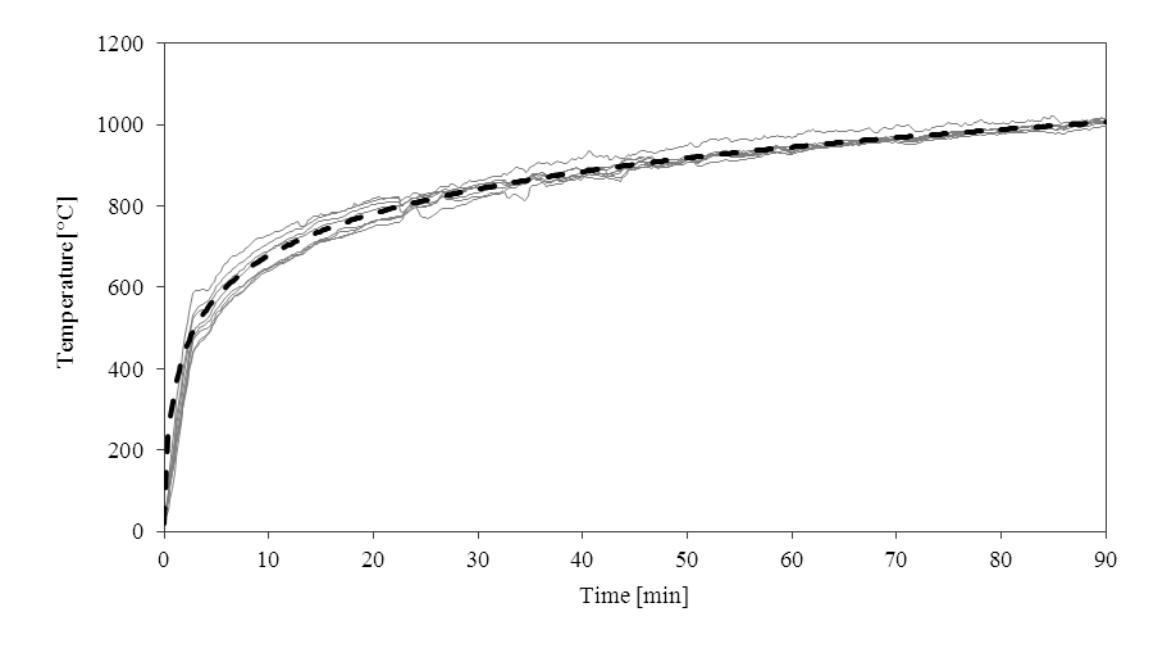
Figure 11 – Furnace gas temperatures measured by the plate thermometers along with the objective
 standard time-temperature curve [32].

318 Temperature measurements from the eight plate thermometers inside the furnace are shown 319 in Figure 11 along with the objective time-temperature curve. Although compliant with the testing standard [32], the temperature measurements show substantial deviation in the temperature measured inside the furnace, especially during the first 20 minutes (see Figure 12). Due to the obvious technical challenge of precisely controlling the furnace to follow the rapidly growing prescribed time-temperature curve [32] during early stages of the test, most testing standards do not prescribe an allowable deviation during the first 5 minutes (see Figure 12).

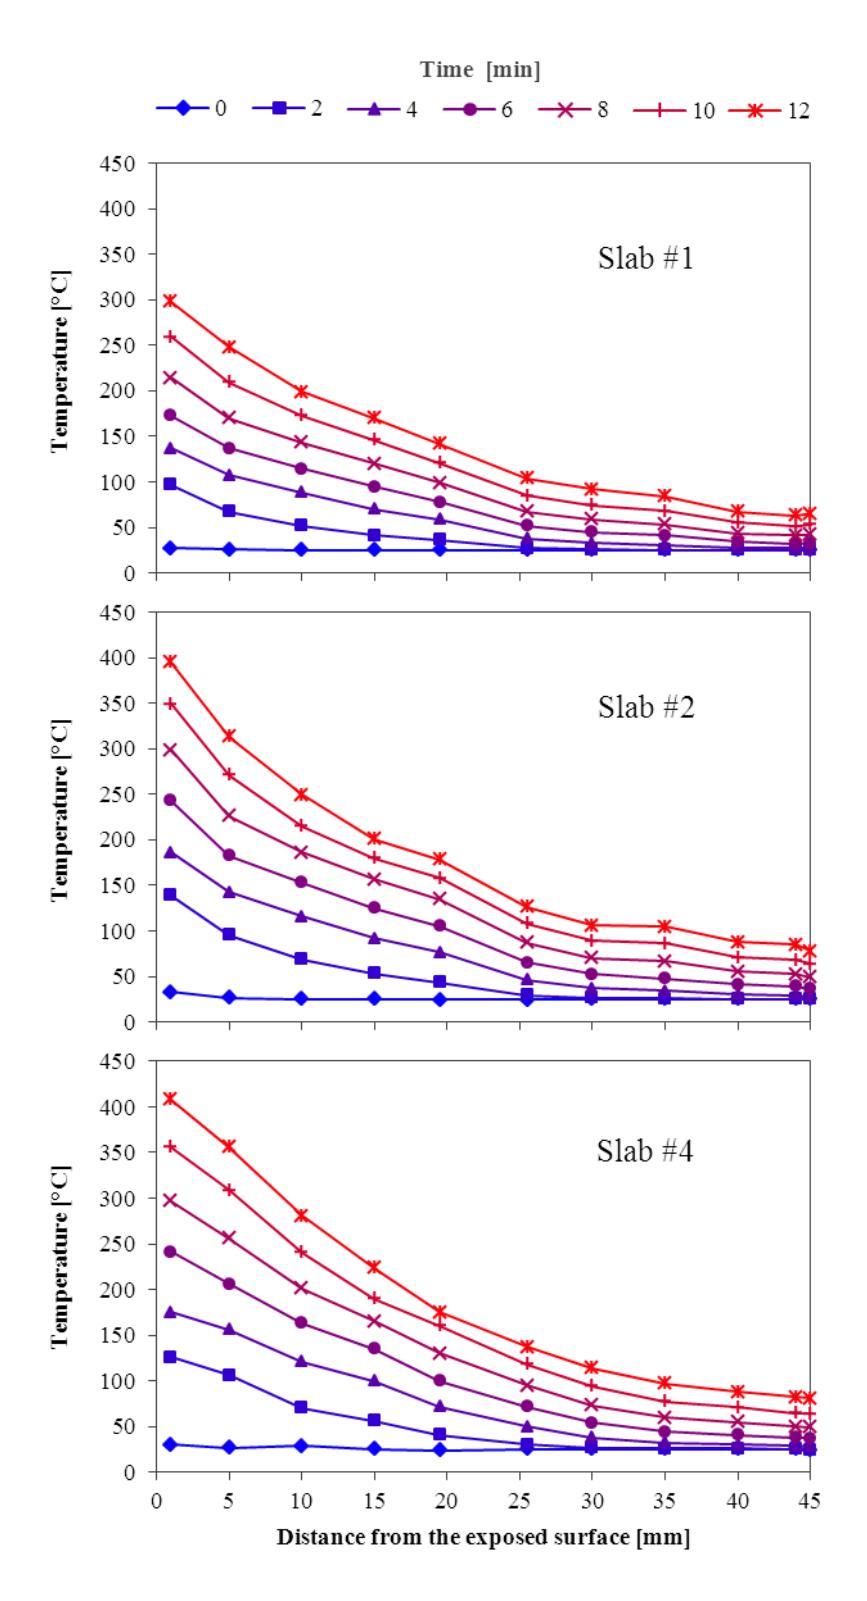
Figure 13 – Midspan through-thickness temperature distributions for 45 mm thick slabs at 2 minute
 intervals during the first 12 minutes of the furnace test.

A comparison of through-thickness temperature distributions measured at midspan is shown in figures 13 and 14 for slabs 45 and 60 mm thick, respectively. Temperature for the first 12 minutes of the test are shown; the time at which the first of the slabs failed due to explosive spalling (refer to Table 1).

338 Considerable variation of through-thickness temperature distributions was observed for slabs 339 with equivalent thickness, possibly demonstrating poor homogeneity of the thermal 340 exposures for slabs tested simultaneously during a single furnace test; this is despite the 341 temperatures measured by the plate thermometers complying with the test standard. Figure 13 342 suggests a more rapid through-thickness temperature increase for 45 mm thick slabs 343 positioned near the centre of the furnace, slabs #2 and #4, relative to Slab #1 positioned near 344 the edge of the furnace (see Figure 7). A similar, however less severe, comparison is shown 345 in Figure 14 for Slab #3, positioned at the centre of the furnace, and Slab #5, positioned near 346 the edge of the furnace.

Slab #2 failed after 12 minutes, whereas the virtually identical Slab #1 failed due to loss of anchorage after 42 minutes of fire exposure (refer to Table 1); Figure 13 shows that Slab #2 experienced more rapid heating during the early stages of the test. This suggests a possible important influence of the time-history of through-thickness temperatures on the occurrence of heat-induced concrete spalling [11]. For instance, Slab #2 spalled when the measured temperature 1 mm from its exposed surface was 400°C, while for Slab #1 the temperature at the same location was only 300°C. The possibility that this was due to misplacement of thermocouples during casting was discarded since equivalent temperature differences
between slabs #1 and #2 were observed for temperatures measured at various positions in the
slab (e.g. 5, 10, and 15 mm from the exposed surface).

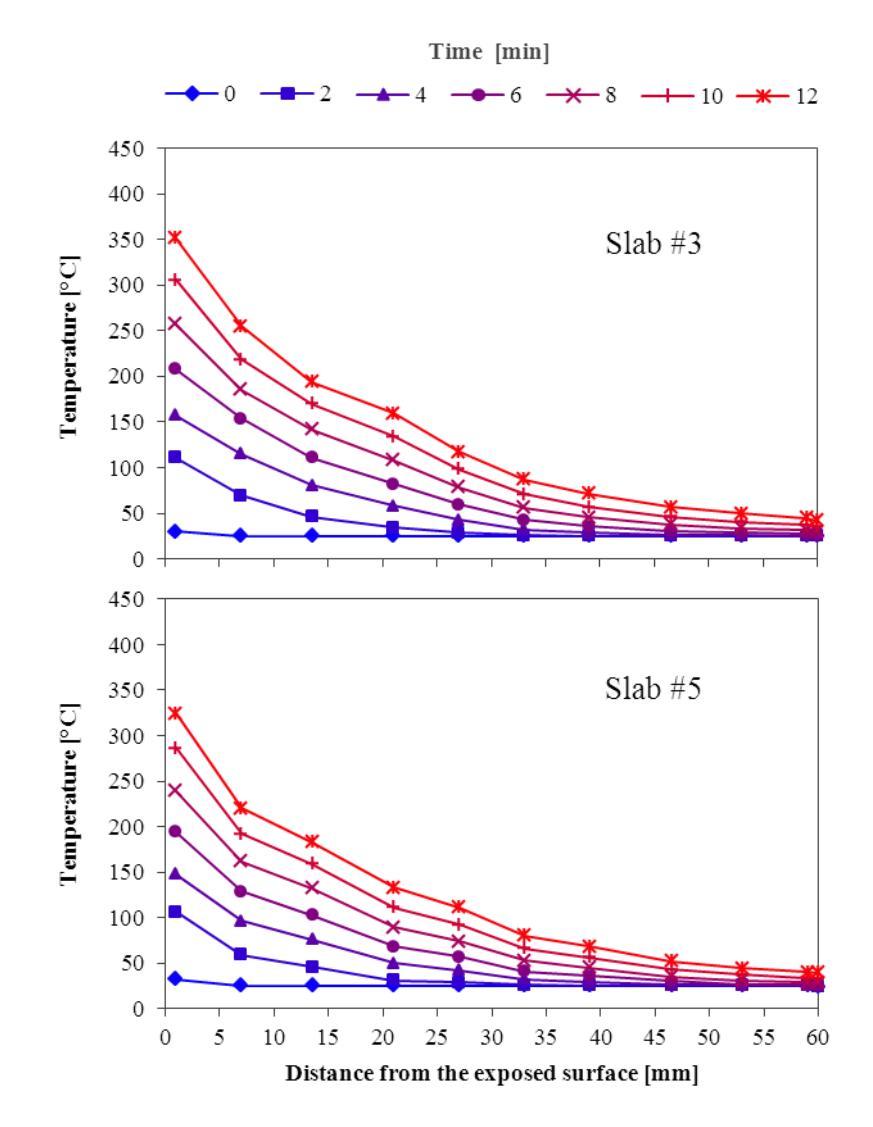
352Figure 14 – Midspan through-thickness temperature distributions for 60 mm thick slabs at 2 minute353intervals during the first 12 minutes of the furnace test.

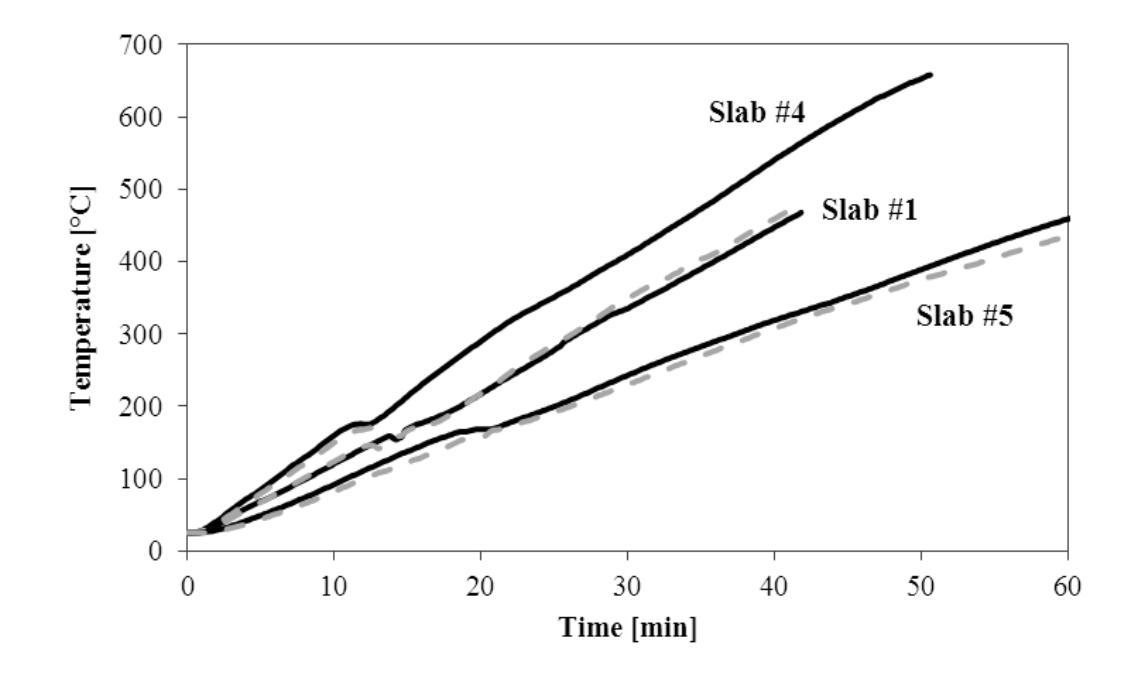
374Figure 15 - Comparison between temperatures of the CFRP tendons measured at midspan (continuous375line) and at 400 mm from the end of the slab (segmented line) for slabs #1, #4, and #5.

Figure 15 shows a comparison of the temperature of the CFRP tendon at midspan and at 400 mm from the end of the slab (still within the heat exposed zone of the slab, see Figure 2) for slabs #1, #4, and #5 (all of which failed due to loss of anchorage). Figure 15 suggests that the temperature of the CFRP tendons was essentially constant over the exposed length of the slabs. It is noteworthy that thermocouples were placed along the lower edge of an interior CFRP tendon, and therefore recorded the temperature at the interface between the tendon and the concrete, rather than the temperature of the CFRP itself. Due to the low thermal inertia of the CFRP tendons relative to that of concrete, the temperature inside the tendon may be lower than that at the tendon-concrete interface in the fire exposed zone (e.g. at midspan); while the opposite may be true in the unheated overhangs.

The first longitudinal cracks were observed at the unexposed surface – This occurs when
 temperature of the CFRP tendons at midspan was between 320 and 390°C (refer to
 Figure 15), regardless of the temperature in the unheated overhangs (e.g. 200 mm from
 the end of the slab, refer to Figure 16). Longitudinal splitting cracks were first observed
 at the unexposed surface (i.e. top surface), near the midspan region (see Figure 20).

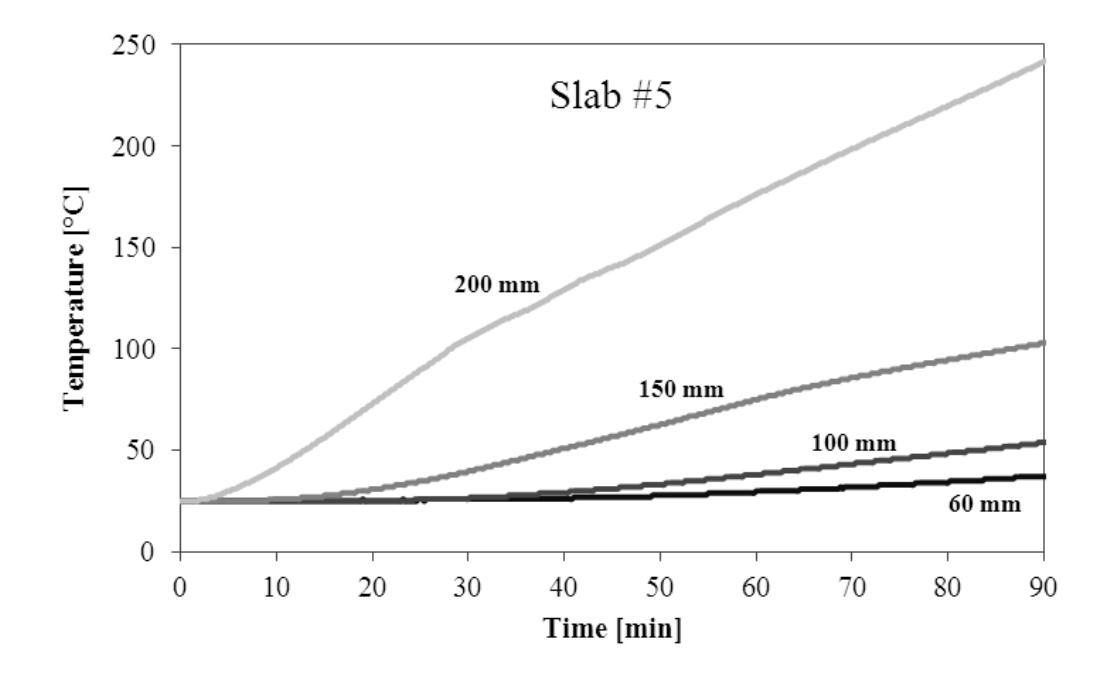
Figure 16 – Typical temperature within the unheated overhang for a central CFRP tendon (Slab #5, 60
 mm thick), for distances of 60, 100, 150, and 200 mm from the end of the slab.

Figure 16 shows a comparison of the temperatures measured in the anchorage zone for Slab #5, demonstrating the effectiveness of maintaining a 'cool' anchorage zone when designing for unheated overhangs.

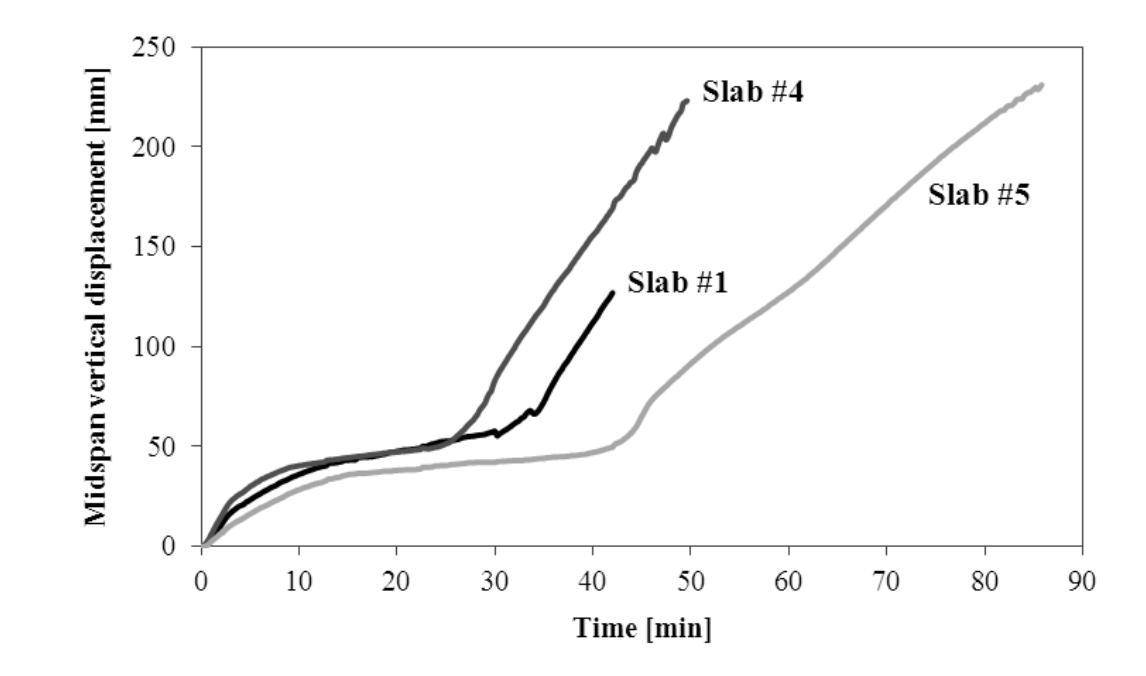
Figure 17 – Time-history of midspan vertical displacement measurements for all slabs that failed due to
 loss of anchorage (slabs #1, #4, and #5).

380 Figure 17 shows the time-history of midspan vertical displacements for the slabs that failed 381 due to loss of anchorage. During the early stages of the test, midspan deflections were induced predominantly by thermal bowing. During this stage an obvious influence of the 382 383 slabs' thickness was observed [37]; wherein thicker slabs experienced less vertical midspan 384 deflection due to lower thermally induced curvatures. Comparison of midspan deflections for slabs #1 and #4 (both 45 mm thick), during the first 10 minutes of the tests, shows that the 385 more rapid increases of through-thickness temperature (observed for slab #4, refer to Figure 386 387 13) resulted in a more rapid increase in midspan deflection due to thermal bowing (see Figure 17). For slabs #1, #4, and #5, all of which failed due to loss of anchorage, a clear change of 388 389 slope in the time-history of midspan deflections, presumed to be associated with loss of 390 anchorage, was observed (discussed later).

Figure 17 shows the time-history of midspan deflections for slabs #1, #4, and #5 all of which failed due loss of anchorage. While deflections at an early stage of the test were governed by thermal bowing of the test specimens, the observed increase in the rate of midspan deflection slope is thought to be linked to loss of anchorage (i.e. tendon slip).

Figure 18 shows draw-in measurements for CFRP tendons in Slab #1, evidencing that drawin initiated 16 minutes from the start of the test; at both the active and passive end of the slab. Thereafter, draw-in progressively increased only at the active end up to 30 minutes from the start of the start when a sudden increase in draw-in was measured at the passive end; around the time at which an increase in the rate of midspan vertical displacement was observed for Slab #1 (refer to Figure 17).

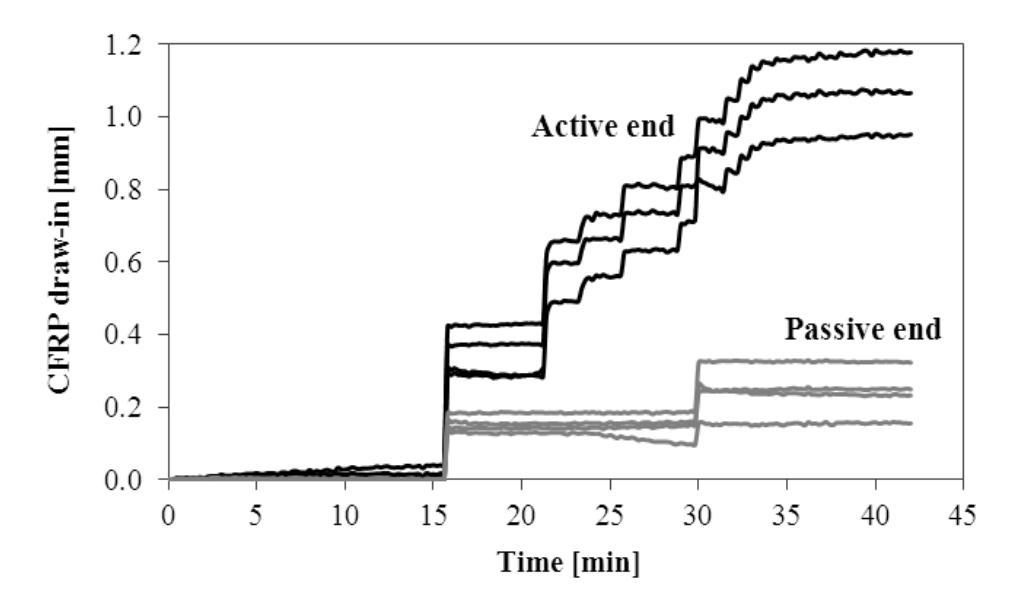
404 Figure 18 – Draw-in measurements for tendons at the active and passive ends of Slab #1 during testing.

395 Draw-in measurements were taken for all four CFRP tendons at both ends of slabs #1, #2, 396 and #3. Unfortunately, because slabs #2 and #3 failed catastrophically at an early stage of the 397 test due to explosive concrete spalling, no useful draw-in measurements were recorded for these slabs. For Slab #1 however, tendon draw-in measurements were taken until failure, at 398 399 42 minutes from the start of the test as shown in Figure 18. While no attempt was made to 400 quantify the relationship between draw-in measurements and the failure mechanism of Slab 401 #1, a qualitative analysis considering draw-in measurements, loss of anchorage, and failure is 402 presented later.

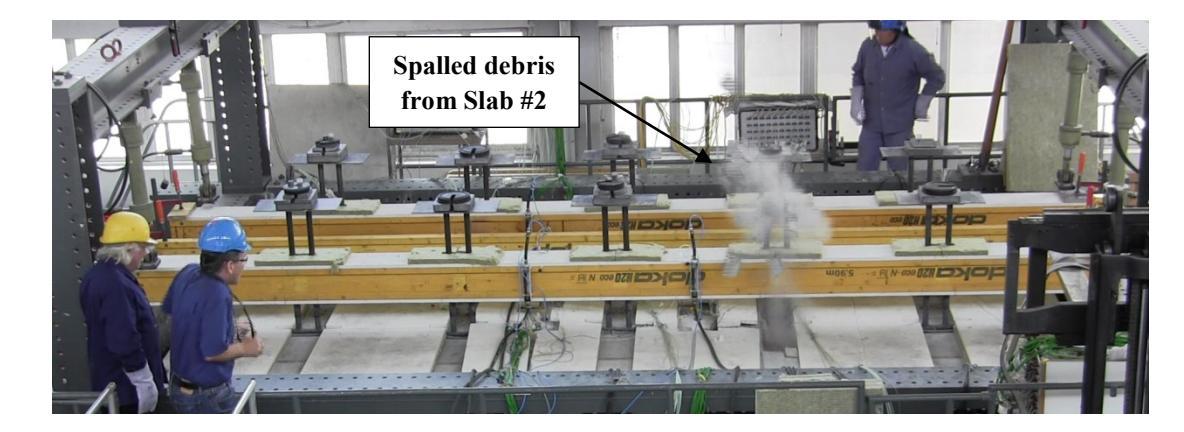
Figure 19 – Explosive spalling and immediate collapse of Slab #2 at 12' 37".

Failure of slabs #2 and #3 was driven by the occurrence of single explosive concrete spalling events, 12 and 22 minutes from the start of the test, respectively (refer to Table 1). Immediately after spalling, each of these slabs suffered catastrophic failure and collapsed into the furnace. Video stills recorded during testing showed the moment at which spalling occurred (shown for Slab #2 in Figure 19).

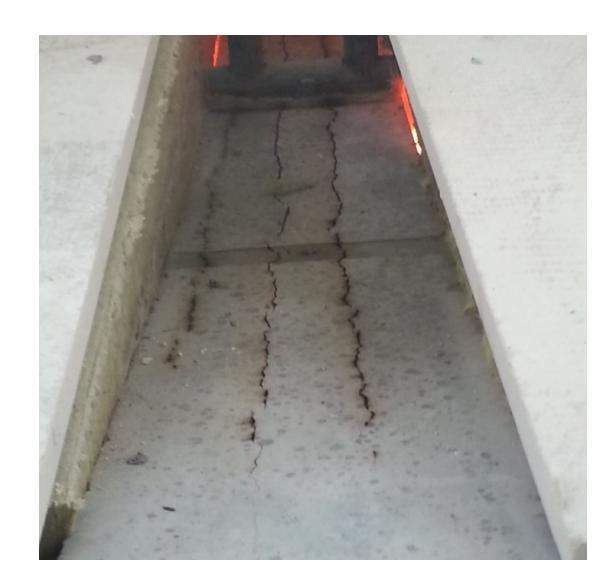
Figure 20 – Longitudinal splitting cracks at the unexposed surface of Slab #4 shortly before failure.

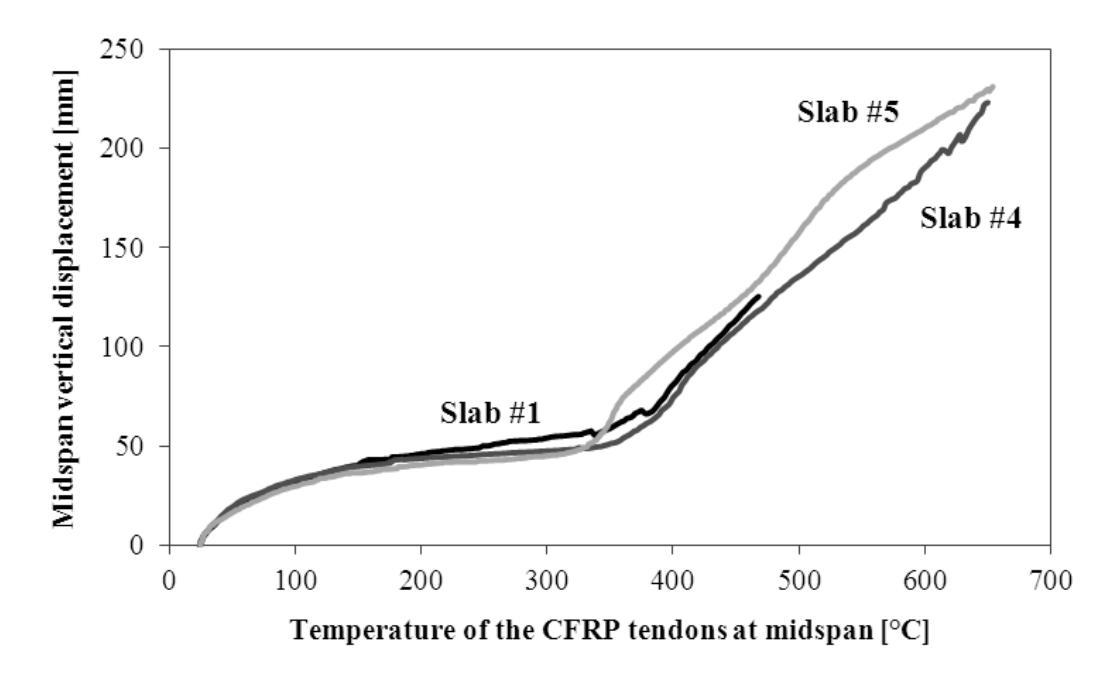
489 Figure 21 – Variation of midspan vertical displacement with temperature of the CFRP at midspan.

478 Interestingly, the time-history of midspan vertical displacement directly correlates with the 479 temperature of the CFRP tendons at midspan (see Figure 21), rather than temperature in the 480 unheated overhangs. This physical mechanism is thought to be associated with heat-induced 481 reduction for strength and stiffness of the epoxy resin within CFRP tendons; since the epoxy 482 resin is essential for anchorage to be maintained [4], and moreover for preserving interaction 483 and stress transfer between individual carbon fibres. Thermogravimetric analysis performed 484 by the authors on these particular CFRP tendons showed that decomposition of the epoxy 485 resin rapidly initiates at around 290°C [4]; in accordance with the temperature of the CFRP 486 tendons at midspan for which an increase in midspan vertical displacement was observed 487 (refer to Figure 21).
