Effect of beam web bolt arrangement on catenary behaviour of moment connections

Li, L, Wang, W, Chen, Y & Lu, Y 2015, 'Effect of beam web bolt arrangement on catenary behaviour of moment connections', *Journal of Constructional Steel Research*, vol. 104, pp. 22-36.
<https://doi.org/10.1016/j.jcsr.2014.09.016>

Effect of Beam Web Bolt Arrangement on Catenary Behaviour of Moment Connections

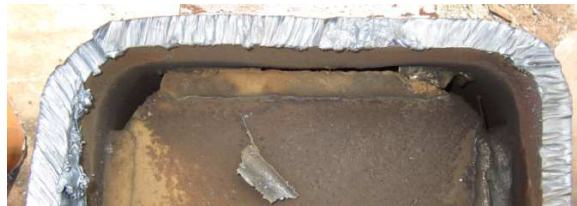
Fig. 9. Separation between the bottom inner-diaphragm and column wall on the west side in Specimen SI-WB-2.

Whereas flexural failure occurred in the critical beam regions in both specimens, specimen SI-WB-2 exhibited a more complex failure process and it also involved local failure (fracture) in the column wall. Close inspection revealed that the bottom inner-diaphragm within the column connection region had separated, as shown in Fig. 9, thus the column wall had to transfer the tension force of the beam bottom flange, leading to large local deformation and eventually fracture in the column wall. It should be noted

Particularly, in order to capture the local failure of the column wall on the west side in Specimen SI-WB-2, it is necessary to reproduce the separation between the bottom inner-diaphragm and the column wall in the test (refer to Fig. 9). For this purpose, special meshes were set at the western part of the bottom inner-diaphragm, whose material possessed a relatively small fracture strain limit. Thus this part could fracture in advance simulating the separation as stated above, which is a precondition for the subsequent fracture of the adjacent western column wall.

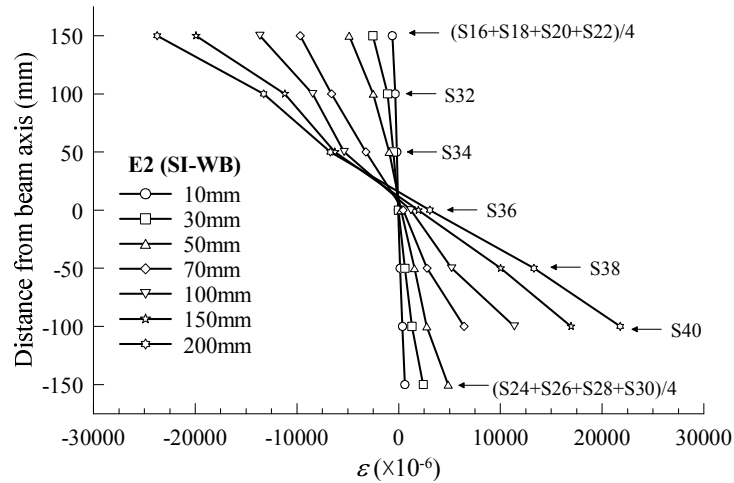
Fig. 13. Strain distributions at Section E2 before bottom flange fracture at Section E3.

Fig. 13 plots the strain distributions of Section E2, which was adjacent to the critical Sections E3, up to the fracture of the bottom flange. Note that some data points are missing because of damage to the corresponding strain gauges. It can be observed that Section E2 also exhibited clear flexural behaviour in the early stage of the response (up to a displacement of about 50mm). With increased loading, the tensile strains at the bottom

flanges and compressive strains at the top flanges grew rapidly because of large plastic deformation. At the later stage the deformation was overwhelmed by the plastic strains, with the maximum strain values exceeding 0.03% before the bottom flanges fractured. This indicates that the critical section was able to achieve almost full plasticity at the verge of the flexural failure.
