Experimental study on fallout behaviour of tempered glass façades with different frame insulation conditions in an enclosure fire

Wang, Y, Sun, J, He, L, Wang, Q & Rush, D 2018, 'Experimental study on fallout behaviour of tempered glass façades with different frame insulation conditions in an enclosure fire', *Proceedings of the Combustion Institute*. <https://doi.org/10.1016/j.proci.2018.07.111>

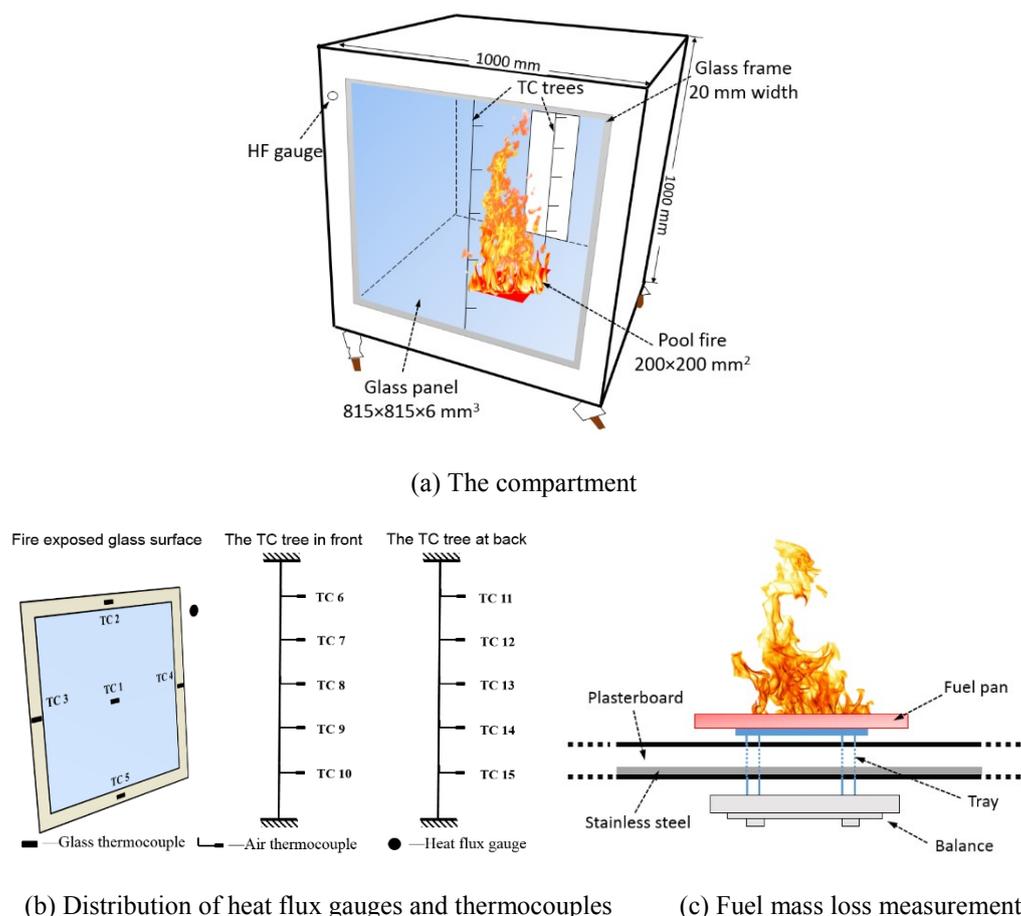
A compartment with an external dimension of $1000 \times 1000 \times 1000 \text{ mm}^3$ was built to resemble the fire conditions in glass façade furnished buildings, as shown in Fig. 1(a). In the compartment model, one face of the wall is totally glass and its opposite side is a door which is to resemble the office in the high-rise buildings. The walls of this enclosure were constructed of 5 mm stainless steel lined with 20 mm-thick plasterboards. To the authors' knowledge and survey, an estimated range of glass façade panel dimension is from $300 \times 300 \text{ mm}^2$ to $6000 \times 6000 \text{ mm}^2$, tempered glass panels of $815 \times 815 \text{ mm}^2$, 6 mm thick, were installed into the front wall in the present work. The glass frame was made of 1 mm thick stainless steel and capable of installing glass panels with different thicknesses. Stainless steel was selected due to its relatively stable behavior in fire compare with other frame materials, such as aluminium extrusion, timber or plastic. In each test, the pressure from frame to the glass in the thickness direction was controlled by four screws. Since the maximum expansion, less than 1 mm, is smaller than the normal gap of several mm between the frame and the glass panel [4, 19], no in-plane restraint from the frame existed in the experiments, thus simulating realistic conditions as closely as possible. In addition, a ventilation opening of $200 \times 1000 \text{ mm}^2$ was incorporated into the back wall of the compartment and a pool fire with a dimension of $200 \times 200 \text{ mm}^2$ was positioned at the center of the compartment. The opening factor of the compartment was 0.033 and is representative of an office the

Fig. 1. The schematic of compartment used for the experimental tests.

Fig. 1. The schematic of compartment used for the experimental tests. (a) The compartment; (b)

Distribution of heat flux gauges and thermocouples; (c) Fuel mass loss measurement.

The measurement systems included the sheet and sheathed thermocouples (TCs), heat flux (HF) gauge, mass loss balance, digital camera and data acquisition. The sheet thermocouples were attached to the glass panes to detect the surface temperature via their high heat-conducting sheets, which is made of aluminium alloy with a high heat conductivity of $226 \text{ W/m}\cdot\text{K}$. The dimension of sheets is approximately $25 \times 15 \text{ mm}^2$, thus it can increase the contact areas between detected objects and a temperature-sensing element. Two TC trees, 30 mm away respectively from the glass wall and back wall, were positioned at the center line of the compartment, as shown in Fig. 1(a). In each tree, five

sheathed thermocouples were fixed equidistantly (158 mm) to measure the gas temperature. Meanwhile, five sheet thermocouples were employed to record the glass surface temperatures at the fire side: four TCs were attached in covered areas and only one at the center of the fire-exposed surface. It should be noted that both sheathed and sheet TCs were K-Type thermocouples with a measurement range of 0-1200 °C and sensitivity of 41 mV/°C. The uncertainty of TCs was estimated at 10-20% [20].

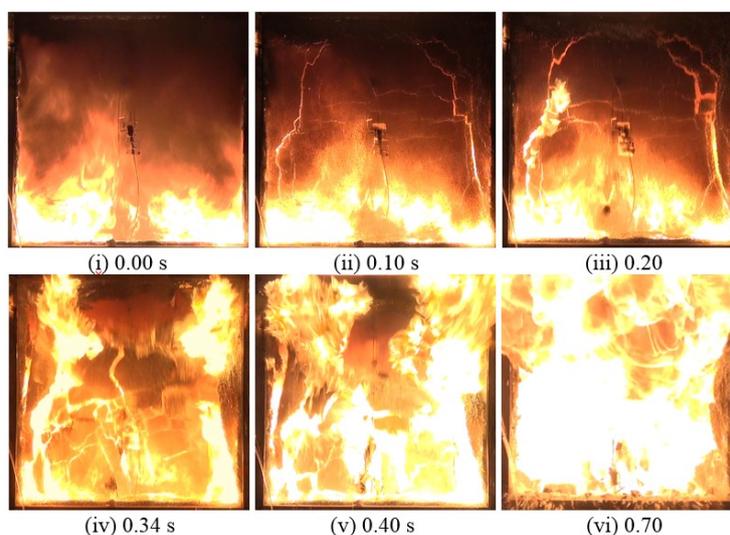
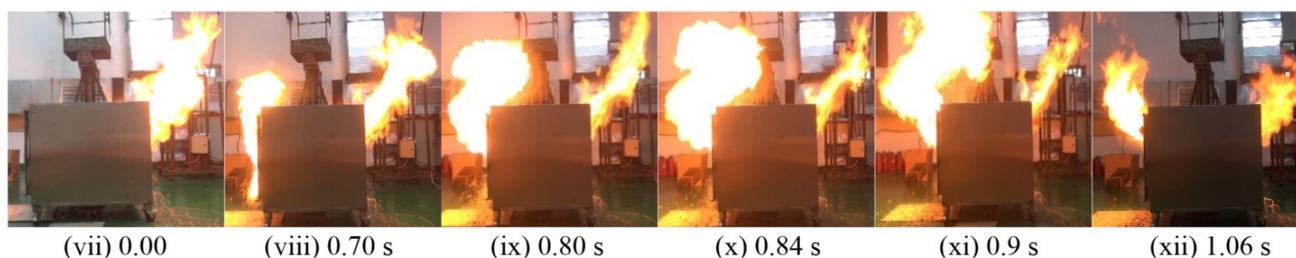
(a) Breakage and fall out

(b) Side view of window-ejected flame (glass located at left side)

Fig. 2. The process of glass fallout and flame spread in Test 3.

Fig. 2. The process of glass fallout and flame spread in Test 3. (a) Breakage and fall out; (b) Side view

of window-ejected flame (glass located at left side)

Fallout of the tempered glass, if critical breakage conditions were satisfied and cracks initiated, occurred very quickly. As an example, the failure of Test 3 is shown in Fig. 2(a). The process only took 0.70 seconds from the crack initiation to complete fallout. It appears that two primary cracks initiated from the top edge of the glass panel and dominated the first 0.2 seconds of breaking. Once the glass had started to fall out, the fallout of the glass allowed a portion of the ejected fuel vapours to ignite outside the compartment. Meanwhile, the whole glass panel broke into a large number of small pieces and started to fall out. This phenomenon occurred in other tests as well. The crack initiation and

Fig. 2(b) demonstrates the ejected flames after the glass completely fell out. The glass fallout affects the ventilation to the compartment which in turn affects the fire dynamics both to the interior and exterior of the compartment. At the front side, the flame with large momentum spread quickly in both horizontal and vertical directions, with the largest visible flame height of 2.1 m above the glass top edge and the largest horizontal distance of 0.7 m from the glass surface. A scale ruler software was used to measure the visible flame dimension in video and pictures using the compartment size as a reference. In the other tests, the ejected flame heights were all above 2.0 m. After 0.36 s, the burning went back to the new stable status again. The ventilation-controlled fire in the fully developed stage switches to a fuel-controlled fire due to glass fallout. Because of the significant effect of glass fallout, we can define the compartment fire development as pre-fallout and post-fallout stages. The effect of ventilation changes on the critical fallout parameters is discussed in the following section.

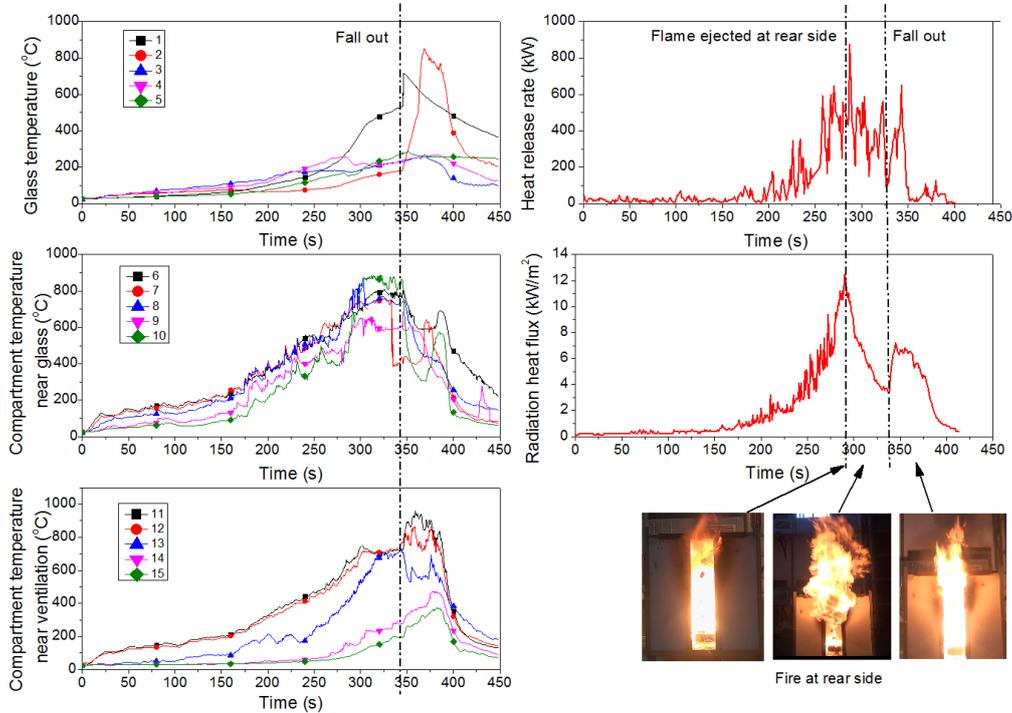
convection, conduction in the remaining tests) were recorded and compared. The parameters in Test 3 are shown in Fig. 3. According to HRR variance, the flashover occurred at around 250 s. From T_{11} - T_{15} , the height of neutral plane decreased gradually until the glass fallout, which can be explained simply but the ideal gas equation: the gas density decreased with the increase of temperature. In addition, the following equation can directly estimate the phenomenon [25]:

Fig. 3. The temporal evolution of the parameters in Test 3.

where h_N and H_o are the neutral plane height and vent height; T_g and ρ_g are enclosure gas temperature and density; ρ_a is the density of air outside the room. Moreover, the exposed glass surface temperature measured by TC1 started to increase much faster than the temperatures in covered areas at around 250 s and the glass fell out at 343 s. At the post-fallout stage, it was found that the T_6 - T_{10} were cooled down rapidly from 800 °C to 400 °C. Meanwhile, the T_{13} declined markedly, which indicates the neutral plane moved higher relative to the floor. The similar phenomena occurred in the other tests.

In HRR curve, it indicates a spike just after the flame ejection (291 s) occurs and is also volatile up until about 350 s. However, it did not change the HRR greatly which stabilized between 400-600 kW. With consideration of the noise in the compartment, this HRR is reasonable. Meanwhile, the incident radiation heat flux (front side) decreased by 60%, and then slightly increased due to the glass fallout. This change in heat flux suggests that the flame radiation, rather than the smoke radiation, dominated the imposed radiation received by the glass panel.

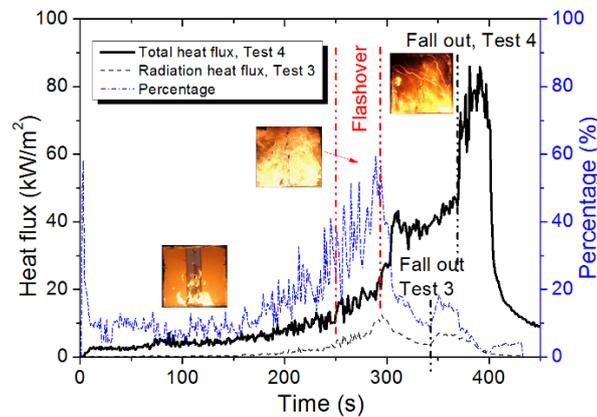
The experimental conditions are assumed identical, and the comparison of imposed total and radiation heat fluxes is illustrated in Fig. 4. It was established that convective heat transfer usually accounts for more than 80% of the glass heating, except during the flashover phase where it is approximately 60%. The convective heat transfer is shown to be the primary heat exchange mechanism between the glass panel and the enclosure fire. This is markedly different from the glass heating in

Fig. 4. The comparison of total heat flux and radiation heat flux.

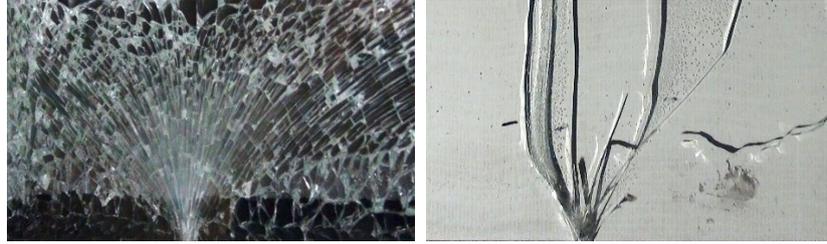
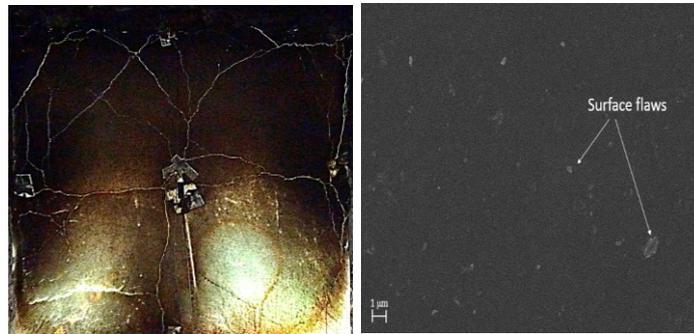
(a) Crack initiation in Test 2.

(b) Crack initiation in float glass.

(c) Crack path in laminated tempered glazing (d) The distribution of tiny flaws on the glass surface

Fig. 5. Post cracks of tempered and float glass panels after heating.

Fig. 5. Post cracks of tempered and float glass panels after heating. (a) Crack initiation in Test 2; (b)

Crack initiation in float glass; (c) Crack path in laminated tempered glazing; (d) The

distribution of tiny flaws on the glass surface.

The fan-shaped cracking pattern at the edge of the tempered glass panel, as shown in Fig. 5(a), exists, similar to that which would be found in float glass (Fig. 5(b)). This implies overloading/overstressing of edge defects in both float and tempered glass can cause failure. The “primary” cracks in tempered glass ran at a very high speed before the whole glass panel disintegrates due to the release of the pre-stress energy [27]. To catch the “primary” cracks, one additional laminated tempered glass panel was tested under the identical condition Fig. 5(c). A scanning electron microscope was used to photograph the glass surface near the panel edge, as shown in Fig. 5(d). The evident crack path and numerous tiny flaws observed confirm that the dominant failure cause of tempered glass in fire is related to the tensile stress concentration near the flaws or defects at the glass panel edges.
